UNITED STATES COAST GUARD

**REPORT OF INVESTIGATION INTO THE
CIRCUMSTANCES SURROUNDING THE
GROUNDING OF THE
M/V MONTROSE
ON FEBRUARY 28, 2007**

MISLE Activity Number: 2879209
Originating Unit: Sector Baltimore
MISLE Case Number: 339349

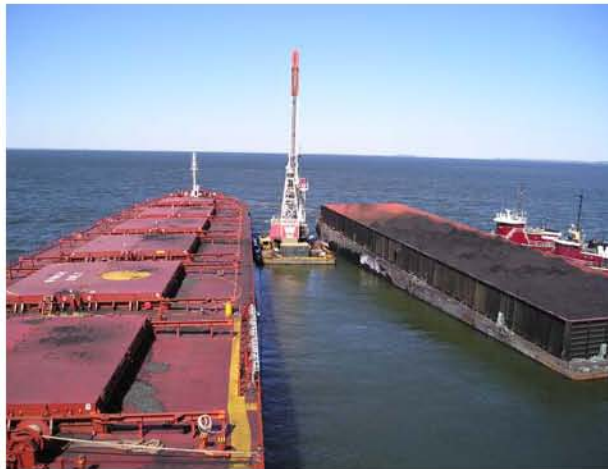
Figure 1: Coal Lightering Operations on the *Montrose*
