**U. S. Coast Guard  
Marine Safety Office  
Morgan City, LA**

**Investigative Report**

**M/V MR FRED Diving Fatality: Mr. Chris Mouritsen**

**July 6, 2002  
Gulf of Mexico  
Eugene Island Block 273**

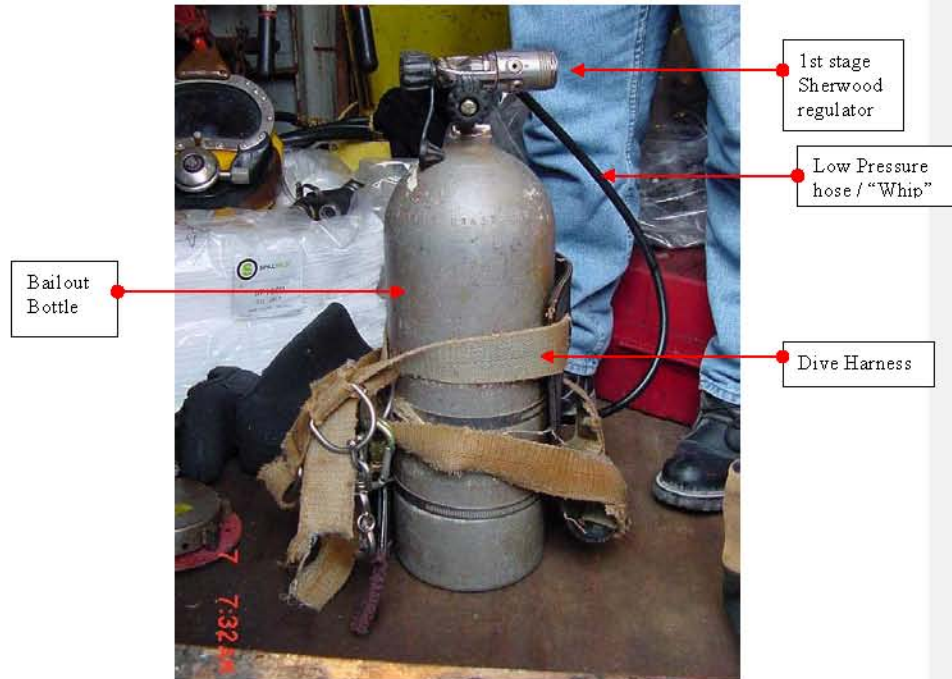
Photo 3: Mr. Mouritsen's "Bailout" Bottle, 1st Stage Sherwood Regulator, and Low Pressure Whip.

25. Mr. [REDACTED] added that Mr. Mouritsen's bailout bottle had a leak in it and that it had been leaking for at least 6 months prior to this dive. He said that Mr. Mouritsen was aware that the bottle had been leaking continually. The bottle would lose about 200psi of air per day. Mr. [REDACTED] said that the Tenders always had to refill Mr. Mouritsen's bailout bottle.

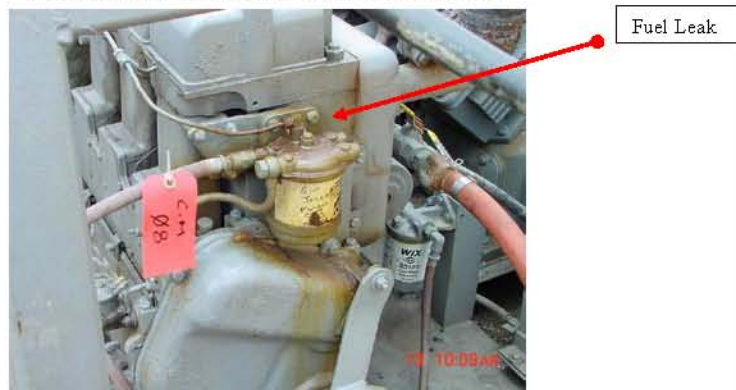
Photo 5: Location of Fuel Leak on Main Compressor

5. There were two other minor discrepancies noted with compressor CDV 197. It had a minor diesel leak at the fuel filter and it had a 3V drive-belt installed on it instead of a 4V drive-belt. Neither of these items affected the compressor's ability to supply breathing air to the diving system.

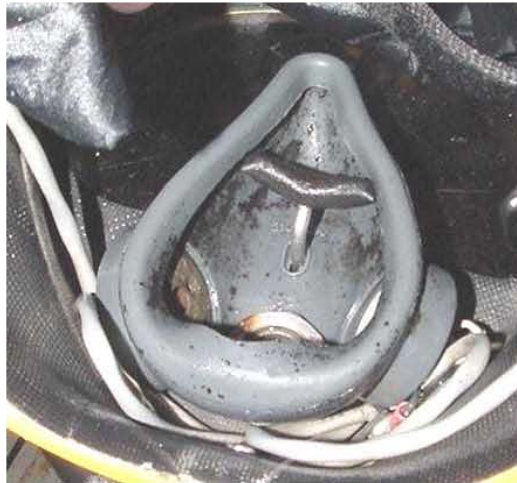
**Photo 6 : Mold in Oral Nasal Mask as Photographed by USCG Investigators on July 7, 2002**

2. A visual inspection of the helmet was conducted by the EDU. The inspection found that the helmet had no serious external physical damage. The neck ring was in good condition as was the neck dam. The neoprene in the neck dam was slightly compressed. The EDU noted that mold was growing inside of the helmet's oral nasal mask, but the mask was functional. Coast Guard Investigators noted the growth of this mold when they took possession of the gear on the morning of July 7, 2002, (see Photo 6 below).

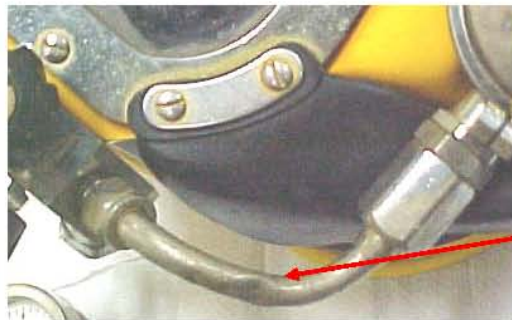
Photo 7: Dent in "Bent Tube"

EDU reported that the main helmet exhaust valve (water dump) also had dried mud around its edges. The bent tube assembly had a dent in it (Photo 7), but was able to deliver air when tested.

Dent in Bent Tube Assembly

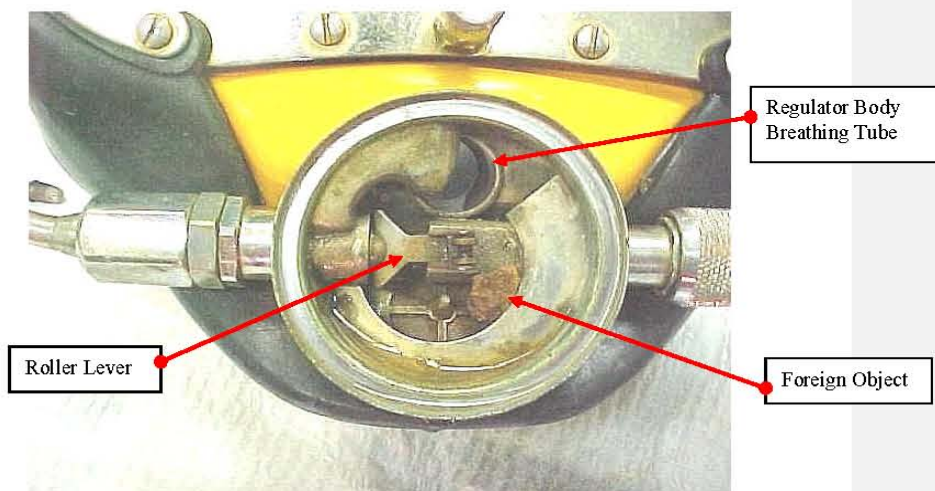
**Photo 8 : Foreign Object as Found in Regulator**

5. After the second attempt to test the helmet, the demand regulator body was opened. A foreign object approximately the size of a nickel was found inside of the regulator beneath the roller lever and on top of the bias adjustment tube (See Photos # 8 & 9 taken by LTJG [REDACTED], USCG MSO Morgan City, LA). The object left a rust colored stain on the regulator body indicating it had been present for a period of time. This object prevented the regulator from operating properly. Based on the size of the object, the EDU concluded that it could only have entered through the regulator body breathing tube. The roller lever was also noted to be loose to the point where it was outside of the manufacturer's specifications. This looseness prevented the purge button on the front of the demand regulator from providing air when depressed. The helmet was tested one

6. The foreign object was removed and the demand regulator disassembled. The internal components of the regulator were found encrusted with fine mud, which prevented them from moving freely within the regulator.

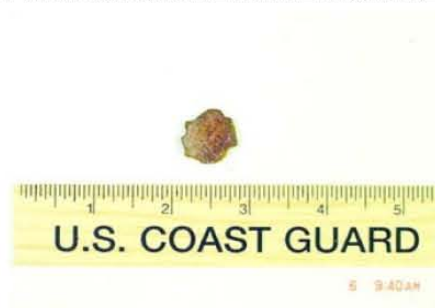
**Photo 9: Foreign Object Removed from Regulator (Below)**

7. The foreign object was later sent to "A and M Technical Services, Inc." in Houston, TX for analysis. The results of the tests showed that it was 83.49 % Iron. The remaining elements found in it were Aluminum, Silicon, Sulfur, Chlorine, Potassium, and Calcium.

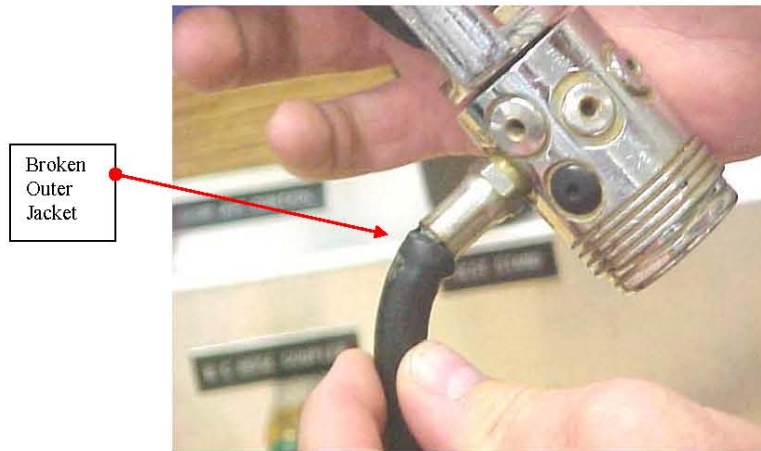
**Photo 10: Low Pressure Hose from Emergency Air Supply**

10. The emergency air supply / bailout system was also examined by the EDU. The air tank was received with the valve open and the tank empty, so an analysis of the emergency supply of breathing air could not be conducted. The outer jacket was broken at one end of the low-pressure hose (See Photo 10, taken by LTJG [REDACTED], MSO Morgan City) used to connect the tank to the helmet. The hose was tested under pressure and did not leak. It was then connected to the emergency gas supply valve (auxiliary valve) on the helmet, which was still in the position it had been in when received by the EDU. The line was pressurized, and a slight flow of air came from the auxiliary valve. The valve’s control knob was tested, and the valve opened and closed properly.

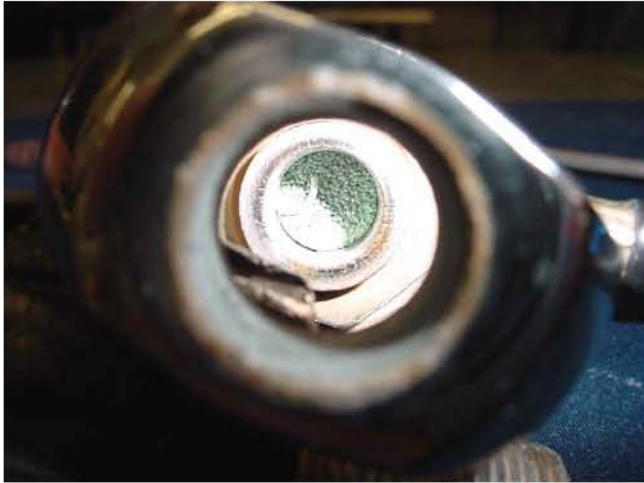
Photo 11: Blue-Green Verdigris encrusted inside 1st Stage Regulator

11. The first stage Sherwood regulator was examined and found to be leaking excessively. The regulator, typically referred to as a “dry air bleed valve,” is designed to leak at a rate of 13-27 cubic centimeters/minute in order to keep the internal parts of the first stage dry. EDU measured the regulator’s leak rate when attached to Mr. Mouritsen’s bailout bottle at 4.5 liters/minute. EDU computed that this would not have drained the tank given Mr. Mouritsen’s bottom time. Further investigation by MSO Morgan City revealed that Mr. Mouritsen had been diving for fifty minutes prior to the accident. A bleed down rate of 4.5 liters per minute over a fifty-minute period equates to a total loss of eight cubic feet of air from the tank. This leak rate would have left him with forty-two cubic feet of air in his 50 cubic foot bailout bottle at the time of the emergency. In addition, the filter in the regulator was encrusted with blue-green verdigris as seen in Photo 11 below.

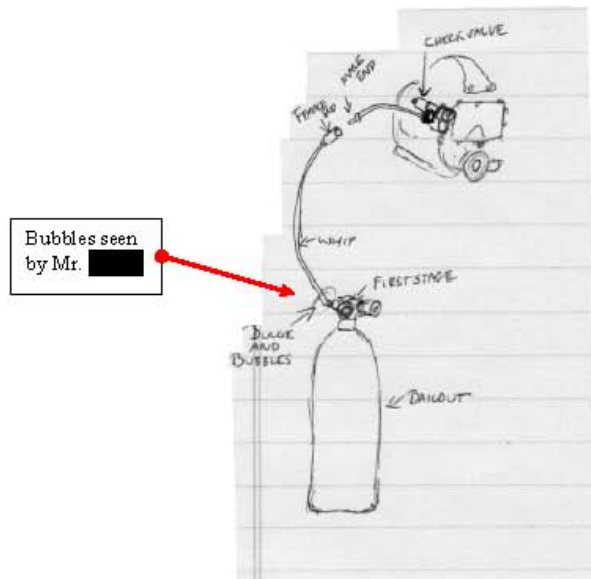
**Diagram 4: Sketch of Bailout System Arrangement and Small Leak**

13. Mr. [REDACTED] stated during his interview (Encl # 23) that he looked at Mr. Mouritsen's bailout before it was locked up on the M/V MR. FRED. He saw that the auxiliary valve on the helmet was open, the valve on the bailout bottle was open and the bailout whip was charged with air. He also noted that some air bubbles appeared to be coming out of the whip where the "bulge" was. See Diagram 4 below, drawn by Mr. [REDACTED], which shows the arrangement of the bailout system and the location of the small leak that he noted.

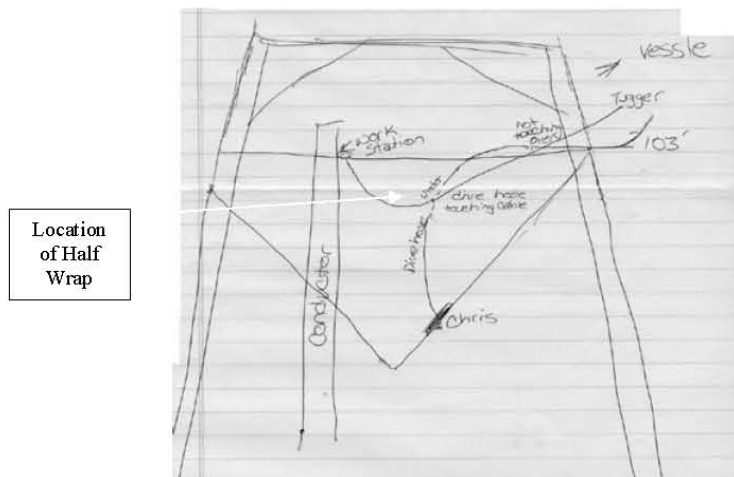
**Diagram 6: Sketch of Location of "Half Wrap"**

22. It is important to keep in mind that Diagram 6 is not drawn to scale, but certain things can be learned from it that shed light on the incident. The workstation was at 103 feet as indicated in the drawing, and Mr. Mouritsen was found several feet below that. The critical item in the diagram is the point where the umbilical and the tugger touch—it is close to the end of the umbilical. This would be sufficiently close to Mr. Mouritsen to have caused a sudden loss of air supply had the tugger crimped the umbilical, but it would also have been close enough for Mr. Mouritsen to have clearly seen the entanglement/crimping if it had occurred. At 20:44:17, however, after Mr. Mouritsen loses his air supply he can be seen making two hand-over-hand motions pulling on his umbilical, and several more feet of the umbilical can be seen in the distance. There is no tension on the umbilical, and the line is clear of entanglements in the area where he was working.

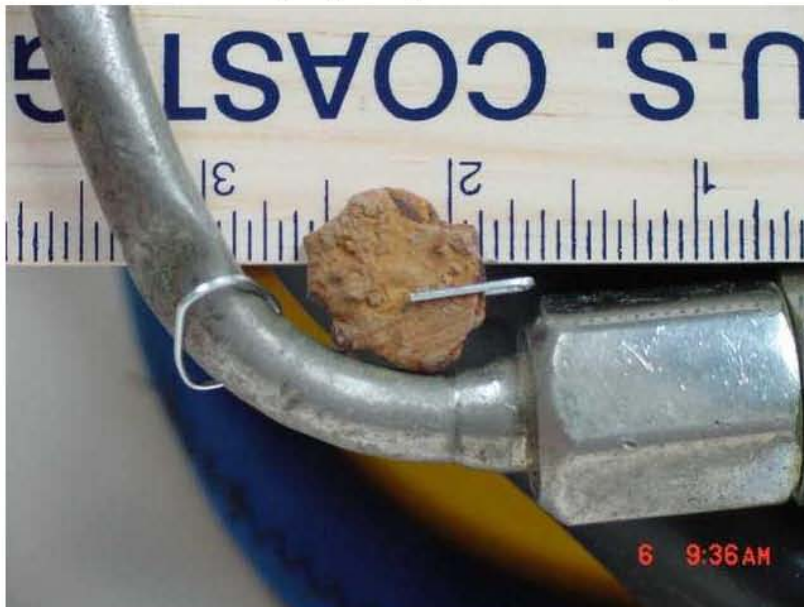
Photo 13: Foreign Object Compared to Bent Tube Assembly

7. Could the foreign object have come down from the surface through the breathing air hose in Mr. Mouritsen's umbilical and then into the regulator? The answer to this is clearly that it could not have happened. Both the airhose, which has a  $\frac{3}{8}$ <sup>th</sup> inch inside diameter, and the fittings on the ends of the airhose are too small for the object to fit through. Even if it had somehow come through the airhose, it could not have traveled through the Bent Tube Assembly and into the regulator with the flow of air. The foreign object is rigid and is too large to fit through the metal bent tube. See Photo 12 below for size comparison. The bent tube has an outside diameter of less than  $\frac{1}{2}$  of an inch and the foreign object has a diameter of nearly  $\frac{3}{4}$  of an inch at the narrow point. It cannot physically fit through the metal bent tube:
