# UNITED STATES COAST GUARD

INVESTIGATION INTO THE CIRCUMSTANCES  
SURROUNDING THE SINKING OF THE

## F/V PATRIOT

14 NAUTICAL MILES OFF THE COAST OF GLOUCESTER, MA  
ON JANUARY 3, 2009 WITH THE LOSS OF TWO  
CREWMEMBERS

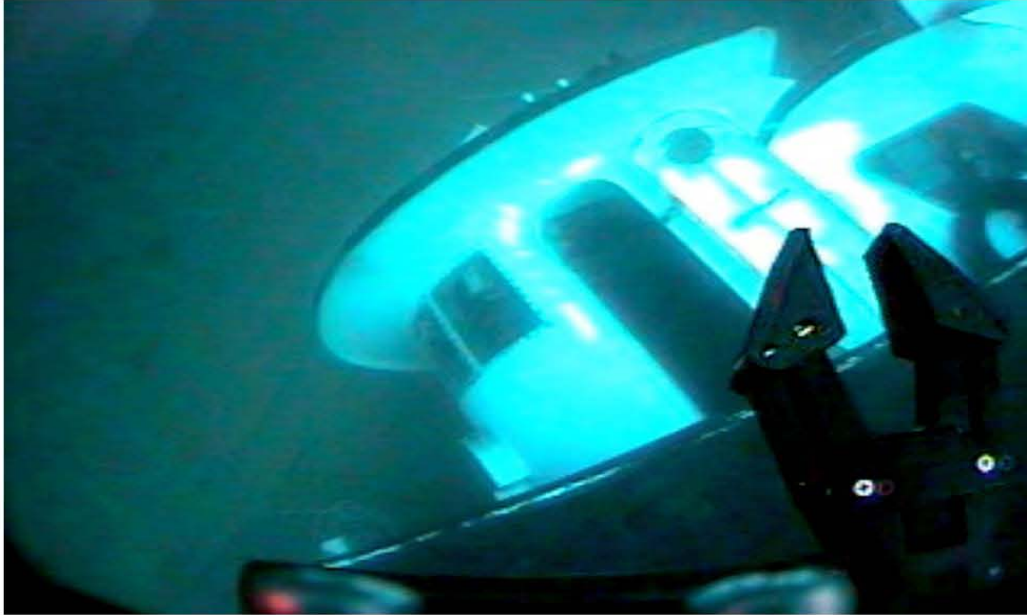
*Figure 4: ROV photo of the port side pilothouse watertight door open*

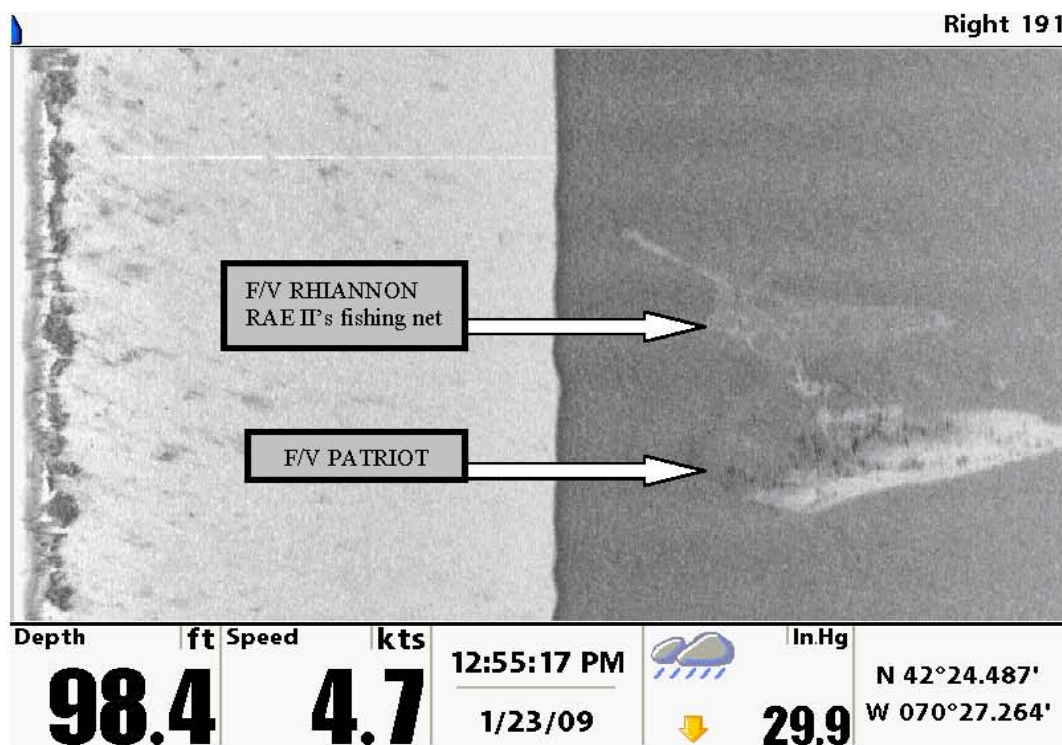
*Figure 6: Side Scan Sonar image of F/V RHIANNON RAE II's fishing net hooked on the F/V PATRIOT*

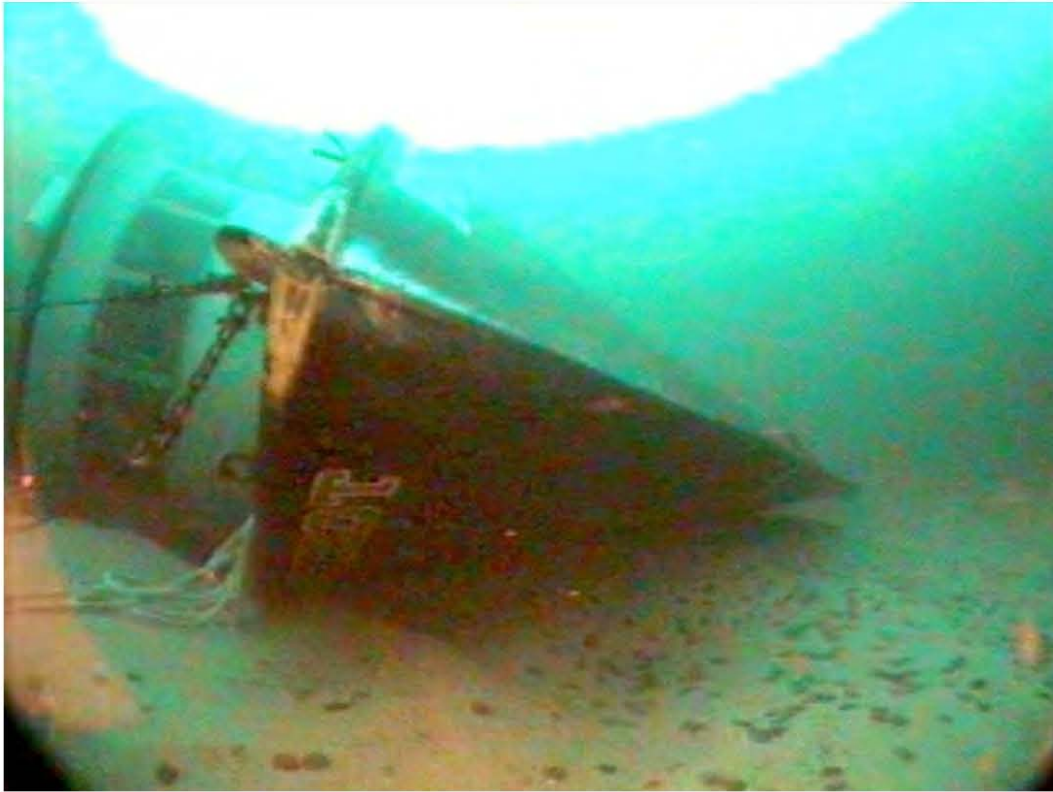
*Figure 7: ROV Photo of the F/V PATRIOT's starboard bow*

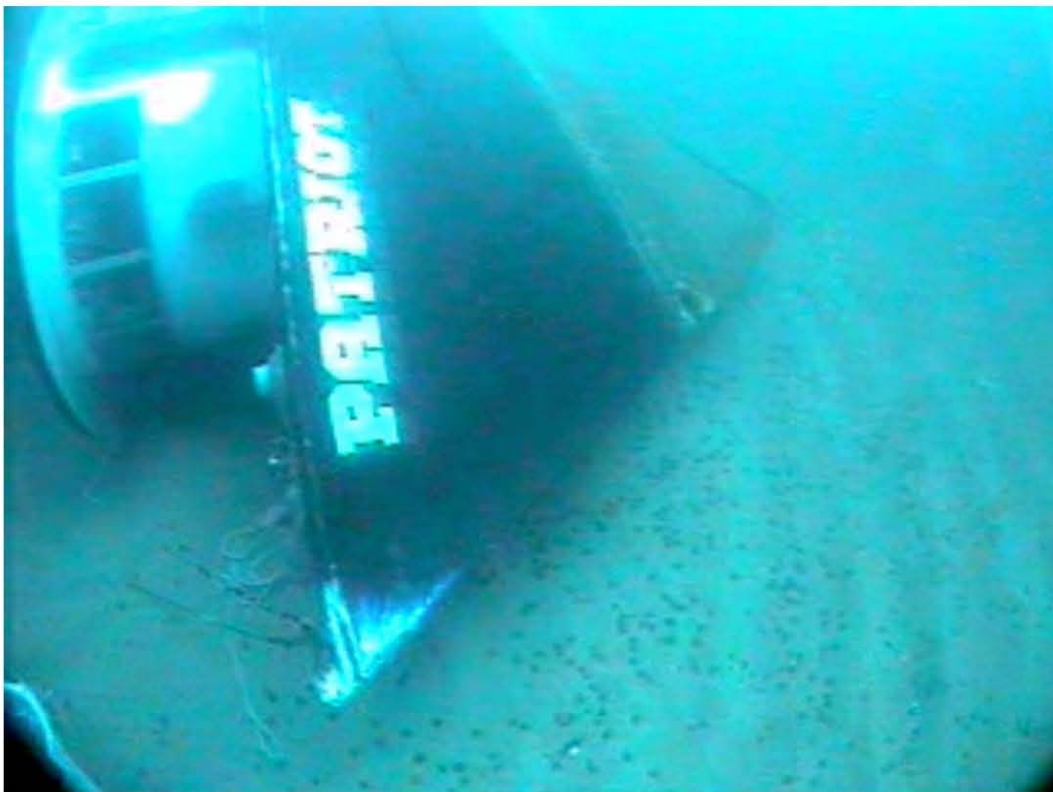
- Paint scrapes along the port side of the hull, including a heavy scrape on both sides of the bow (See Figure 8).
- A slight bend in the top of rudder (See Figure 14).
- The top of the pilot house shows significant scrapes and damage, including a bent radar stand and a sheered antenna (See Figure 9).
- The starboard block on the gallows frame has a significant bend in it and the wire running through it is parted (See Section 1.24)

The paint scrape damage could have been caused by the F/V RHIANNON RAE's fishing gear or by some event relating to the casualty.

*Figure 8: ROV photo of the F/V PATRIOT resting orientation*

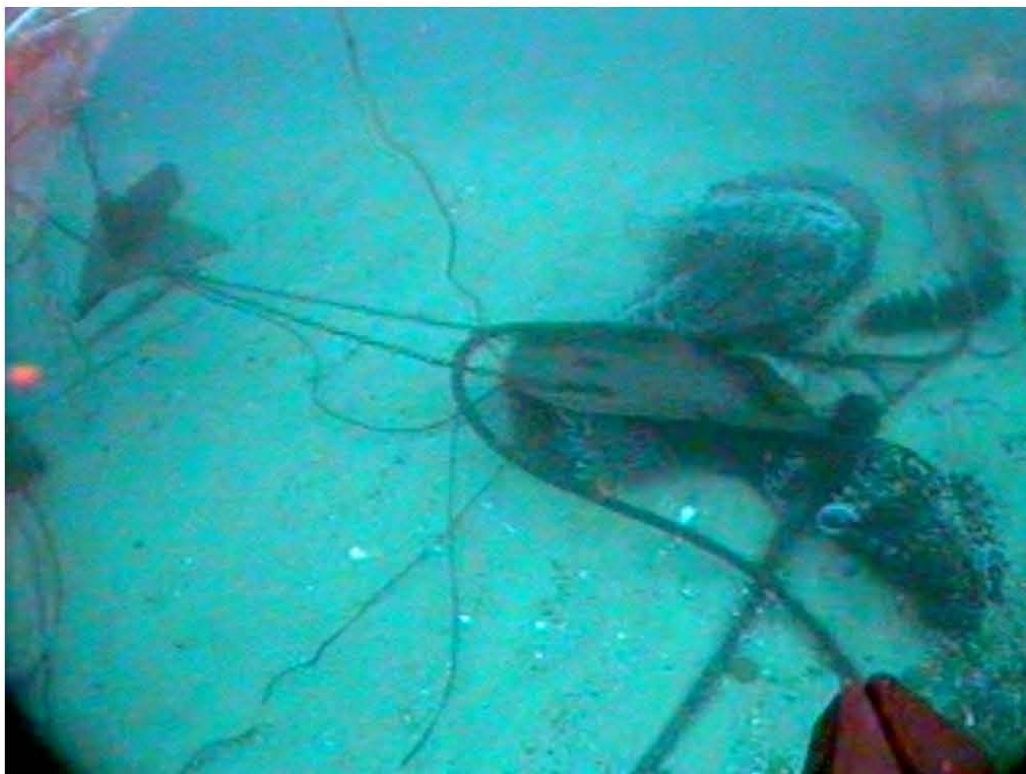
- The overall condition of the wreck appears to be good with no apparent breaches or insets on the hull.
- Fishing gear from the F/V RHIANNON RAE is wrapped around the wreck of the F/V PATRIOT (See Section 1.14 and Figures 11, 12, 13, and 14).

*Figure 11: ROV photo of a trawl door from the F/V RHIANNON RAE II*

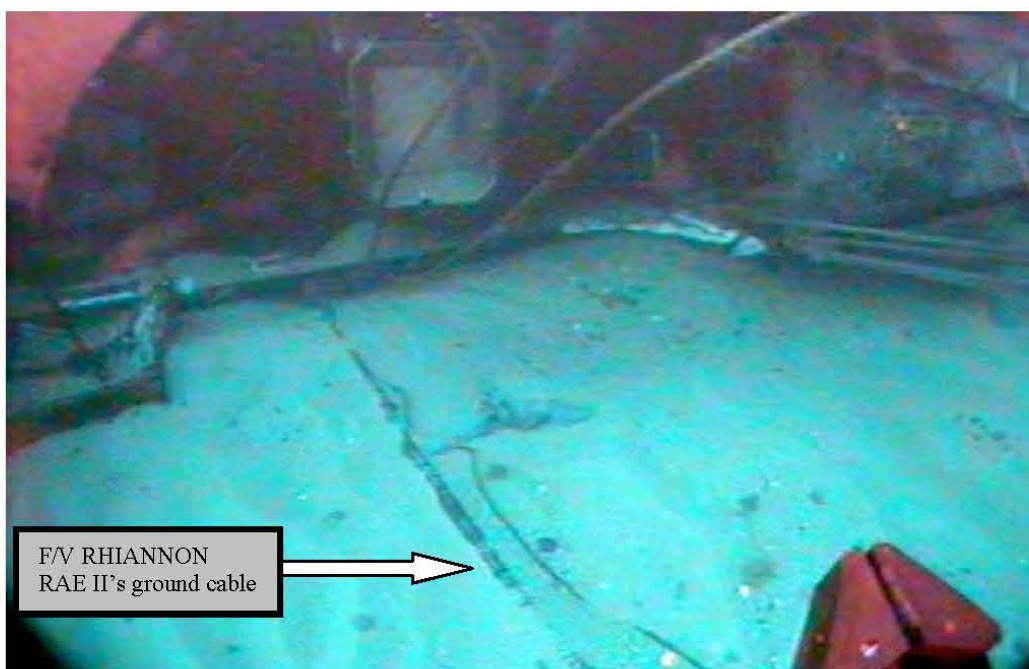
*Figure 12: ROV Photo of F/V RHIANNON RAE II's fishing gear ground cable under the F/V PATRIOT*

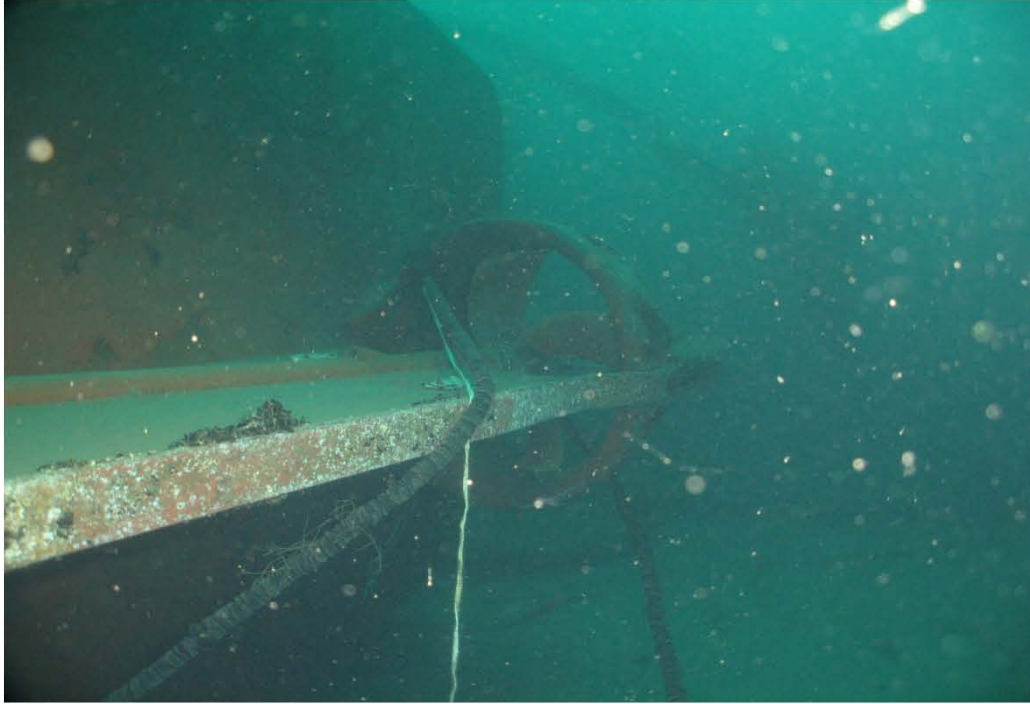
*Figure 13: ROV Photo of F/V RHLANNON RAE II's fishing gear ground cable looped on the F/V PATRIOT's propeller*

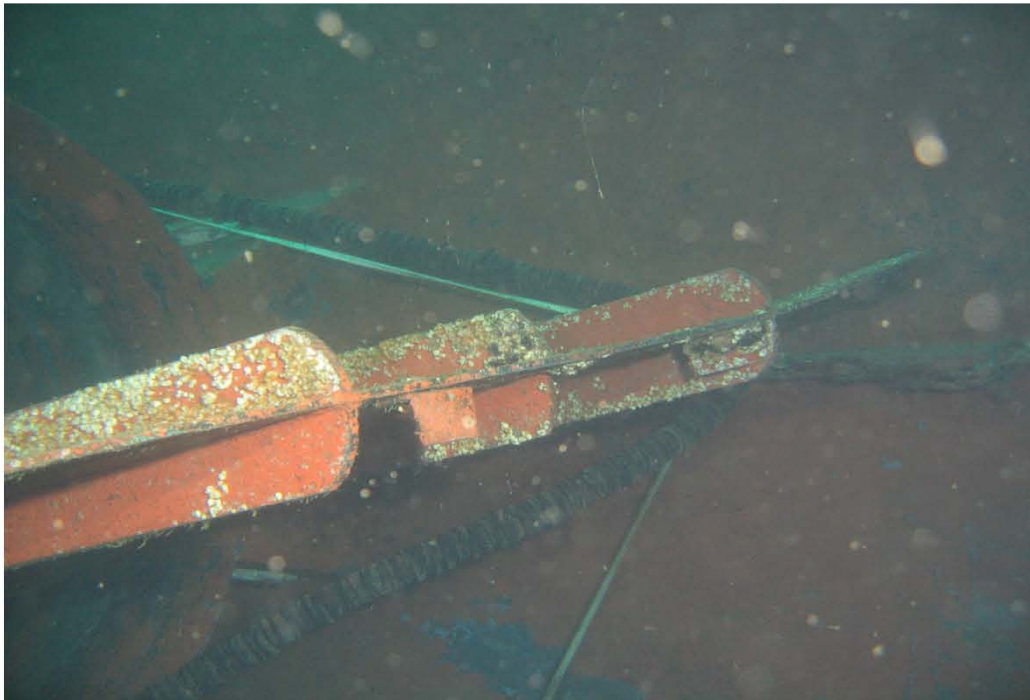
*Figure 14: ROV photo of F/V RHLANNON RAE II's fishing gear ground cable and F/V PATRIOT's life raft painter line looped on the F/V PATRIOT's slightly bent rudder*

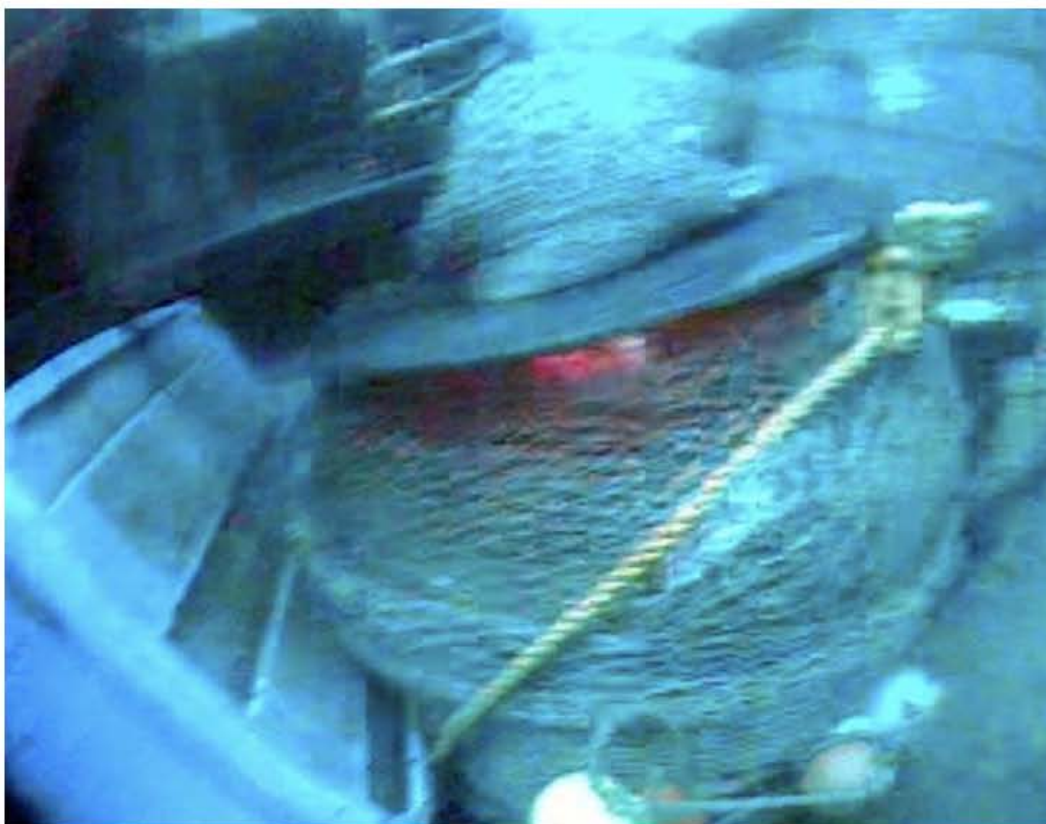
*Figure 15:ROV photo of the F/V PATRIOT's forward net reel with fouled net*

Video footage from both ROV and dive surveys of the wreck site reveal other signs of difficulty with the haul back. Underwater footage reveals that there is an unknown quantity of net that had come off the forward reel presumably while the net was being hauled in. The net is wrapped tightly around the axle outside the port flange of the forward reel, possibly jamming the net reel. The underwater surveys also show that the

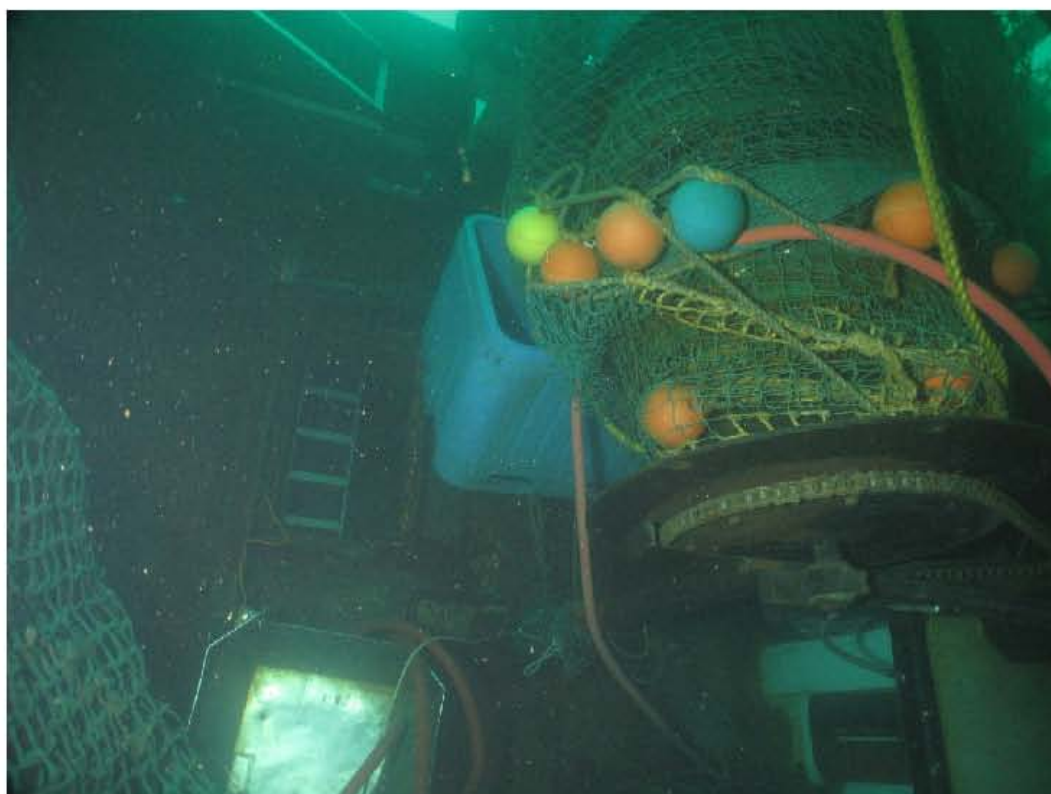
*Figure 16: Dive photo of washdown hose entangled in the forward net reel*

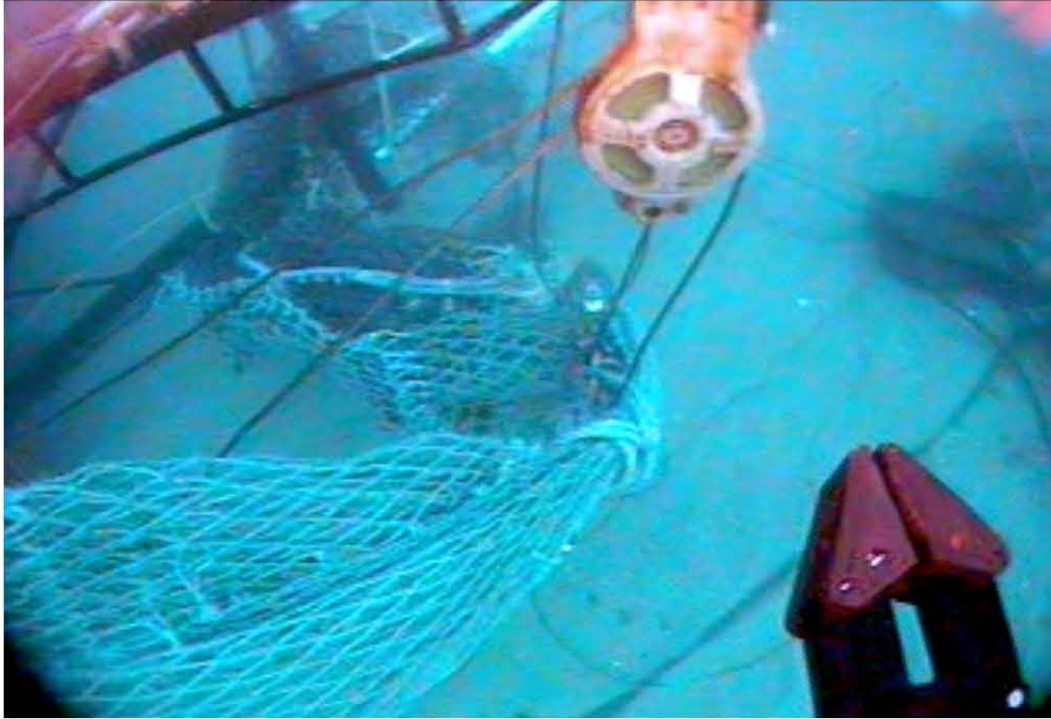
*Figure 17: ROV photo of the F/V PATRIOT's cod end of the aft fishing net*

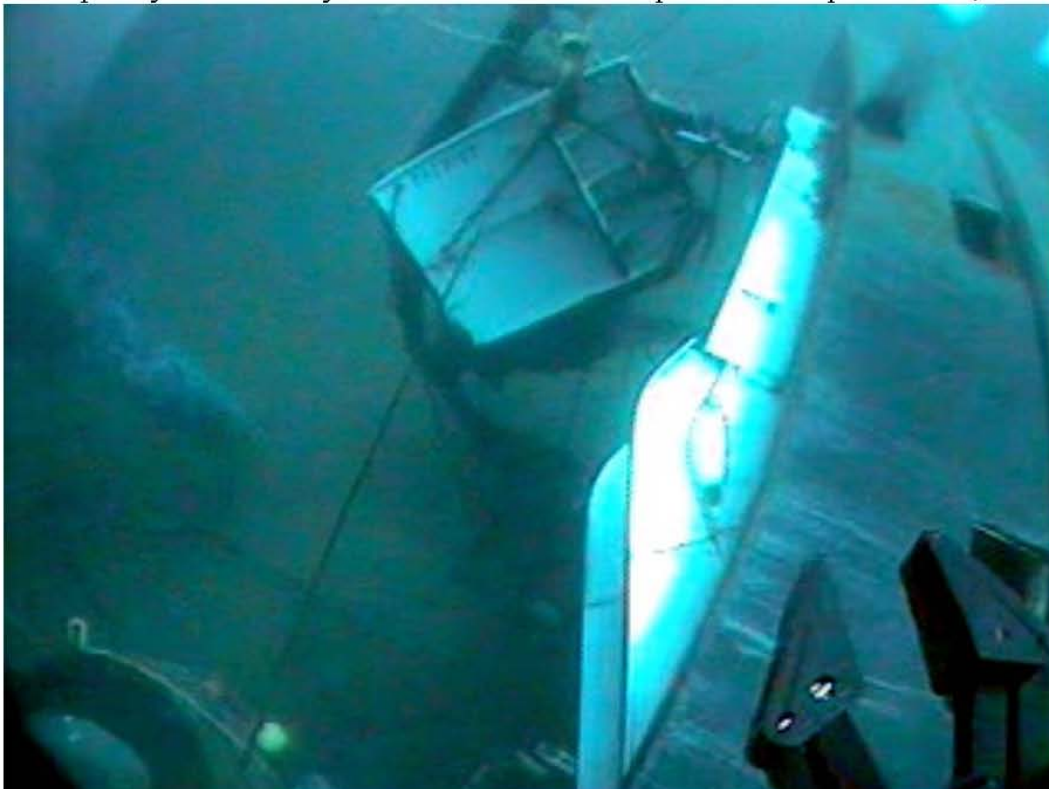
Underwater ROV footage shows the port side trawl door tight to the block and flipped upside down. The port door's wire rope is tightly under strain and in a straight line going back to the winch. The starboard side door was found lying in the sand below the gallows frame with its wire rope both parted and frayed, and its starboard block bent and deformed (See Figures 20 and 21). Neither door is still clipped to the gallows frame.

*Figure 20: ROV photo of the port 10 ton block and door.*

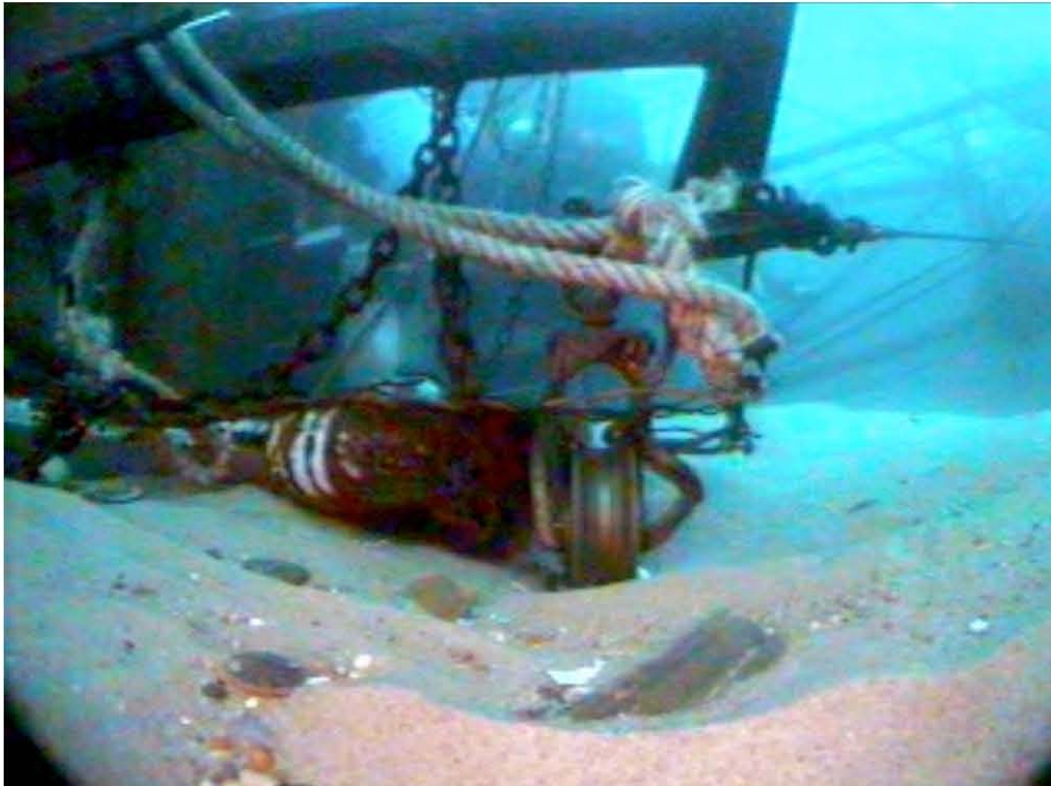
*Figure 21: ROV photo of the starboard 10 ton block and frayed wire rope*

2009. The Inspectors noted damage that included a deflection of the sheave guard and a misalignment of the pulley. Divers had cut the attachment ring off to remove the block from the wreck. The Coast Guard purchased an identical block and sent it to Detroit Testing Laboratory, Inc (DTL) in Warren, Michigan to conduct destructive testing. DTL determined that, depending on the angle that the force was applied, it would take between 4,066 and 5,591 lbs of force to create damage similar to that of the starboard block on the F/V PATRIOT.
