**REPORT OF THE DISTRICT FORMAL
INVESTIGATION
INTO THE
SMALL PASSENGER VESSEL SPIRIT OF
NORFOLK (O.N. 982944) FIRE AND
SUBSEQUENT TOTAL CONSTRUCTIVE LOSS
ON THE ELIZABETH RIVER, NORFOLK,
VIRGINIA ON JUNE 7, 2022**

MISLE ACTIVITY NUMBER: 7476562

SMALL PASSENGER VESSEL SPIRIT OF NORFOLK (O.N. 982944) FIRE AND SUBSEQUENT TOTAL CONSTRUCTIVE LOSS ON THE ELIZABETH RIVER, NORFOLK, VIRGINIA ON JUNE 7, 2022

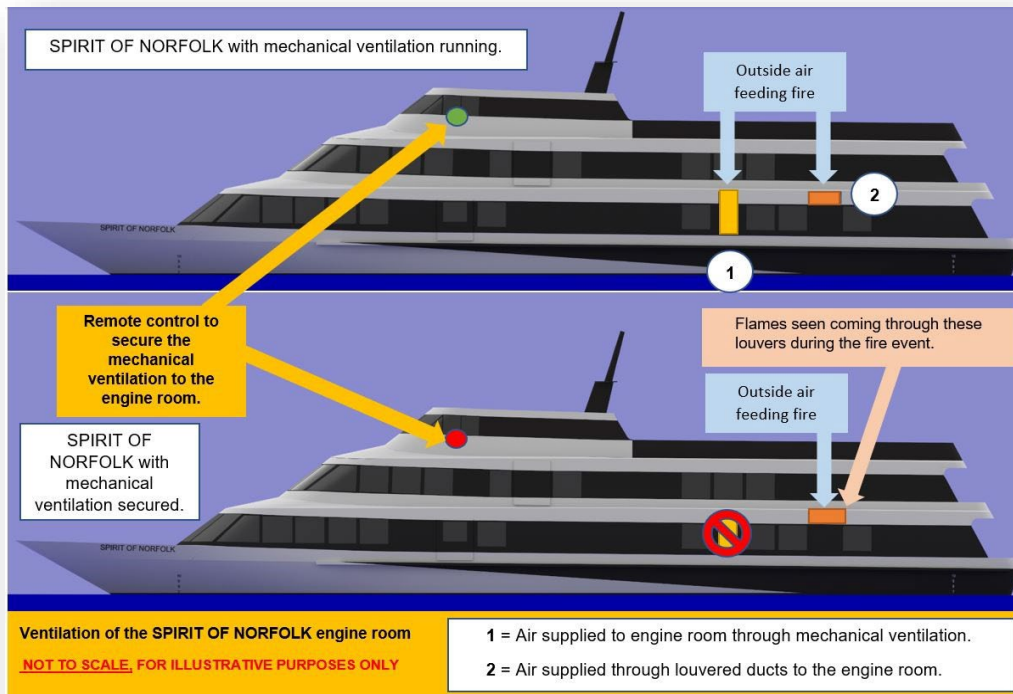
3.12.17. The Captain shut down mechanically powered ventilation remotely from the bridge and gave an order for a crewmember to shut remote fuel valves. Although it was not required by the regulations, natural ventilation to the engine room was not equipped with a readily available closure device(s) to secure the natural air supply from inside or outside the engine room. A Senior Deckhand subsequently closed the remote fuel valves.

Figure 5 - Port side of the Spirit of Norfolk showing the mechanical and natural air ventilation for the engine room. In the upper image the mechanical system is in operation prior to the crew securing the system through a wheelhouse remote control. In the bottom image, the natural ventilation for the engine room would feed the fire, allow smoke and flames to escape, and allow fire water to enter the engine room. (Source: USCG)

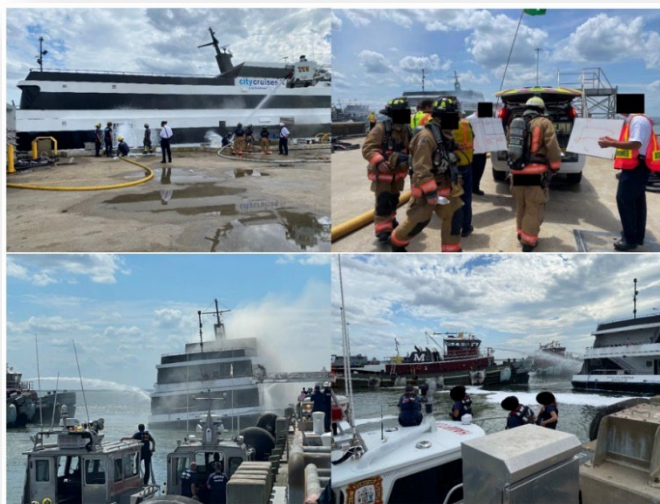
Figure 9 – Montage of photos of firefighting activities taken on June 7, 2022. Upper left, dockside firefighters apply foam and cooling water to the side of the *Spirit of Norfolk*. Upper right, the vicinity of the Command Post on the dock at Navy Pier 4. Lower left, towing vessels and shoreside firefighting activities on the afternoon of the accident day, note the horizontal ladder used to allow firefighters to access the ship for a RECON and attack on the fire. Lower right, towing vessels cool the exterior of the offshore side of the *Spirit of Norfolk*. (Source: USCG)

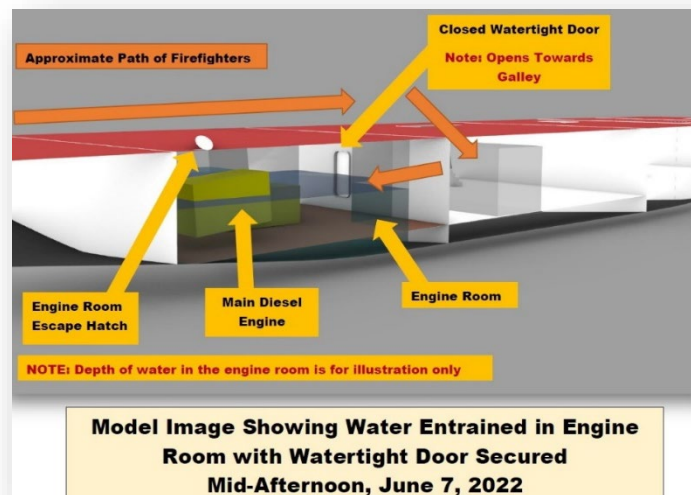
- 4.2.9.2. *“The entry team was eagerly directed on the ship to get the foam in operation. At this point, conditions had started to change drastically. visibility had decreased, but was still manageable, and the entry decking was a little warmer. Entry was made downstairs, into the galley area for foam deployment. The plan was to open the engine/fire room door, open the foam nozzle and keep it open and rapidly vacate the structure. With a slight quarter turn on the turn wheel, pressure from behind the door was felt. Instantly, the engine room door exploded open causing what appeared to be a minor back draft/flash over inside the kitchen area where the engine room was located. Thousands of gallons of rapid water came rushing out from the fire room.”*

Figure 13 – Image that displays a representational amount of entrained firefighting water in the engine room prior to the opening of the engine room watertight door. Firefighters reported opening that door and being engulfed with a four-foot wall of water and a backdraft of flame. (Source: USCG Marine Safety Center)

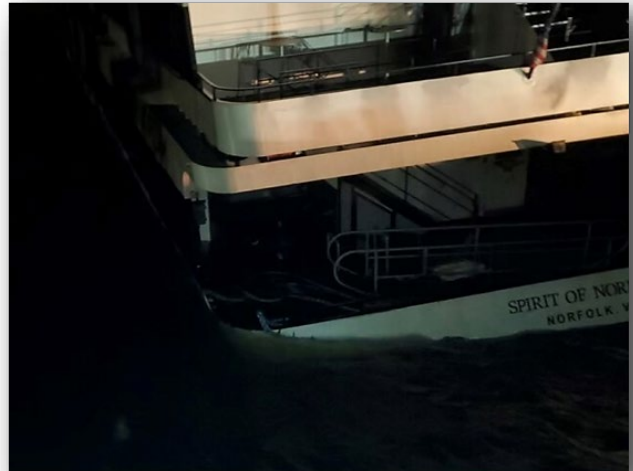
4.3.8. Despite difficulties with pumps, and with the assistance of Navy personnel and additional equipment, by approximately 7:30 AM on June 9, 2022, more than 77,000 gallons of oily water had been transferred off the *Spirit of Norfolk* to the tank barge. Stability and draft readings of the vessel in the water greatly improved.

Figure 14 – Photo taken at 3:55 AM on June 9, 2022, showing the *Spirit of Norfolk* listing heavily to port and the bulwarks on the main deck submerged. (Source: USCG)

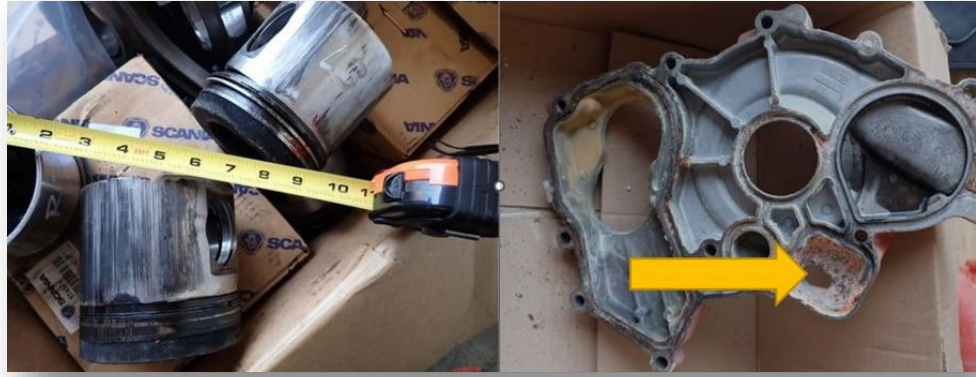
- 5.2.6.5. Bay Diesel technicians went onboard the vessel a third time on May 18, 2022, and replaced the left bank turbocharger, oil supply lines, exhaust pipe bolts, and gaskets.

Figure 15 – Damage to PMDE from the initial coolant leak in that engine on May 15, 2022. Left, damaged pistons from the overheating event necessitating a top end overhaul of the engine. Right, arrow points to hole in the water pump cover caused by internal corrosion. (Source: Bay Diesel & USCG)

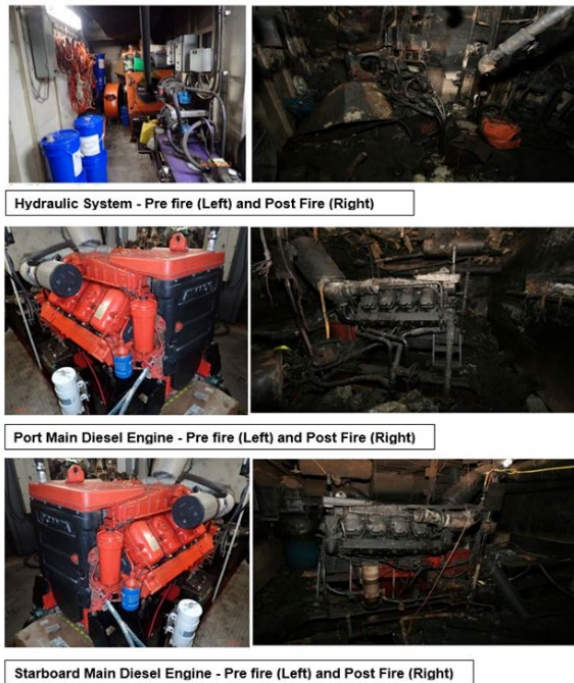
Figure 18 – Pre fire photos of main diesel engines and hydraulic area on the left. On the right images of the same equipment post fire showing the extent of the damage. (Source: Castlerock and Milner Surveys June 2,3 and 6, 2022, post fire images taken by NTSB)

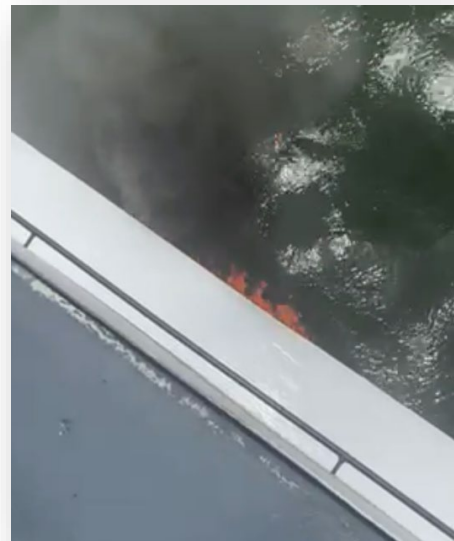
- 6.2.7. Early incident photos at the discovery of the fire displayed visible flames outside the engine room escaping through the port side vent, suggested an intense fire on the port side of the vessel. The image to the right (Figure 20) is approximately five minutes after the initial discovery, displaying visible flames emanating from inside the engine room.

Figure 20 – Video capture by passenger view from the upper most deck looking over the port side of the *Spirit of Norfolk* approximately 5 minutes after discovery of the fire. (Source: Passenger)

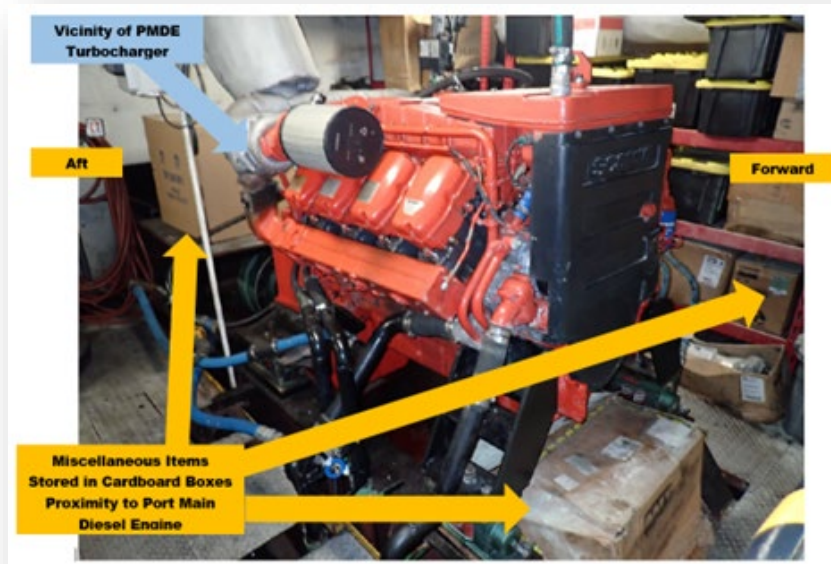
- 6.3.3. The regulatory requirement for old Title 46 Subchapter T references the applicability of Title 46 Subchapter H, which requires combustible materials be kept clear of internal combustion engines. This requirement is normally and appropriately left to the discretion of a Marine Inspector and if noted, resolved “on-the-spot,” and not typically documented as a deficiency in the Coast Guard database. A search of the vessel history did not identify this item as noted as a deficiency during any Coast Guard inspection. It is unknown whether this condition was related to the ignition, rather more likely a notable factor in the spread of the initial fire after ignition.

Figure 21 – Stored combustible materials near the port main diesel engine room. (Source: Milner Post Engine Damage Survey, taken June 2 and 3, 2022)

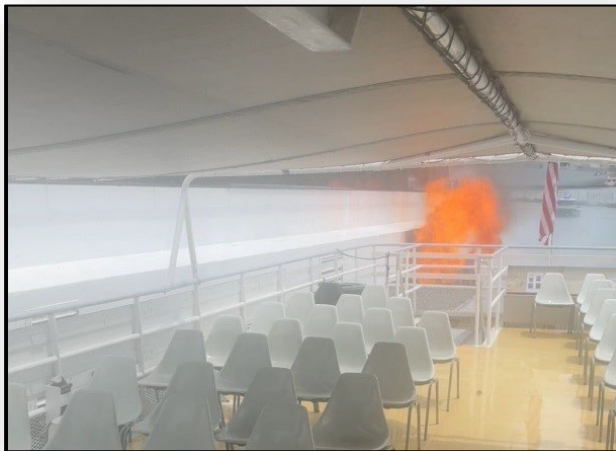
Figure 25 – Screen capture from a video shot by a passenger on the *Victory Rover* while on the upper deck of that vessel and looking at the *Spirit of Norfolk* on the left side of the image. Flames are coming from the louvers for the natural ventilation to the engine room. (Source: Passenger).

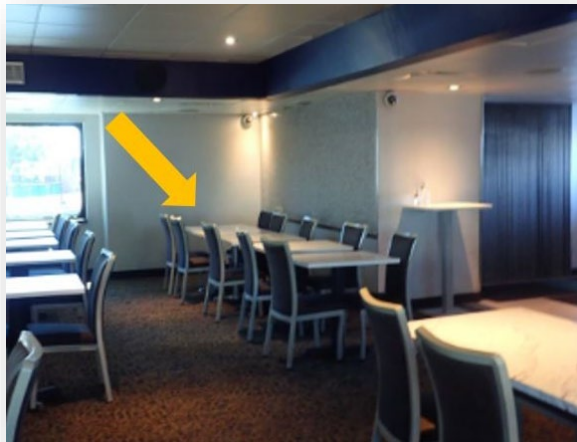
6.11.7. As already described, the first aggressive firefighting action was a plan to have a RECON party locate the engine room escape hatch on the main deck, starboard interior, and direct firefighting foam agent into the engine room. The escape hatch was covered by a piece of carpet on the deck indistinguishable from the surrounding carpet, and potentially obscured by tables and chairs in the area, although there is no direct evidence on this point. The RECON team that went aboard failed to locate the hatch in the deck and proceeded further into the vessel, down a flight of stairs, turned around and opened a watertight door in the engine room bulkhead. Evidence indicates at this juncture the watertight door was then resecured.

Figure 26 – After starboard side of the main deck of the *Spirit of Norfolk*. Arrow marks the approximate location of the emergency escape hatch from the engine room, which is on the deck. The location is described as the area around the tables and the inside starboard interior wall. (Source: Castlerock June 6, 2022, Survey)
