UNITED STATES COAST GUARD

REPORT OF THE INVESTIGATION INTO THE

PIPELINE P00547 RUPTURE AND DISCHARGE OF OIL IN SAN PEDRO BAY APPROXIMATELY 4 MILES FROM HUNTINGTON BEACH, CA, ON OCTOBER 1, 2021

**ANCHOR STRIKE RESULTING IN A PIPELINE OIL SPILL FROM
FIXED PLATFORM ELLY IN SAN PEDRO BAY, CALIFORNIA
ON OCTOBER 1, 2021**

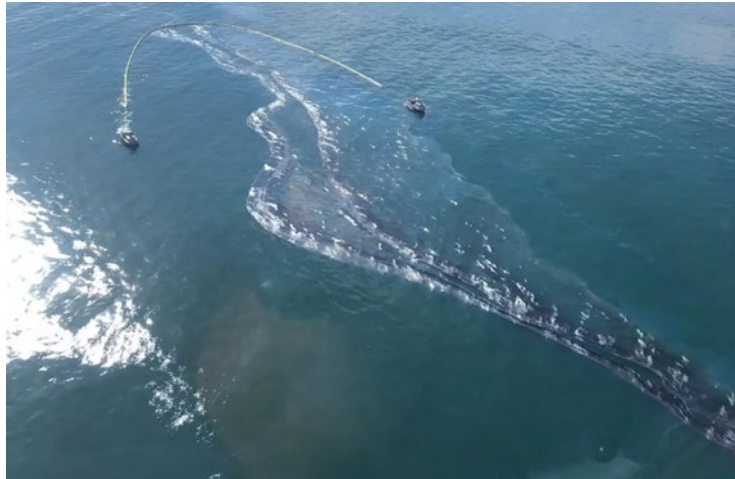
Figure 1 Aerial photo of San Pedro Bay oil spill cleanup near Huntington Beach, CA

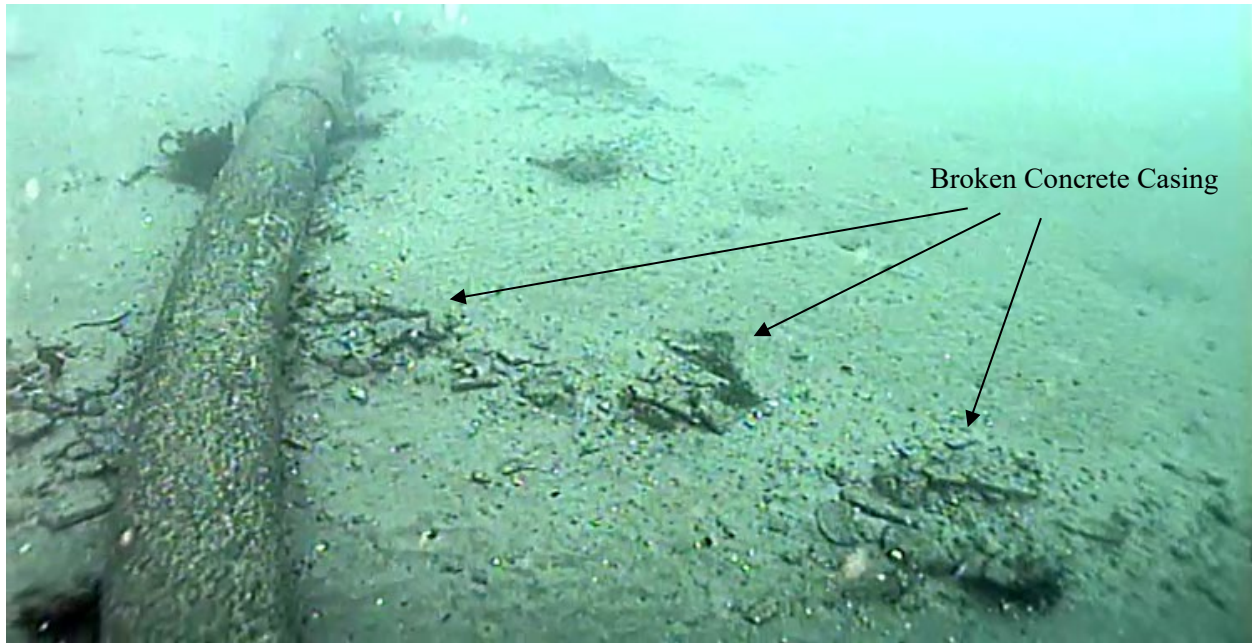
pipe section was sent to the NTSB laboratory in Washington, DC for further examination. This section contained the temporarily repaired rupture site. The NTSB materials laboratory found a 13-inch crack along the toe of the longitudinal seam weld at the rupture site. The fracture surface exhibited a relatively flat region with curved arrest marks extending through the wall from the outer surface to a maximum depth of 0.3-inch. Features consistent with ratchet marks were observed on the fracture surface extending from the outer surface. The fracture appearance was consistent with fatigue cracking initiating from multiple origin areas along the toe of the seam weld on the outer surface of the pipe. No evidence of intergranular or branched cracking was observed. Mechanical properties and material chemistry analysis were consistent with API standards.

Figure 12 Still Image from ROV survey showing damage (provided by Amplify)

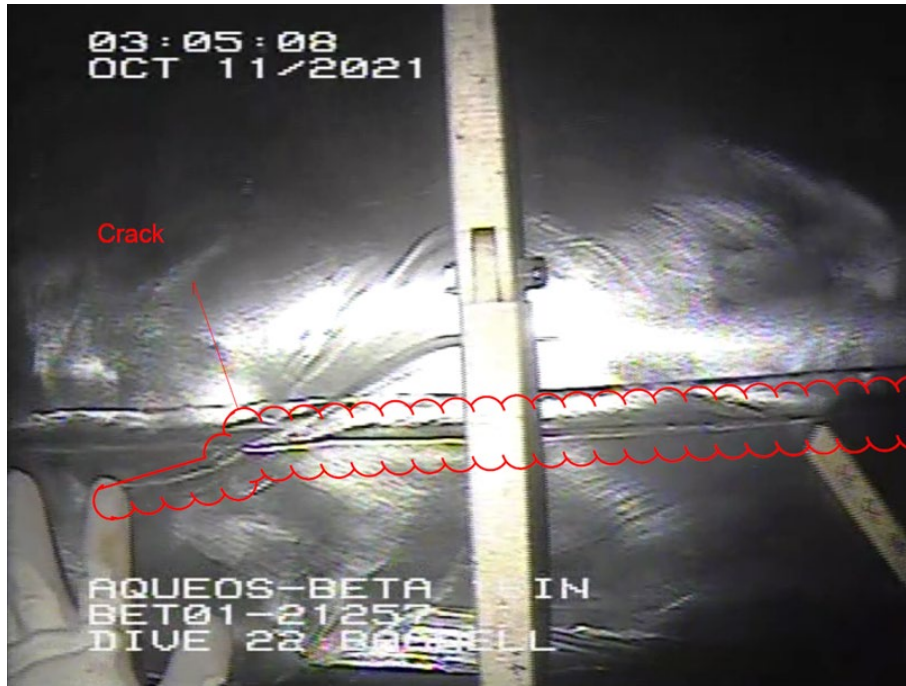
Figure 13 Still image from diver survey showing cleaned and buffed longitudinal crack (provided by Amplify)

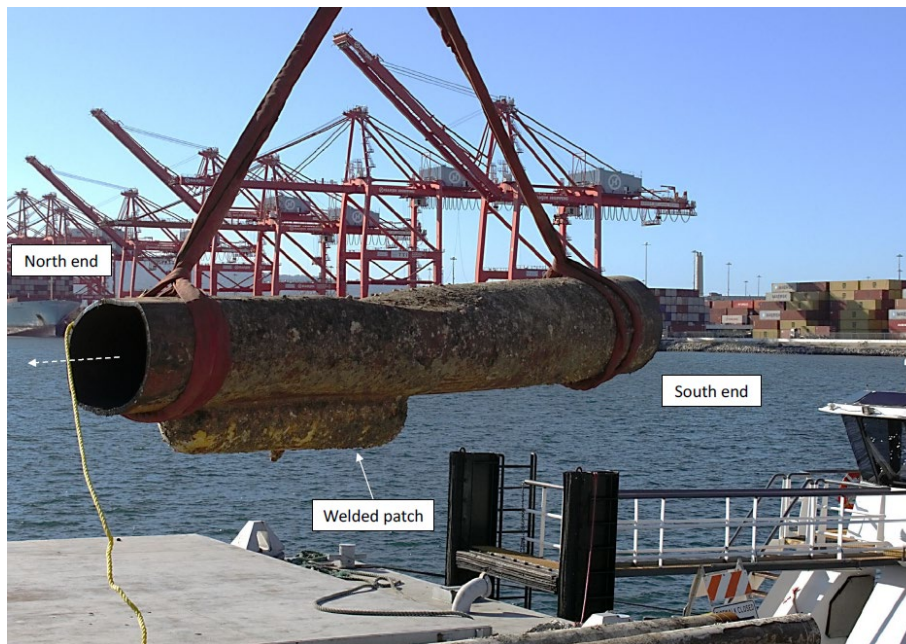
Figure 14 Damaged section of pipe after removal from the sea floor. (Image from NTSB Materials Laboratory Factual Report 23-045)

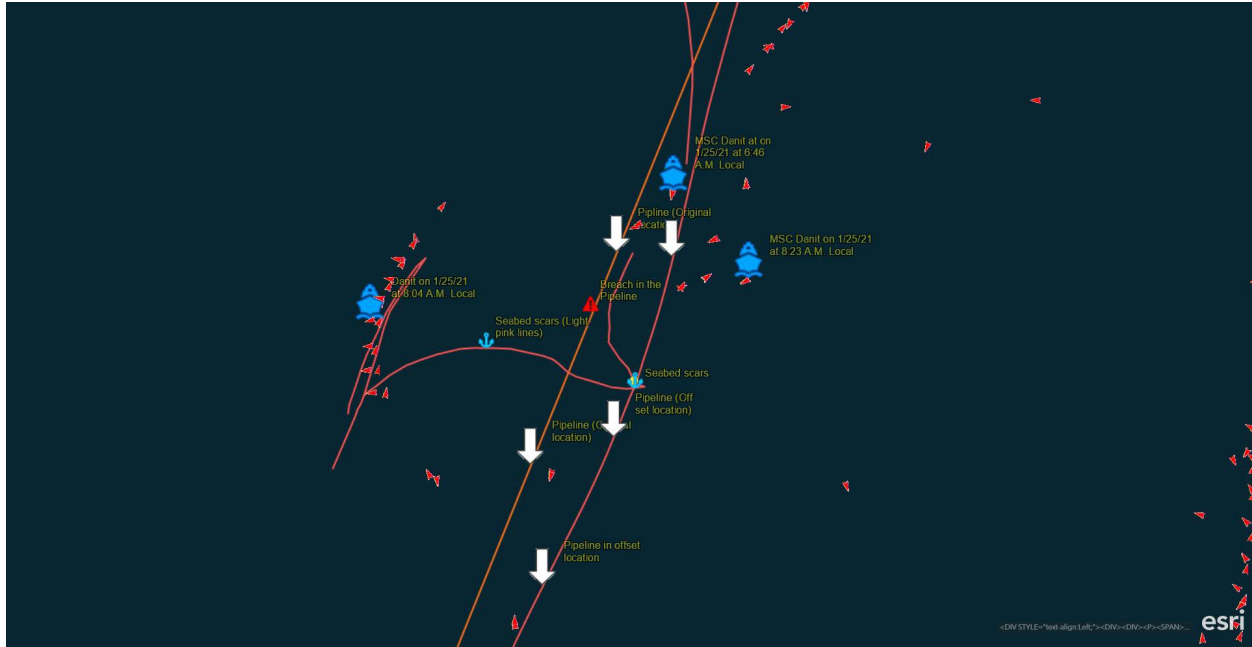
AIS positions from MSC DANIT and BEIJING show that both vessels substantially traversed P00547 while anchored. The largest pipeline displacement occurred near the leak location and is in the vicinity of where MSC DANIT traversed the pipeline. South of the leak location, anchor drag marks correlate with BEIJING's recorded AIS positions.

Figure 15 AIS Positions of MSC DANIT with P00547 Overlay

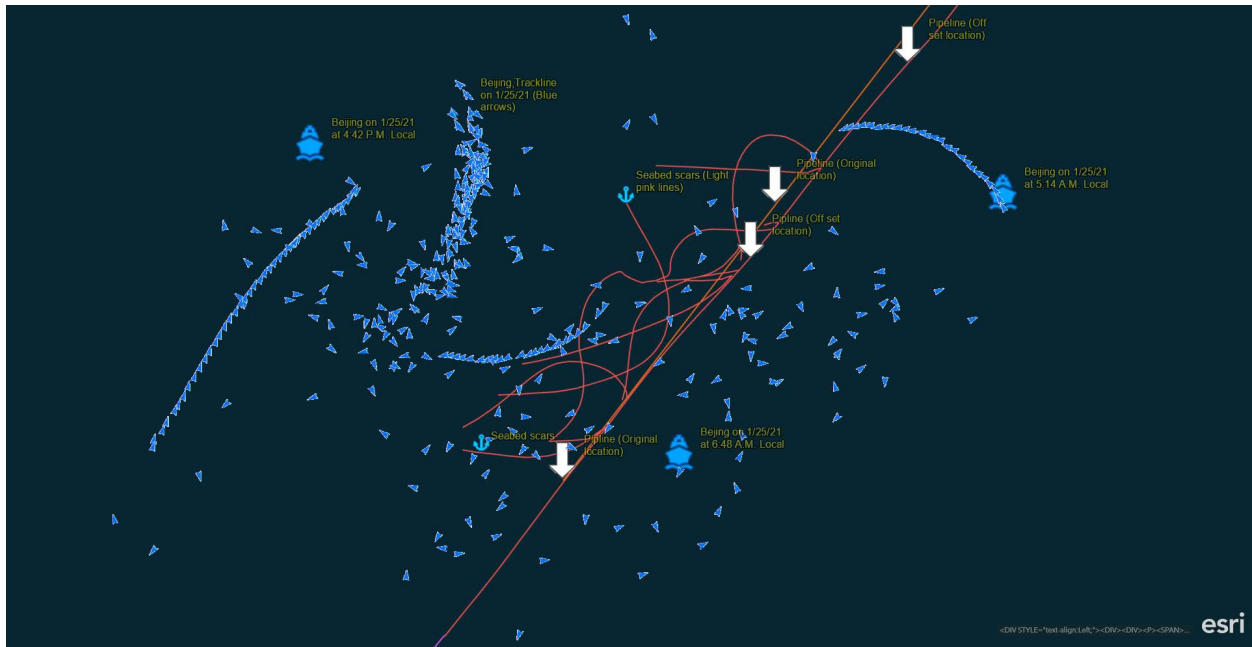
Figure 16 AIS Positions of BEIJING with P00547 Overlay

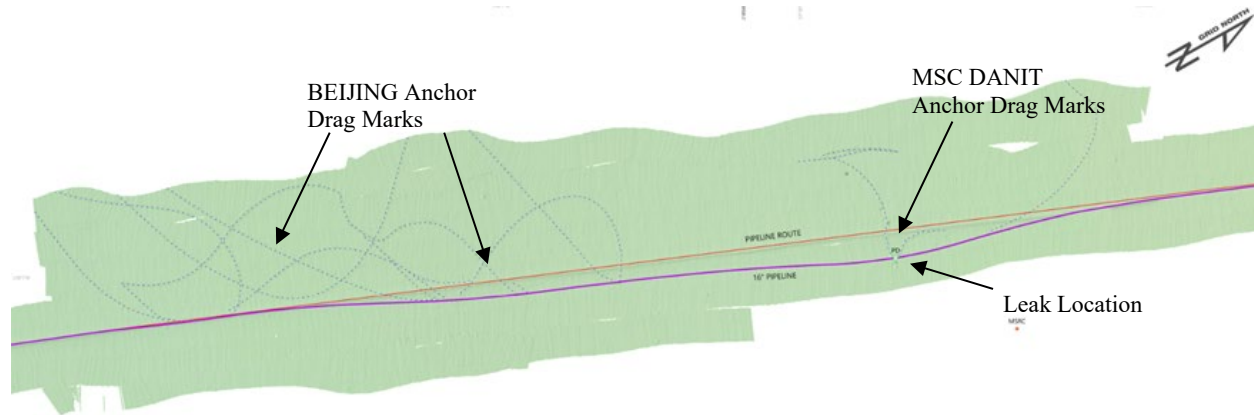
Figure 17 Image from multibeam survey conducted by Fugro (provided by Amplify)

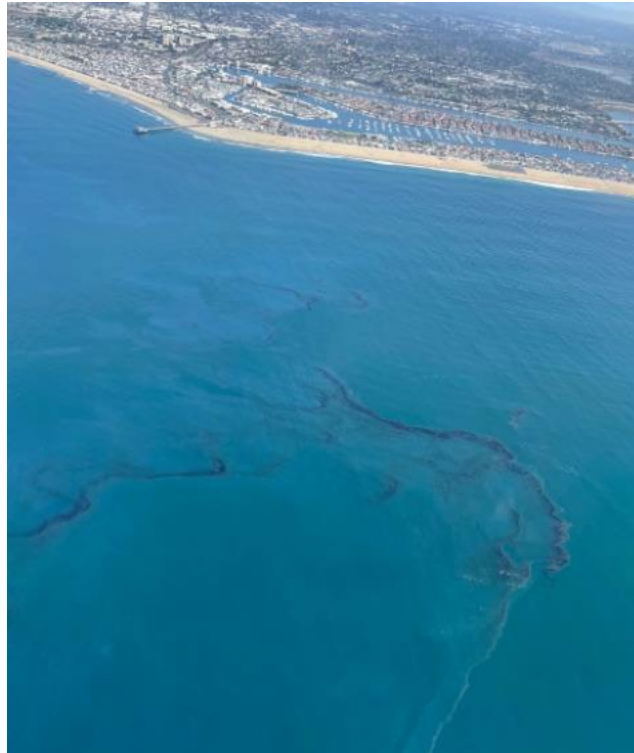
Figure 18 Crude oil in the Pacific Ocean on October 3, 2021 with Newport Beach, CA in the background

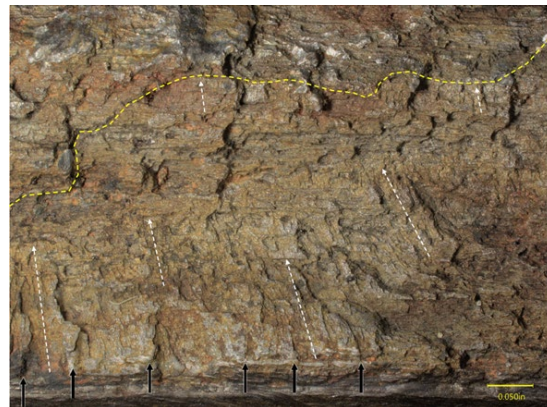
force applied to the pipeline, based on observation of ratchet mark features, it is likely that the altered stress state induced by the deformation damage led to localized crack initiation and propagation due to cyclic pressure loads from normal oil pipeline operations. The damage caused by the anchor strike went unnoticed until after the pipeline failed and oil was discharged in October 2021. Crack propagation and material failure due to fatigue cracking is characterized by the graph in Figure 22.

Figure 23 Digital microscope image of the fracture surface. Black arrows indicate features resembling ratchet marks emanating from the outer surface. White arrows indicate fracture progression direction. Yellow dashed line indicates a boundary between the progressive fracture region and overstress region. (Image from NTSB Materials Laboratory Factual Report 23-045).

It can be concluded that when the anchors of MSC DANIT and BEIJING struck and deformed P00547, local stress concentrations developed in the pipeline which allowed cracks to initiate and propagate over time. P00547 eventually failed following a high-pressure event noted on the SCADA recorder at 1605 on October 1, 2021. Although the internal fluid pressure did not exceed
