UNITED STATES COAST GUARD

REPORT OF INVESTIGATION INTO THE ELECTROCUTION OF A LICENSED THIRD ENGINEER ONBOARD THE S/R WILMINGTON OFFSHORE GALVESTON, TEXAS

ON 01/07/2009

MISLE ACTIVITY NUMBER: 3390690

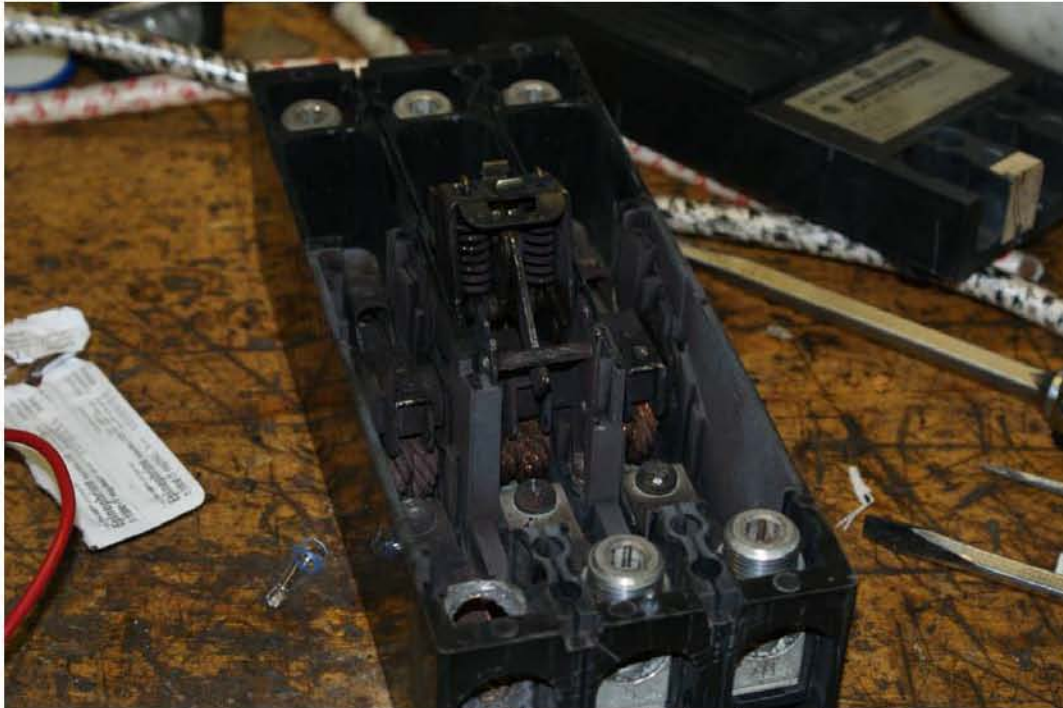
Figure 4: Photograph of Damaged Circuit Breaker

the S/R Wilmington. The circuit breaker, which supplied the motor controller for the fan, was in an electrical distribution panel positioned on a bulkhead and was not equipped with an under-voltage release solenoid. The breaker failed due to a loose lead connection from a power supply to the circuit breaker. An inspection of the loose lead and circuit breaker revealed the circuit breaker was damaged and needed to be replaced (ECN 3390690-31-██████████ ECN 3390690-34-██████████).

14. During the evaluation of the damaged circuit breaker (Figure 4), [REDACTED] selected Christopher Erickson to assist him with the further investigation and examination of the failed circuit breaker. A new work permit was not filled out for [REDACTED] and Christopher Erickson's participation (ECN 3390690-34-[REDACTED]).

17. After evaluation by ██████████ and Christopher Erickson, it was decided the circuit breaker was irreparable and a new circuit breaker was needed to restore the engine room supply fan. S/R WILMINGTON's Safety Management System "Instructions for Work Permits" Section 1, Bullet 3 states, "If there are any changes in work scope and/or time frame from the original permit, a new permit must be issued, reviewed and signed by all of those involved." A new work permit was not filled out (ECN 3390690-34-██████████).

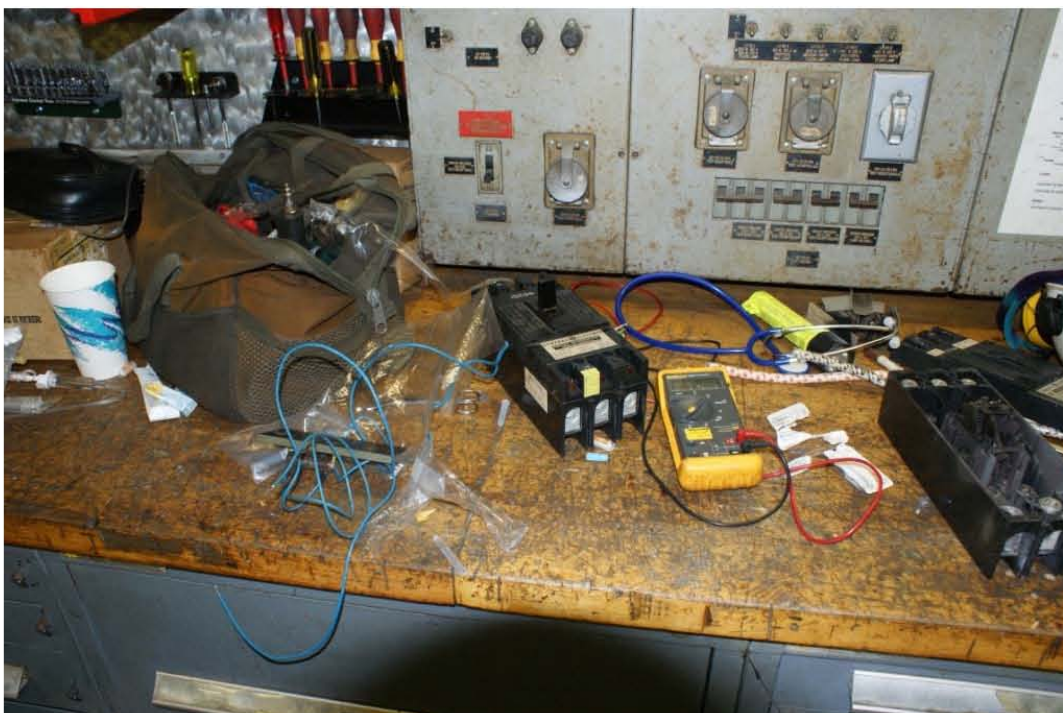
Figure 5: Photograph of the undamaged circuit breaker with the undervoltage release functionality (left) and the damaged circuit breaker (right)

Findings of Fact #20/21 (Page 12): The electrical breaker being replaced was not equipped with an undervoltage release function. However, the replacement breaker was equipped with an undervoltage release. While the model number and operational specifications of the replacement breaker matched those of the damaged breaker, it is unknown whether or not the distribution panel in which this breaker was to be installed was set up to receive the wire connections for the undervoltage release. First Assistant Engineer [REDACTED] and Third Assistant Engineer Erickson did not intend to remove the undervoltage capabilities of the new breaker rather they were in the process of testing it prior to installing the new breaker in the electrical distribution panel for the engine room supply fan. While the replacement breaker equipped with the undervoltage release could be made to work as a suitable replacement for the damaged breaker, it was not the correct replacement breaker for the intended application.

18. Christopher Erickson retrieved a new circuit breaker from the storage area adjacent to the electrical workshop. After retrieving the new breaker, Christopher Erickson returned to the electrical test panel workbench (Figure 5) (ECN 3390690-34-██████████).

20. At 1530, ██████████ and Christopher Erickson inspected the new circuit breaker and found it had an undervoltage release function. General Electric representatives informed investigators that replacement breakers are shipped with an under voltage release solenoid that was an accessory to be used in applications which required such protection. For applications that did not require its use, the solenoid is detached by loosening two screws. To test the under voltage release solenoid, General Electric, the breaker's manufacturer, recommended: "Do appropriate functional check as described... prior to installation." The function check reads: "1. Using rated control voltage apply power to blue under voltage coil leads. 2. Reset and turn circuit breaker on. 3. Remove control power, the circuit breaker should trip, if not, recheck accessory installation." The rated control voltage for the new circuit breaker was 480 volts (ECN 3390690-18-██████).

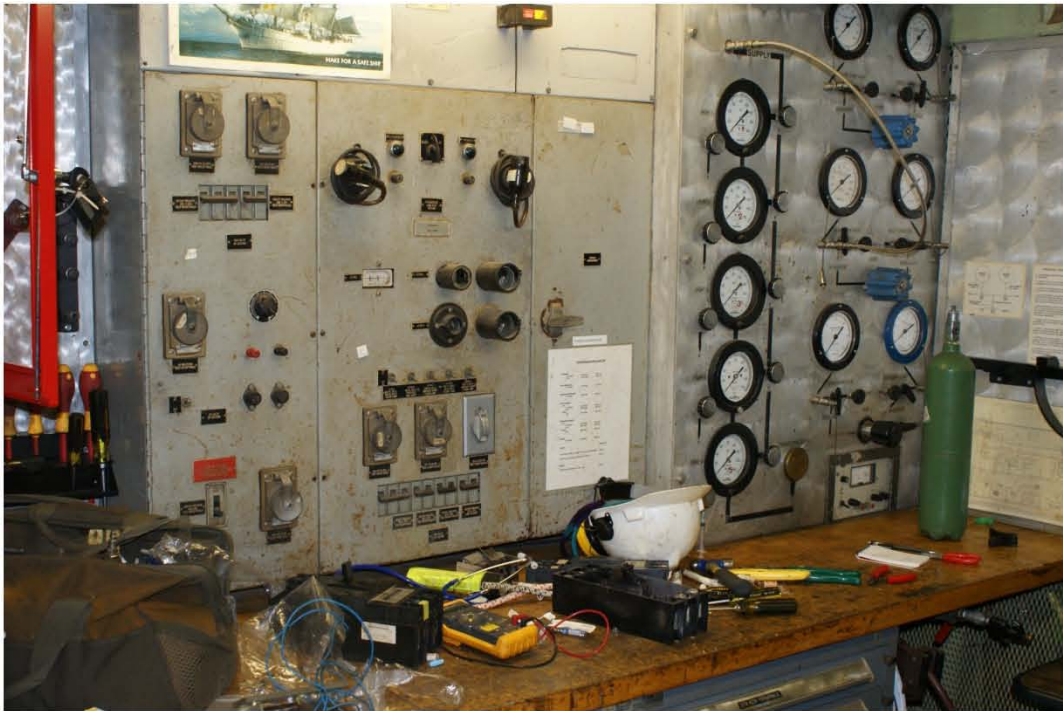
Figure 6: Photograph of the S/R WILMINGTON Electrical Test Panel and Workbench.
Note: the test panel also includes a pneumatic testing area (right side).

19. The electrical test panel in the electrical workshop is a Hose-McCann Telephone Co., Inc. test panel. Hose-McCann, located in Englewood, New Jersey, designed the electrical test panel for installation at construction of the S/R WILMINGTON in 1985 (ECN 3390690-22-██████).

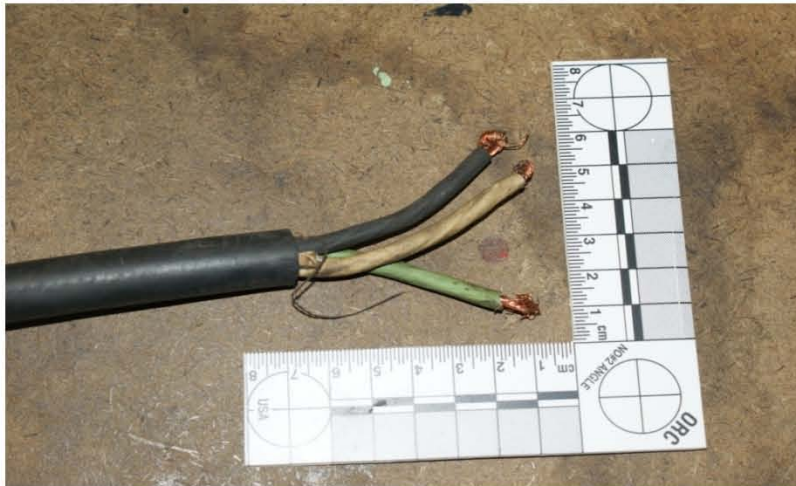
Figure 7: Photograph of the fabricated electrical test lead test lead or "pigtail" consisting of a four (4) prong plug, a six (6) foot insulated cord, and three bare exposed wires.

5. Finally, defenses were removed and supervisory oversight was inadequate. For example, the engineers used a “makeshift” electrical test lead with the designed insulated alligator clips removed. Additionally, defenses, such as briefings, training and personal protective equipment, were missing or inadequate.

23. The original 480 volt test lead was not on board the vessel. The engineers were using a test lead that had been fabricated for use with the 480 volt receptacle. Engineers interviewed were unable to recall exactly when the test lead was fabricated. The fabricated test lead, or "pigtail," consisted of a four (4) prong plug, a six (6) foot insulated cord, and three bare exposed wires (ECN 3390690-31- [REDACTED]).

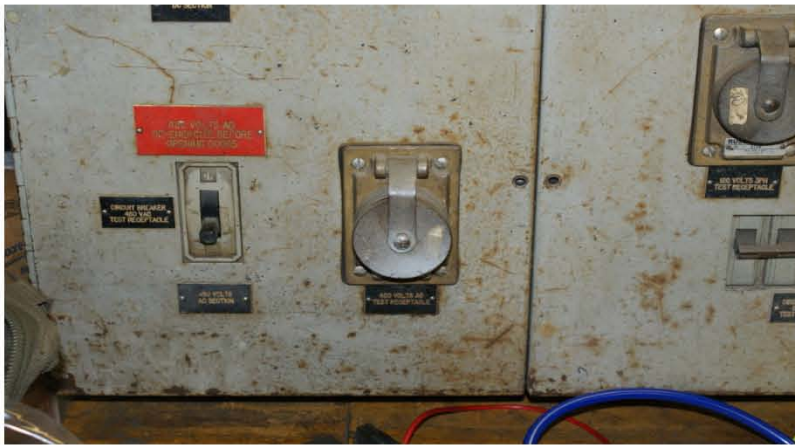
Figure 8: Photograph of the Test Panel Safety Placard and 480 Volt Receptacle

Finding of Fact #28 (Page 14): The red warning placard shown in Figure 8 reads as follows: "480 VOLTS AC DE-ENERGIZE BEFORE OPENING DOORS." The testing panel has three access/maintenance doors to which this warning placard refers (See Figure 6, page 12). This placard may not have referred to the 480V receptacle cover as detailed in the report as no other testing receptacles and corresponding switches on the panel were marked with similar warnings. The placard in question was installed in a location that may have caused confusion regarding what it applied to. Coast Guard investigators were told by members of the vessel's crew that they believed the placard referred to the 480V receptacle. Nevertheless, the breaker servicing the 480V receptacle should have been verified to be in the OFF position prior to utilizing the receptacle. No separate instructions should have been required or expected for engineers on the S/R WILMINGTON to secure the 480V breaker prior to utilizing the receptacle as this would be considered part of their basic knowledge of their position as licensed engineers.

4. The Production Factors Element included a human error related latent unsafe condition as personnel were not following safety placards.

28. [REDACTED] opened the 480 volt receptacle door. Of note, the red placard (see Figure 8) on the test panel states “480 VOLTS AC DE-ENERGIZE BEFORE OPENING DOORS” (Figures 6 and 8; ECN 3390690-34-[REDACTED]).
