# UNITED STATES COAST GUARD

INVESTIGATION INTO THE CIRCUMSTANCES  
SURROUNDING THE LOSS OF THE COMMERCIAL  
FISHING VESSEL

## CAPE FEAR

THREE NM SW OF CUTTYHUNK, MASSACHUSETTS  
ON JANUARY 9, 1999 WITH THE LOSS OF TWO LIVES

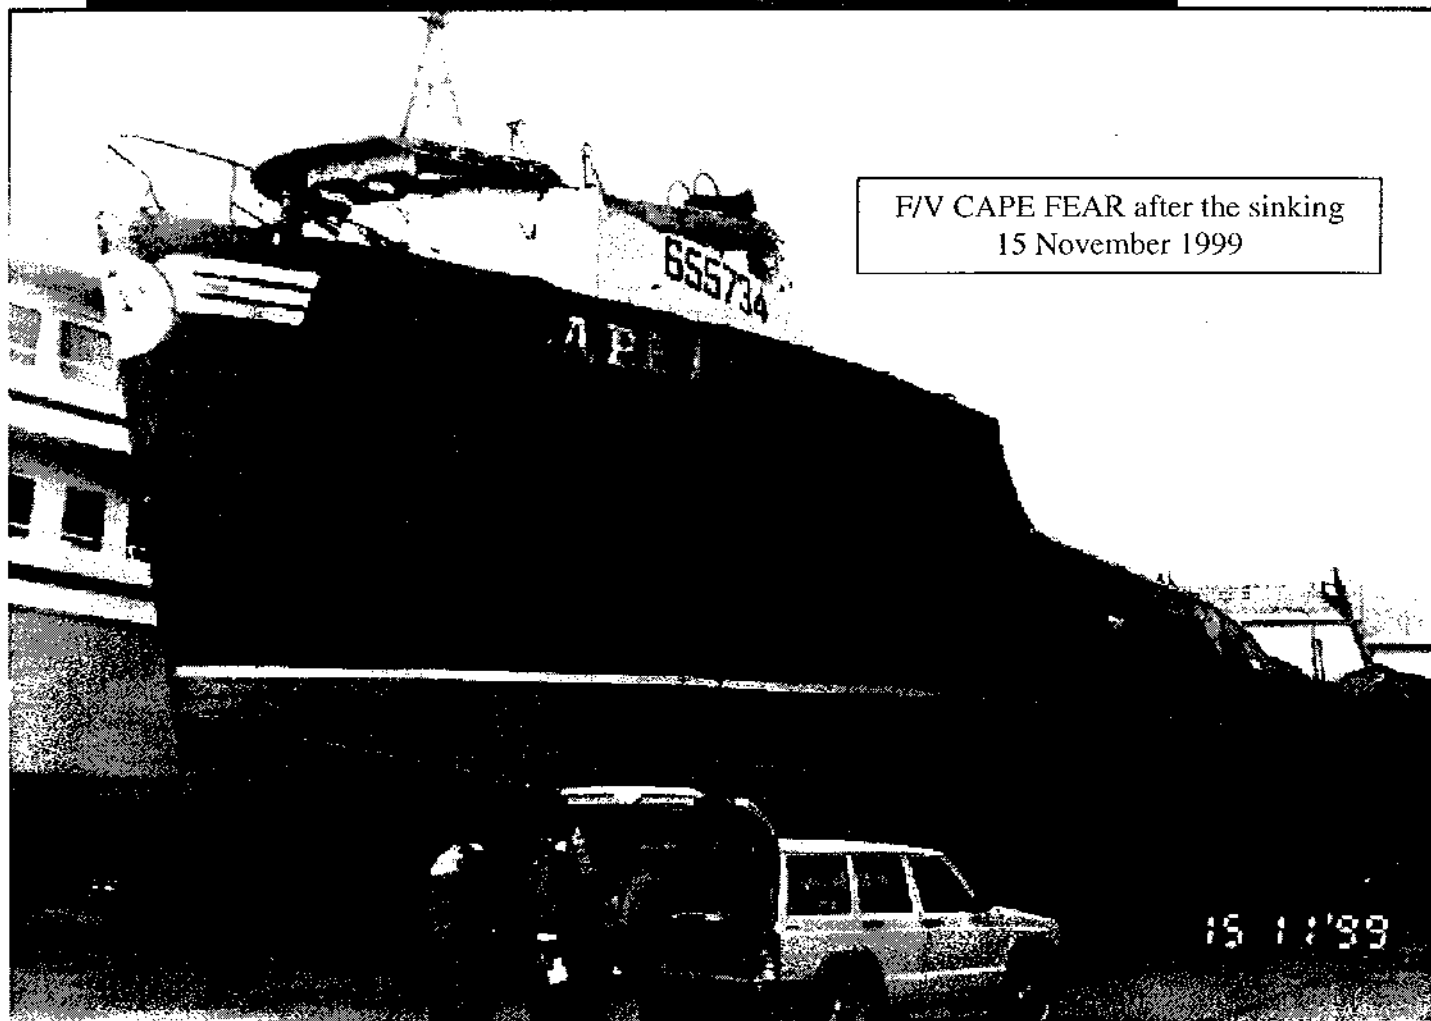
F/V CAPE FEAR after the sinking  
15 November 1999

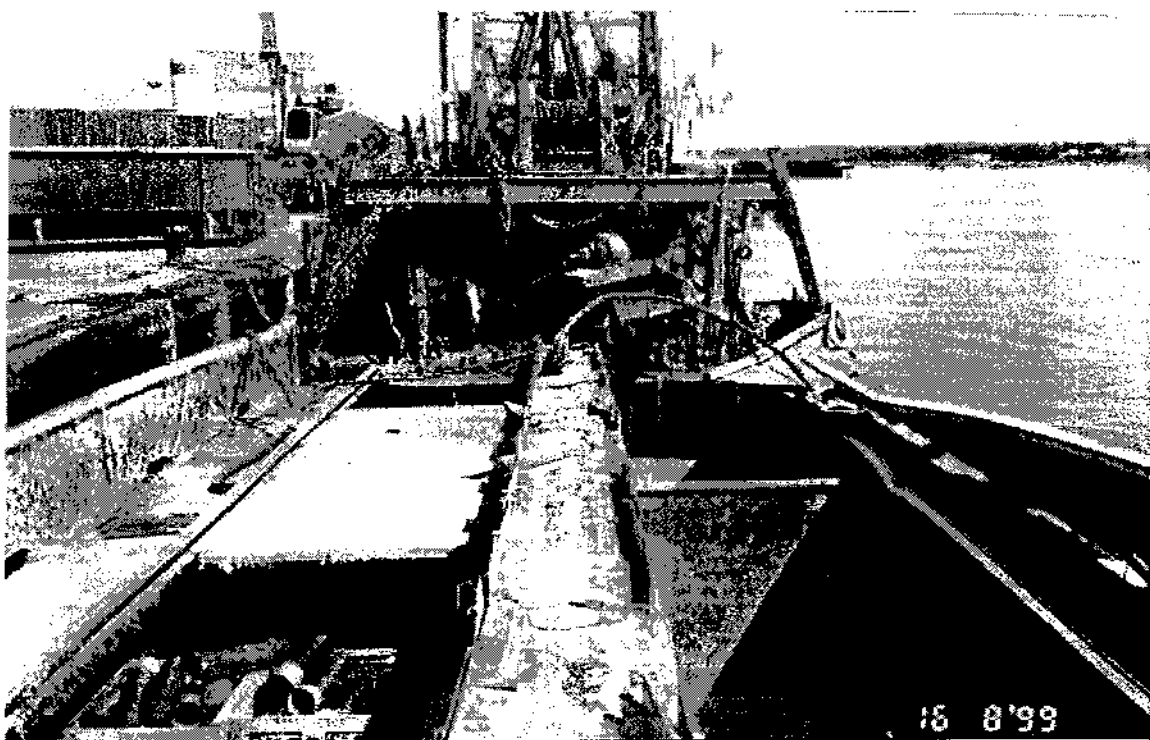
F/V CAPE FEAR Clam Tanks & Hatch Covers on Main Deck facing Aft  
Photo Taken 16 August 1999

The clam tank hatch covers were made of steel. There were deck ribs running underneath the covers, which were not normally visible due to insulation that had been sprayed on the underside of the hatches to keep the clams cool. The forward and after edge of each hatch had a 3 inch steel lip on it.

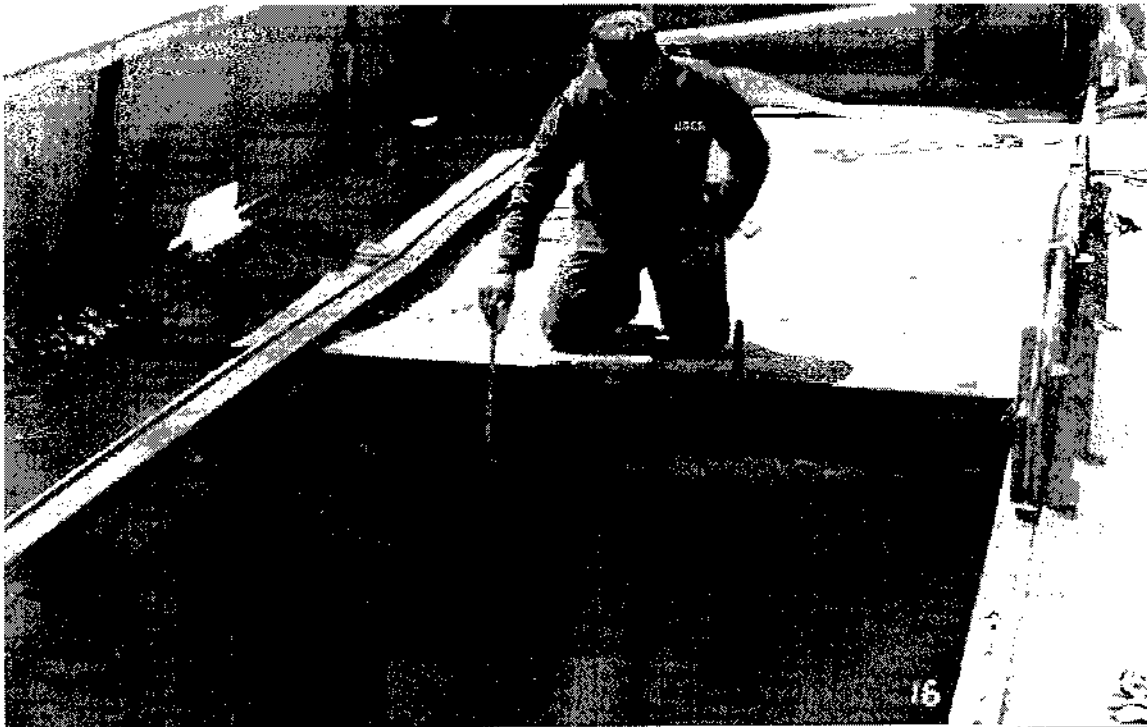
The number 3 hatch covers ran on a lower track than the number number 1 and 2 hatch covers. When closed there was a  $\frac{3}{4}$  to 1  $\frac{1}{2}$ -inch vertical gap between the bottom of the number 2 hatch cover and the top of the number 3 hatch covers. The number 2 hatch covers overlapped the forward portion of the number 3 hatch covers by 2 to 4 inches.

The hatch covers were 18 feet long. The leading edge of the number 3 hatch covers, when closed, would sit directly above the transverse bulkhead separating the number 2 and 3 clam tanks. There was a 5  $\frac{1}{2}$ -inch vertical gap between the bottom of the number 3 hatch covers and the top of the transverse bulkhead separating these clam tanks.

F/V CAPE FEAR Number 1 & 2 Port Clam Tanks and Hatch Cover on lower track  
Shows vertical gap between transverse bulkhead and hatch cover on lower track.  
Photo taken 16 September 1999
