# UNITED STATES COAST GUARD

## REPORT OF INVESTIGATION INTO THE CIRCUMSTANCES SURROUNDING THE FIRE ABOARD ROYAL CARIBBEAN INTERNATIONAL PASSENGER VESSEL

### NORDIC EMPRESS

IN THE ATLANTIC OCEAN  
JUNE 15, 2001  
RESULTING IN MAJOR DAMAGE  
NO LOSS OF LIFE OR INJURY

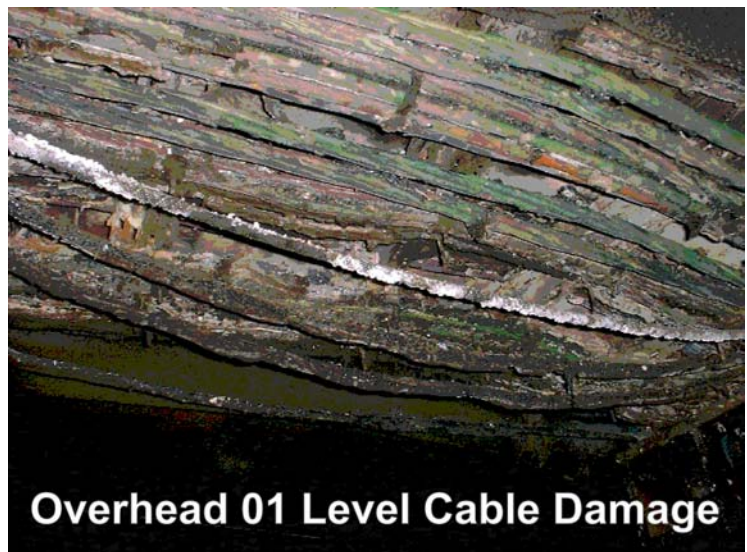
One deck up on the 01 level in the main engine room, forward side, is an athwartships platform that is about two meters wide for the width of the compartment. The aft edge of the platform does not overhang the area above the engine fronts. Along the centerline of the overhead above the platform runs a cableway for its entire length. The cableway contains hundreds of conductors serving various motors and controls for fans and pumps, valve actuators, ventilation, automation controls, remote indication systems and lighting circuits for the machinery, controls and equipment in the main engine machinery space. All of this wiring was destroyed, their insulation and shielding completely disintegrated revealing bare conductors.

Also damaged in this area was an eleven-section electrical control panel situated against the forward bulkhead containing the operating controllers for the machinery within the space. It suffered significant damage externally and limited damage internally.

Generally all lighting, annunciating and visible alarms, shields and lense covers were destroyed on this level (01) and the next upper level in this space (02). The paint on various equipment, structures, and pipe lagging or coverings was damaged on the upper levels. Two large intake plenums above the port main engines were warped because of the fire. In the same general area and damaged after closing were actuating cylinders that operated the inlet dampers for exhaust fans of this space.

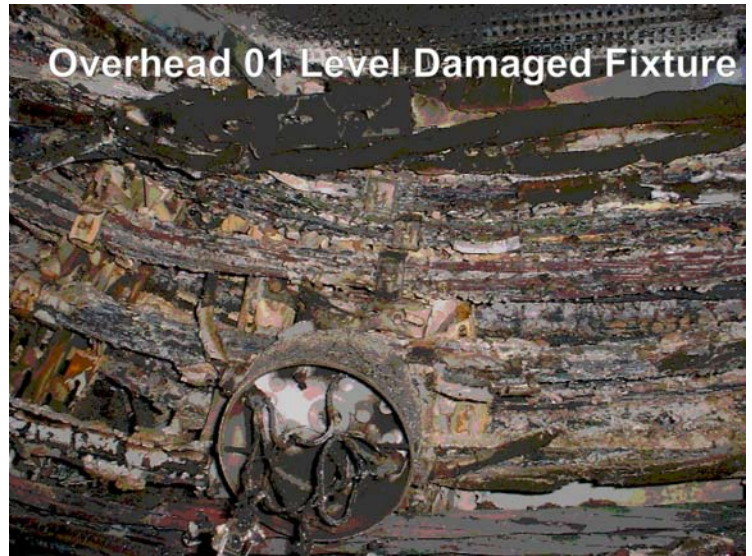
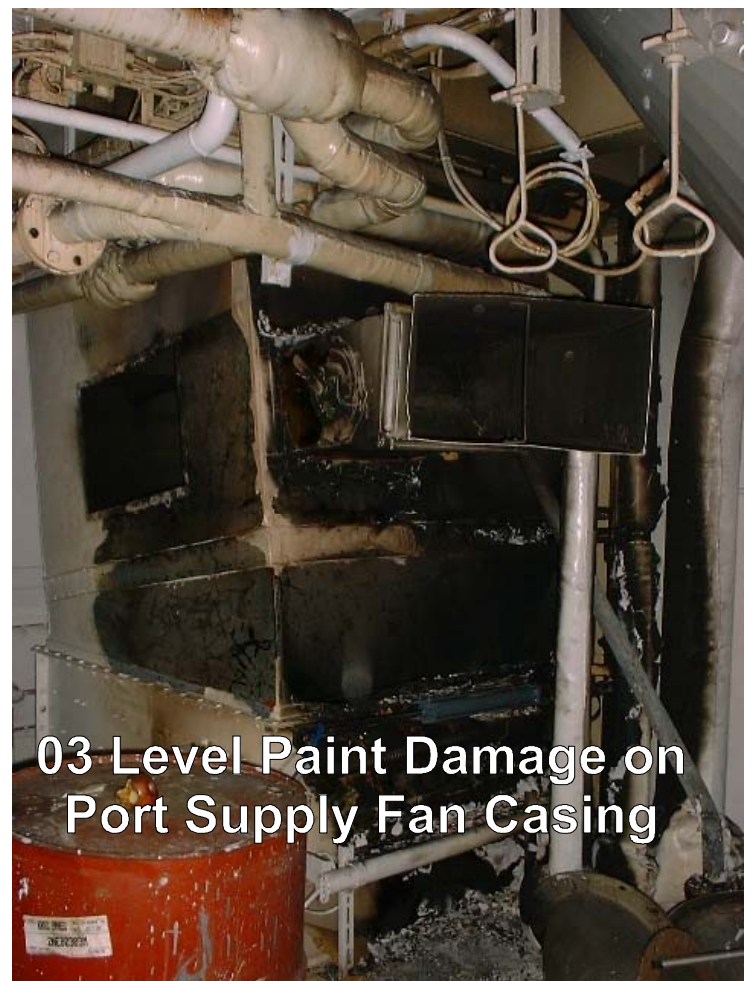
Structural damage appeared to be limited to a few slightly distorted stiffeners located on the forward bulkhead, port side, between the 02 and 03 levels. The stiffeners associated with the deck on the 03 level were also distorted and the deck plating at the forward end of the fan room was warped and bowed. However, none of the deflection affected machinery or its associated mounting arrangements within the fan room. The only other damage present in this area was the overheating of paint on the port supply fan discharge casing which resulted from the conduction and convection of heat from the intake plenums located above the port main engines.

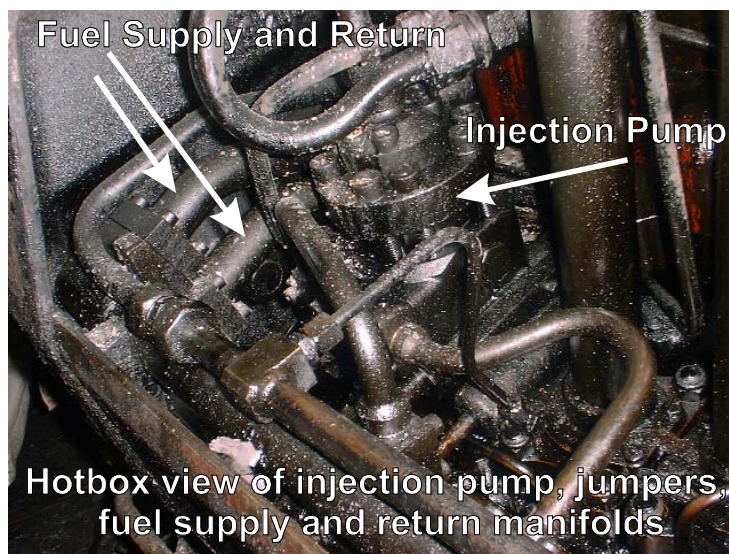
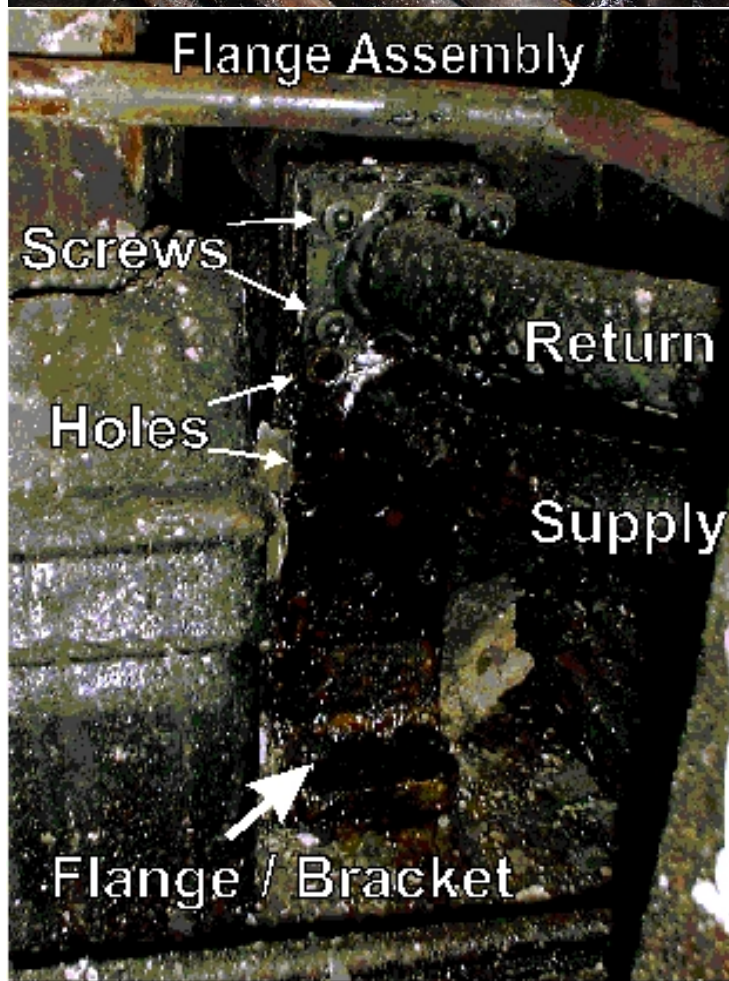
After the casualty, an inspection revealed that three of the four socket type hex screws attaching the fuel supply piping of the lower fuel line from the outboard manifold within the hotbox to the bracketed flange assembly had failed at the flange.

Only one screw remained which freely allowed movement of the pipe and facilitated separation at the flange. The sealing of the flange was accomplished by using an o-ring recessed in a groove machined into the surface of the piping flange.

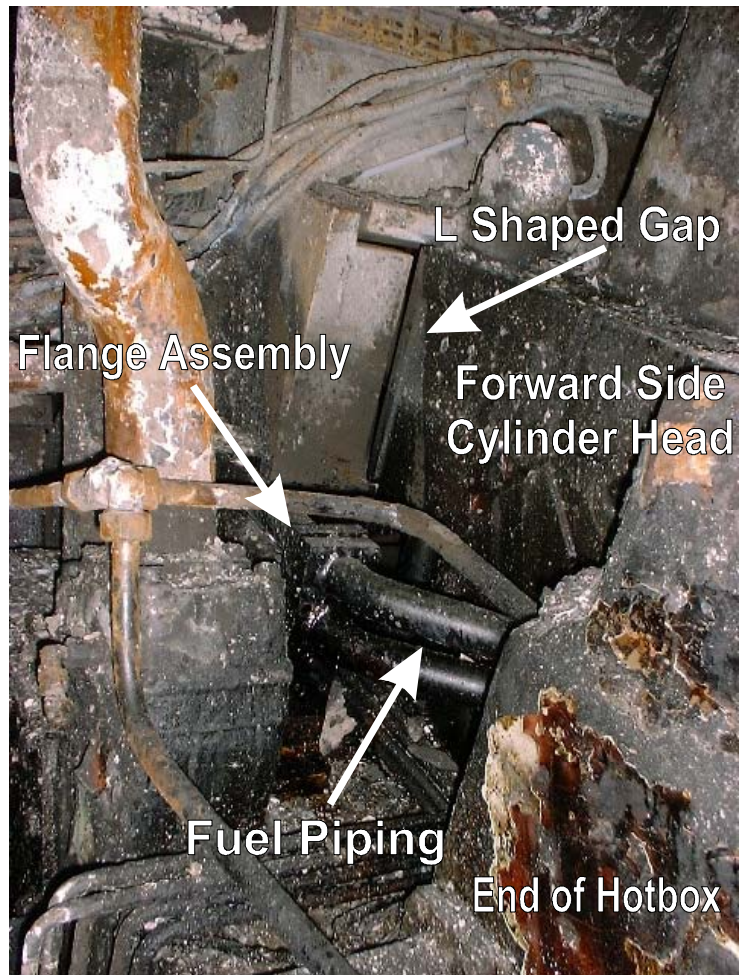
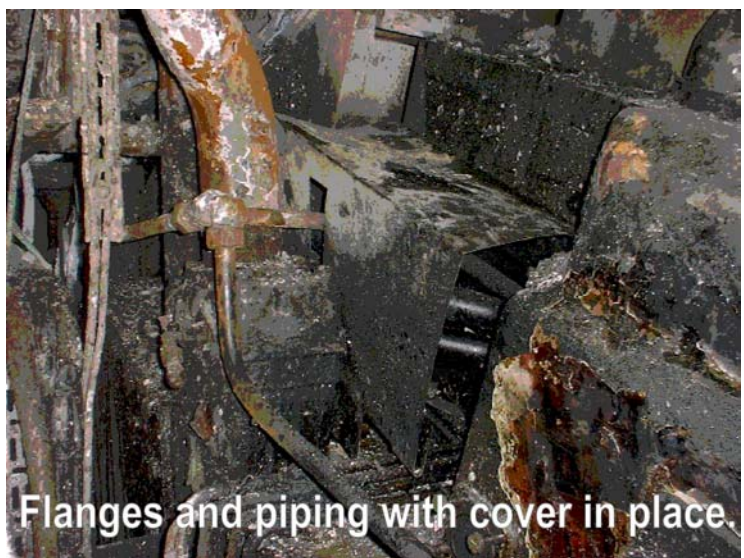
The failed flange was located along the forward side of the number one cylinder head. The exhaust piping from the cylinder was located on the inboard side of the cylinder head. The heads of each cylinder formed part of a larger manifold casing that in turn contained all the exhaust piping as it is piped to the turbocharger inlets. An inverted "L" shaped gap approximately 10mm wide by 260 mm in height with a 16 mm high by 60 mm wide horizontal opening was formed along the corner edge of the head and manifold casing. Just beyond this opening and less than 30 cm away from the failed flange, although not readily visible, was the exhaust piping from the number one cylinder.

The spraying fuel ricocheted and atomized under the piping cover. It was guided by the cover's aft edge to the nearby exhaust pipe and manifold. It instantly autoignited lighting off the remaining fuel spraying out in all directions from the openings in the cover. The fire engulfed the entire front of both engines serving the port propeller shaft.

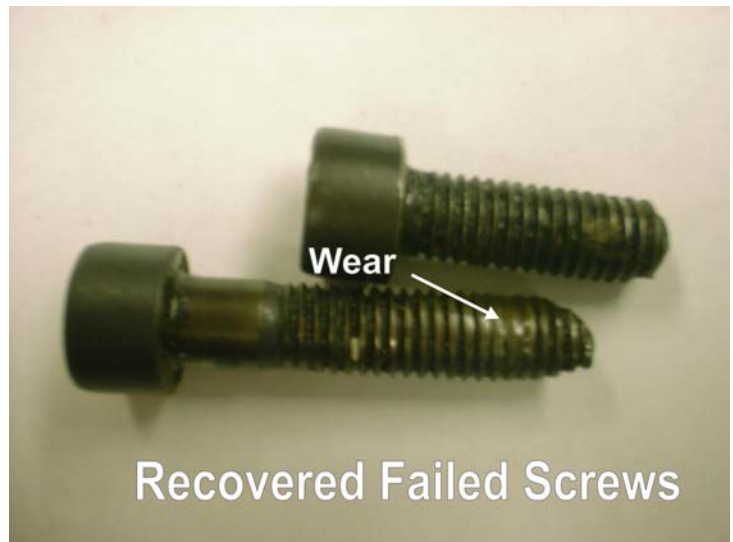
Two of the fractured screws recovered were 23 mm and 36 mm in length. The screws were also of different quality. Different qualities necessitated different torque requirements.

Tightening too close or beyond the screw's yield strength may result in failure or torque loss, while tightening to a lower range of the yield may result in insufficient preload for sealing and insufficient residual load to maintain the seal. The fuel line flange was designed for screws 30 mm long yet after the casualty a much longer screw requiring spacers was found. Additionally other improperly sized screws were observed on flanges of the number three main engine crossover piping.
