UNITED STATES COAST GUARD

INVESTIGATION INTO THE CIRCUMSTANCES
SURROUNDING THE EXPLOSION, FIRE, AND SINKING OF
THE UNINSPECTED FISH PROCESSING VESSEL

GALAXY

OFFICIAL NUMBER 576981, IN THE BERING SEA ON
OCTOBER 20, 2002, WITH TWO PERSONS DECEASED AND
ONE PERSON MISSING AND PRESUMED DEAD

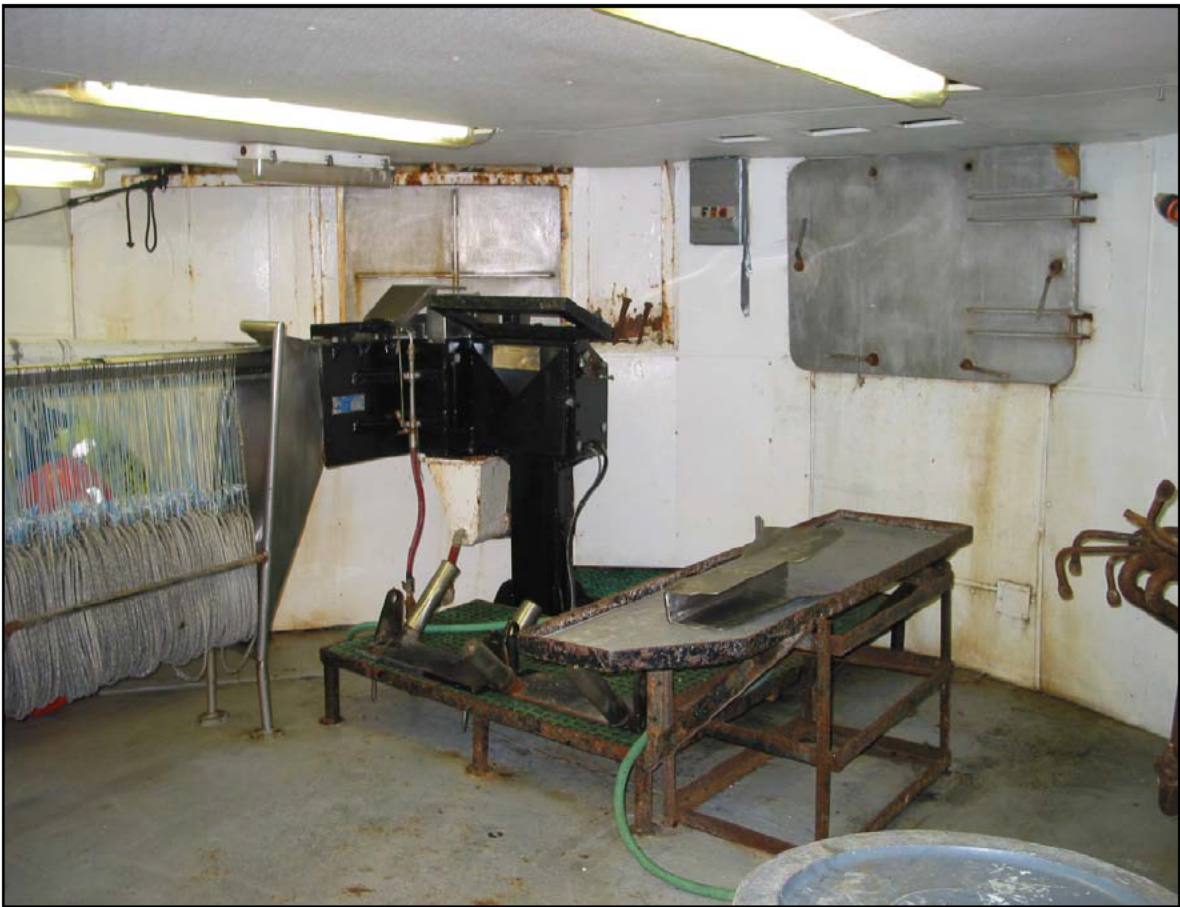
Figure (17): Photo of Gear Setting Hatch taken December 2001

~1626 (Gear Setting Hatch) A photo of the gear setting hatch is provided in Figure (17) below. The three fire team members were positioned at the gear setting hatch, trying to get fresh air. [REDACTED] testified that the fire team members knew they were in a bad situation. They were in the process of attempting to evacuate the space by climbing up the stern of the vessel with lines provided by the crew on the top deck. Mr. [REDACTED] and Mr. [REDACTED] testified that they had made contact with Mr. [REDACTED] who was in the process of retrieving lines for them. Mr. [REDACTED] was standing on the starboard side of the hatch, Mr. [REDACTED] in the middle, and Mr. [REDACTED] on the port side. Mr. [REDACTED] was standing on a table with his waist just above the level of the hatch. Mr. [REDACTED] and Mr. [REDACTED] testified that both Mr. [REDACTED] and Mr. [REDACTED] stepped back to grab the SCBA and then set it on the baiting table and were returning to hang out the hatch. Mr. [REDACTED] and Mr. [REDACTED] were immediately adjacent to the hatch, but not leaning out of it when an explosion occurred violently ejecting all three from the vessel and into the water.

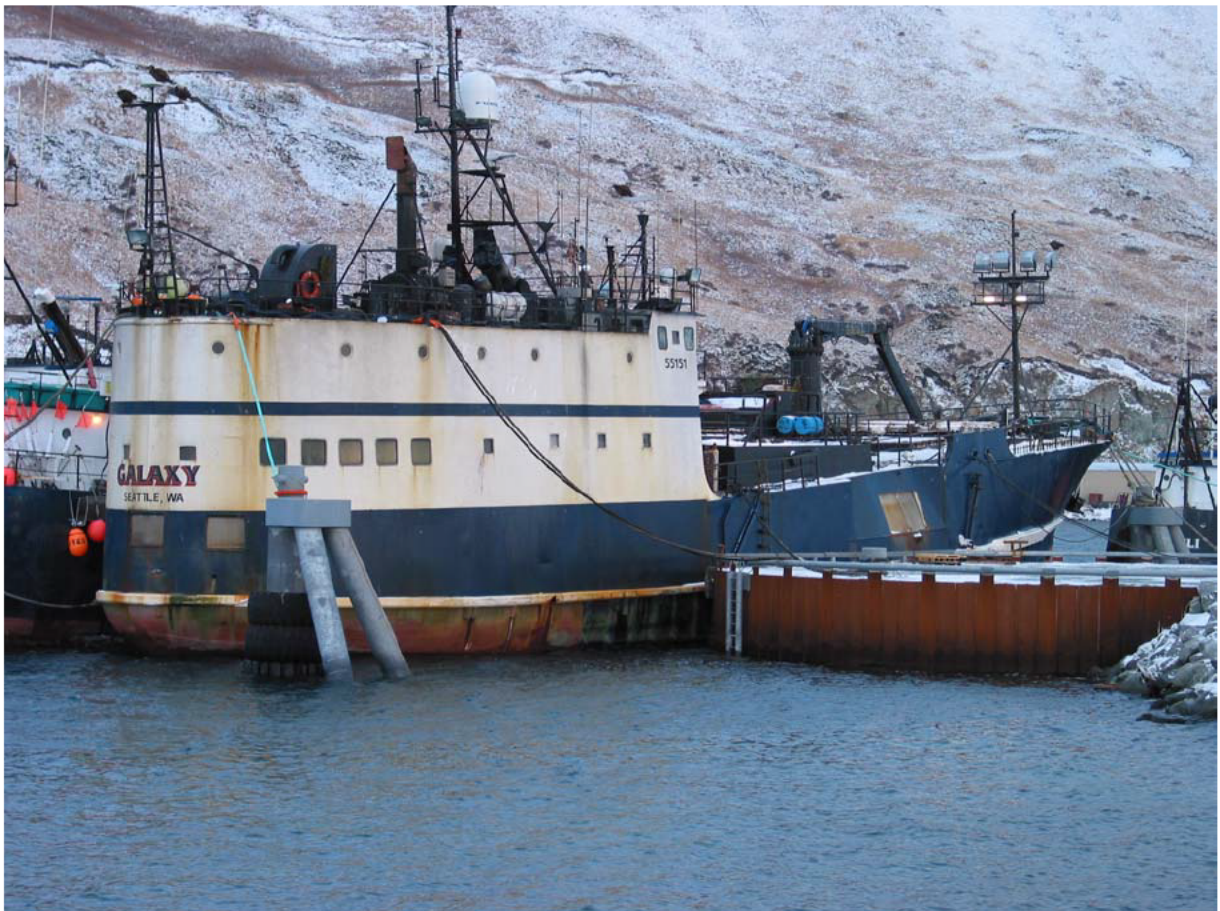
Figure (18): Photo of the Stern of FPV GALAXY taken December 2001.

Figure (18) shows the FPV GALAXY. Note the gear setting hatch on the stern directly beneath the “LA” in the vessel name and height from the waterline to the aft top deck.

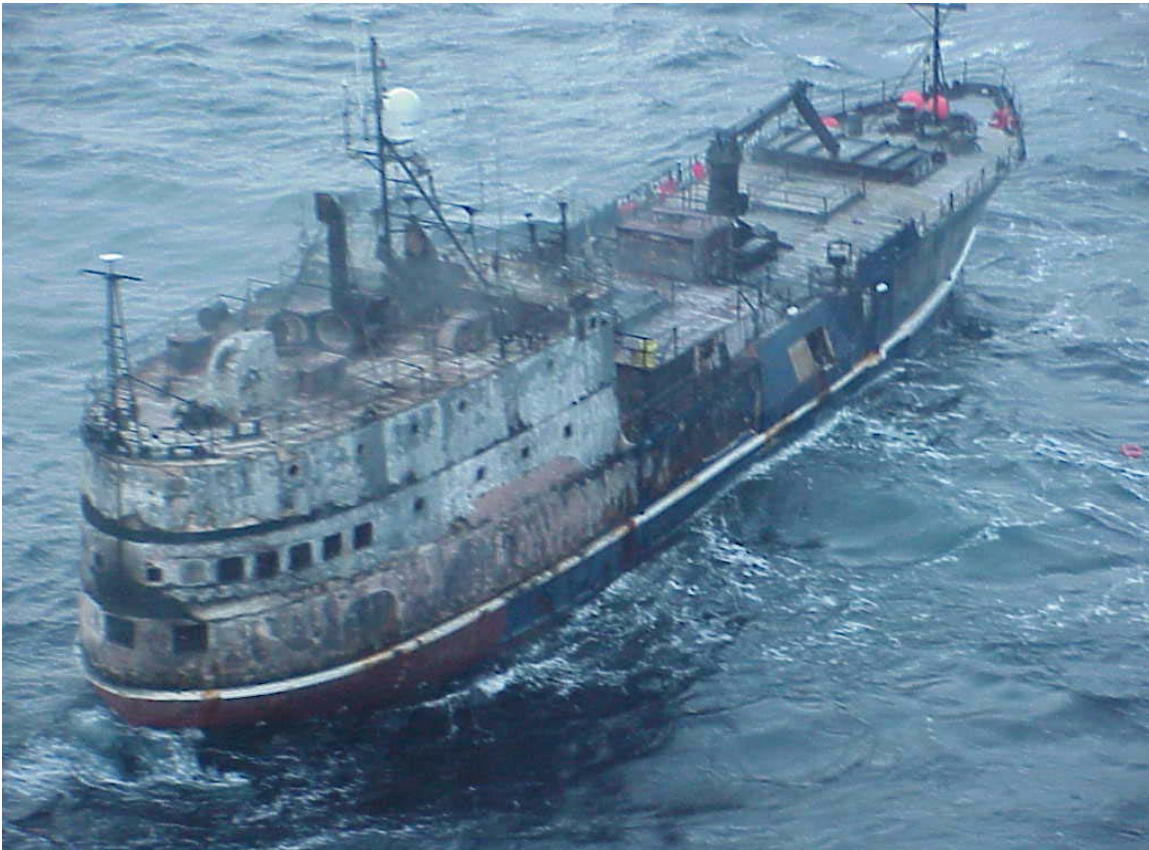
Figure (21): Last Known Photograph of FPV GALAXY taken October 21, 2002

Attempted Recovery of the FPV GALAXY: Following the initial SAR phase of the accident, U.S. Coast Guard Marine Safety Office Anchorage initiated efforts to track the drifting vessel due to the possibility of a large diesel spill if the vessel grounded. The principal platforms utilized to track the vessel were U.S. Coast Guard aircraft and the USCGC JARVIS. These assets tracked the vessel by conducting visual searches. The FPV GALAXY was last sighted by the U.S. Coast Guard in position 56-22 N, 171 -20 W at 1715 on October 21, 2002. The vessel was photographed at that time and is shown in Figure (21).

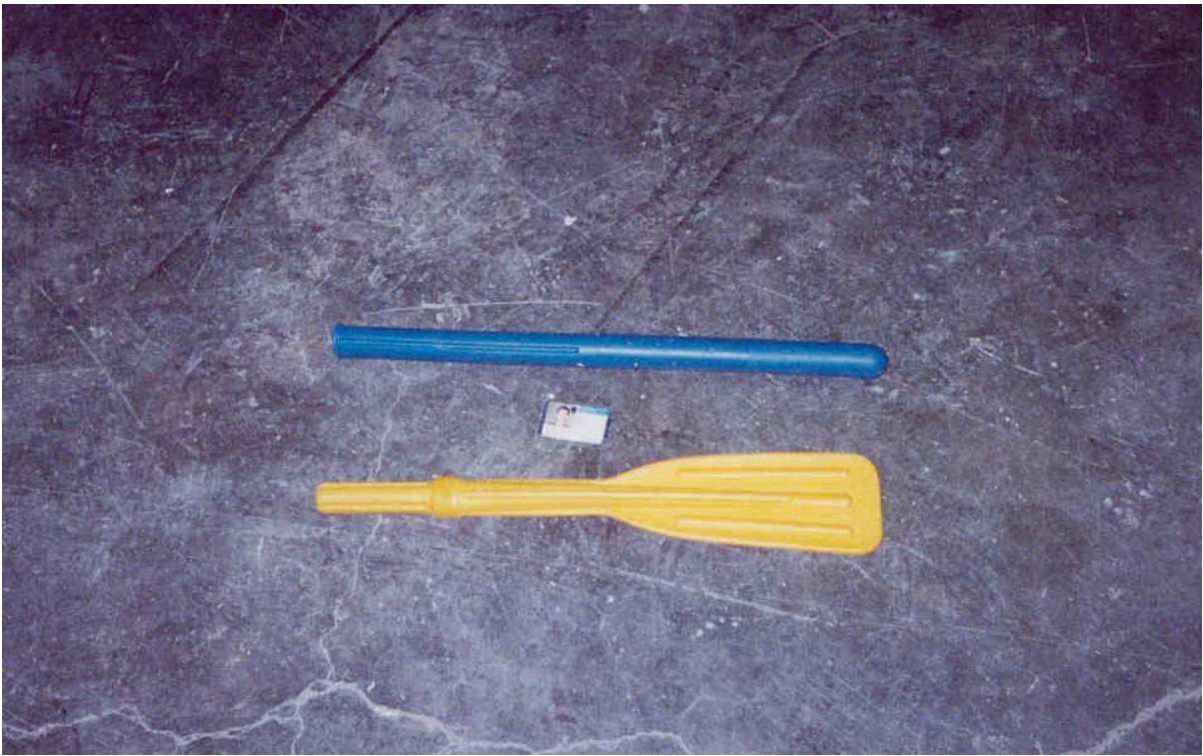
Figure (22): Photograph of Liferaft Paddles taken November 26, 2002.

paddles, it appears that the existing standard for liferaft paddles is not sufficiently rigorous for typical conditions in the Bering Sea. Figure (22) below is a photograph of a paddle recovered from the liferaft used in the evacuation of the FPV GALAXY. The paddles are of plastic construction. A driver's license was included in the photograph to provide scale. Mr. [REDACTED] stated during testimony that it was his opinion that paddles for a children's raft were of more suitable construction than the paddles provided within the liferaft on the FPV GALAXY.

Recommendation 27: The U.S. Coast Guard, through the International Maritime Organization, should develop regulations to require that liferaft paddles in SOLAS A and SOLAS B rafts be designed of a material suitable for use in life threatening and emergency situations.

Action: We concur with this recommendation. At present, the only specific International Maritime Organization (IMO) requirement for paddles provided in a liferaft is a demonstration that they can be used to maneuver the liferaft a short distance in calm water. We will pursue improvements at the next opportunity to review the IMO requirements for liferafts. In addition, the International Organization for Standardization (ISO) is currently developing an international standard for survival equipment carried in lifeboats, liferafts, and rescue boats. We will propose that the requirements for paddles in this standard take into account use in a seaway and in adverse climatic conditions. In the meantime, we will also share the results of this investigation with suppliers of liferafts and paddles so that they are aware of the difficulties and failures exhibited in this casualty.

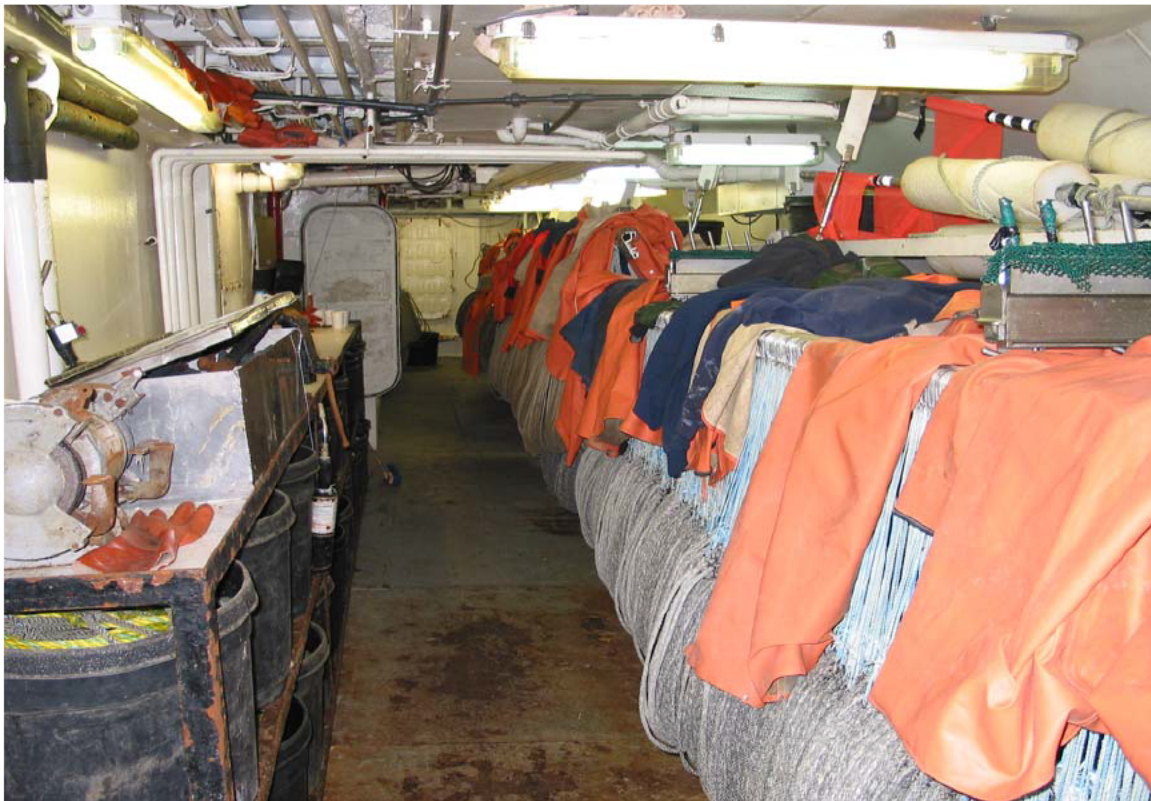
Figure (23): Photo of Gear Line Looking Forward towards Upper Engine Room Hatch (December 2002)

Fire Team Response: The crew of the FPV GALAXY were not trained, equipped or had experience as professional marine fire fighters. Based upon testimony, the vast majority of the fire team responded to the scene with hoses, extinguishers, SCBAs and fireman's outfits immediately following the detection of smoke and the activation of the fire alarm. Figure (23) is a view looking forward on the gear line.

It is important to note that approximately four minutes elapsed between the time that smoke was first detected and the time of the explosion. With approximately only four minutes to properly assess and respond to the emergency, there was no opportunity for mistakes. The on-scene leaders, Mr. [REDACTED] and Mr. [REDACTED] quickly attempted to find the source of the smoke, and when they did find the source, the two initially made the decision to attempt to don an SCBA and fight the fire with a portable extinguisher. In retrospect, this decision to fight the fire delayed Mr. [REDACTED] later decision to discharge the vessel's fixed CO2 firefighting system. However, within 30-45 seconds of Mr. [REDACTED] initial decision to attempt reentry, he reassessed and made the decision to discharge the vessel's fixed CO2 firefighting system. At this point, the command and control of the fire team as described in the WQSB began to break down. While most of the crew reported on scene as required, several crew members did not. In particular, [REDACTED], [REDACTED], and [REDACTED] did not report as required by the WQSB. Captain [REDACTED] noted in his testimony that he was looking for his messengers. Mr. [REDACTED] and Mr. [REDACTED] held those assignments. Instead of reporting to Captain [REDACTED] or one of the fire team leaders, they evacuated to the top deck. Also worth noting is that although the fire team reported to the scene (except as previously noted) and all the major fire fighting functions were addressed (with the exception of the messengers), not each fire team member performed their assigned functions.

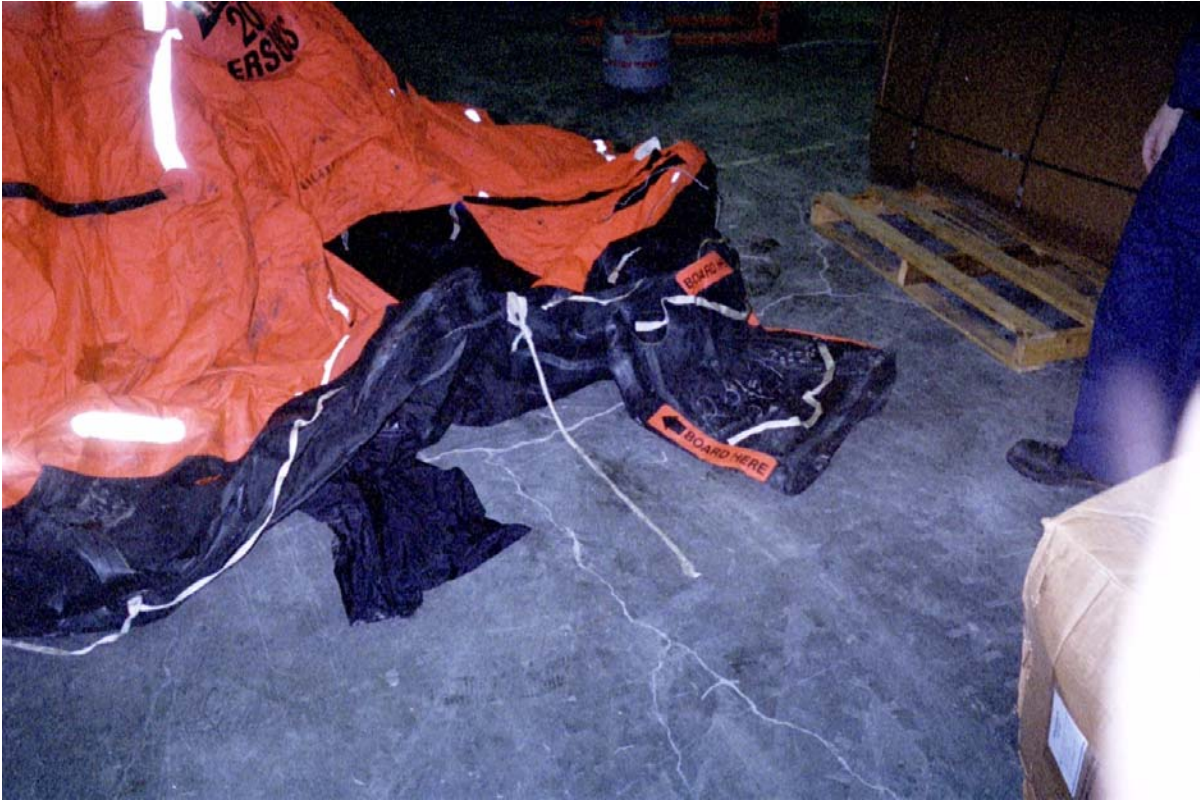
Figure (24): Photo of the Cut Sea Painter and Raft taken November 26, 2002

Raft was Cut Free: Testimony from the crew members in the raft and on the top deck indicate the raft was cut free. Although no crew members ever admitted to cutting the raft, an examination of the liferaft in Kodiak, Alaska on November 26, 2002 by LCDR [REDACTED] and MST2 [REDACTED] clearly reveals the sea painter was cut. According to LCDR [REDACTED] assessment of the raft, the remaining piece of the sea painter attached to the raft was approximately three feet long. There was no evidence on the sea painter of chaffing, fraying or burning. The end of the sea painter which would have led back to the vessel appeared to be cut with a knife. Figure (24) is a photo of the sea painter for the raft recovered by the F/V GLACIER BAY on October 20, 2002.

It is possible that the sea painter had been cut following the raft's recovery by the F/V GLACIER BAY. Mr. [REDACTED] testified that he had removed the knife from the raft and had cut pieces off the raft as souvenirs. However, the observations of the crew (from both inside and outside the raft) at the time of the accident and the physical evidence clearly indicate that the raft had been cut free from the FPV GALAXY.
