**REPORT OF INVESTIGATION INTO THE CIRCUMSTANCES
SURROUNDING THE GROUNDING OF THE**

MONARCH OF THE SEAS

**ON PROSELYTE REEF IN GREAT BAY, PHILIPSBURG,
ST. MAARTEN, NETHERLANDS ANTILLES ON**

DECEMBER 15, 1998

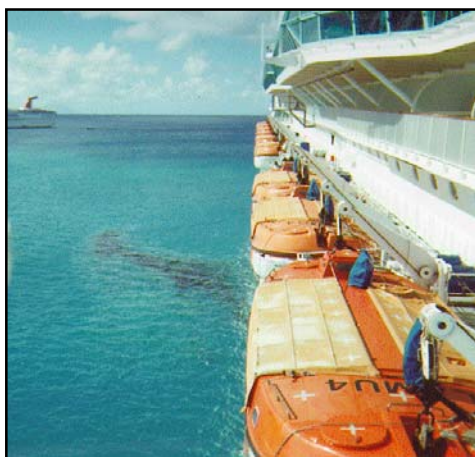
**View of lifeboats from the starboard
bridge wing looking aft. Note oil spill.**

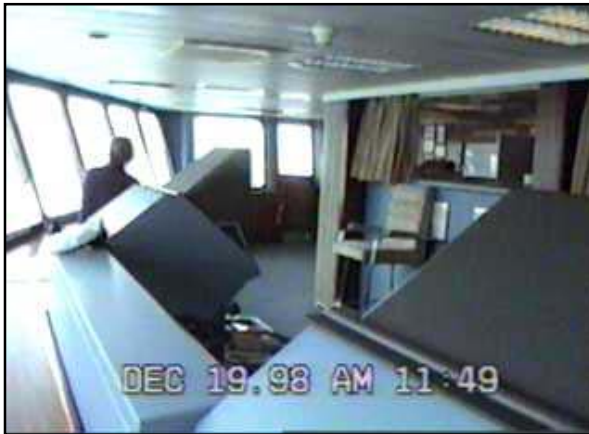
MONARCH's bridge, view from centerline forward to starboard. Hooded equipment on middle-left of photo is the ARPA in use by the OOW at the time of casualty.

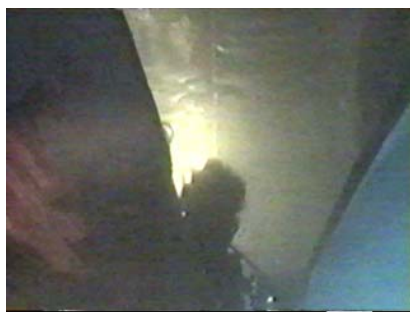
Diver surveying a crack in bottom shell plate

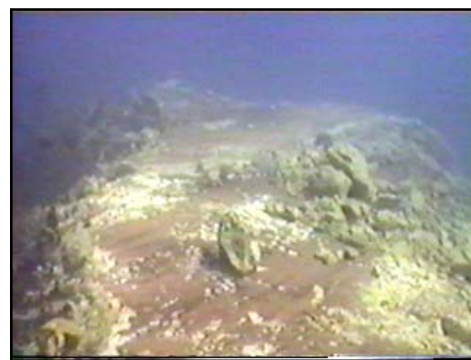
Reef Damage

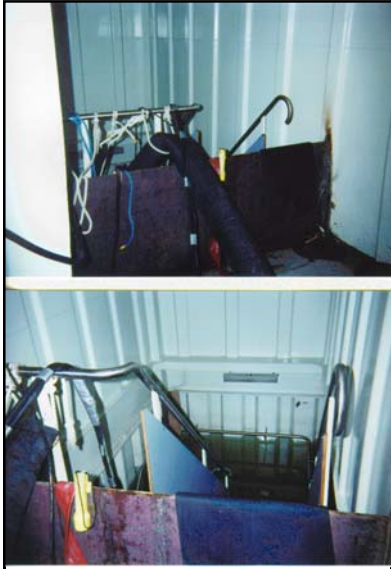
Resultant flooding of stairwell on main deck, port side, forward passageway. Note the welded steel plate across opening to prevent further progressive flooding.

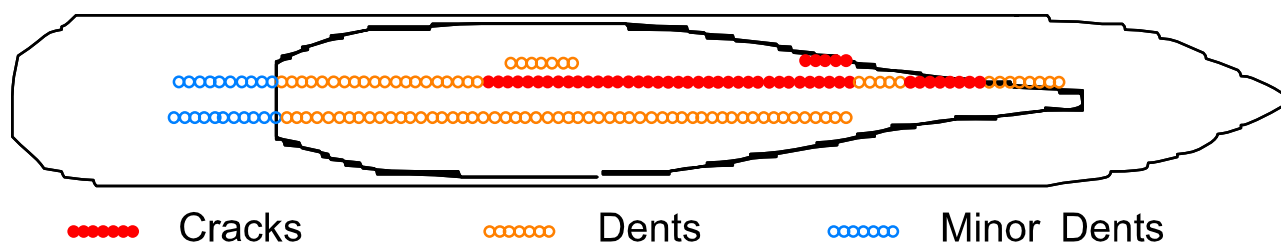
Approximate Limits of Damage to the Ship's Bottom

Summary of damage to the ship's bottom:

Double Bottom Damage	Inner Hull Damage
9 ballast tanks	Laundry area
5 voids	Photo labs
2 fuel tanks	2 pump rooms

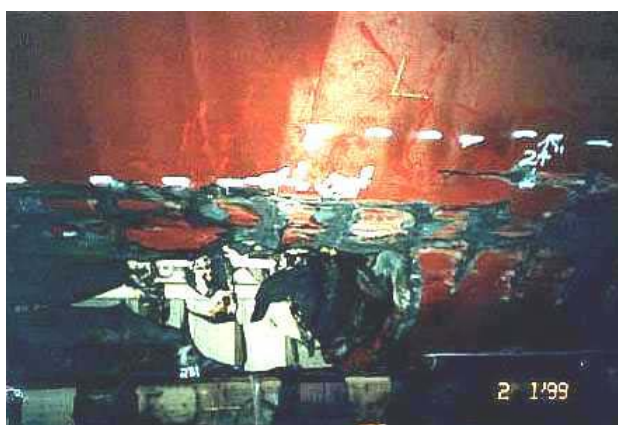
Damage to the bottom, port side.

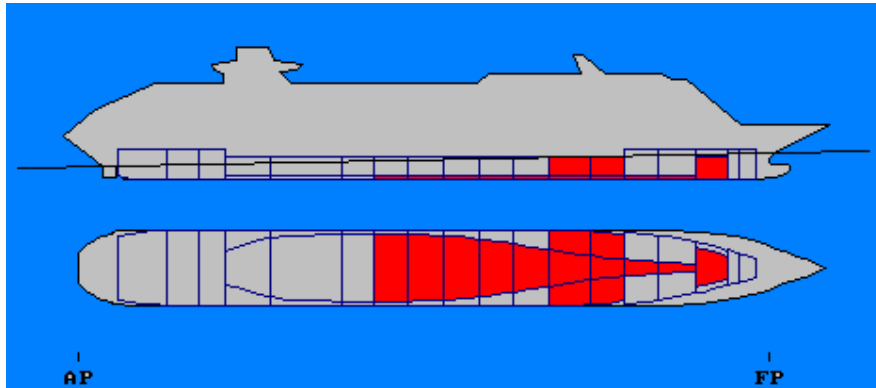
Flooded Areas of the Vessel

- The Coast Guard's stability analysis concluded that *MONARCH OF THE SEAS* would have stayed afloat in open water **provided** that there was no progressive flooding due to additional structural failures such as watertight subdivision boundaries.
- The vessel would have remained afloat at least 12 hours during which the vessel would have remained stable enough to launch its lifeboats and liferafts.
- The presence of double bottoms greatly contributed to the vessel's ability to survive.
- SOLAS damage requirements ensured adequate reserve buoyancy.

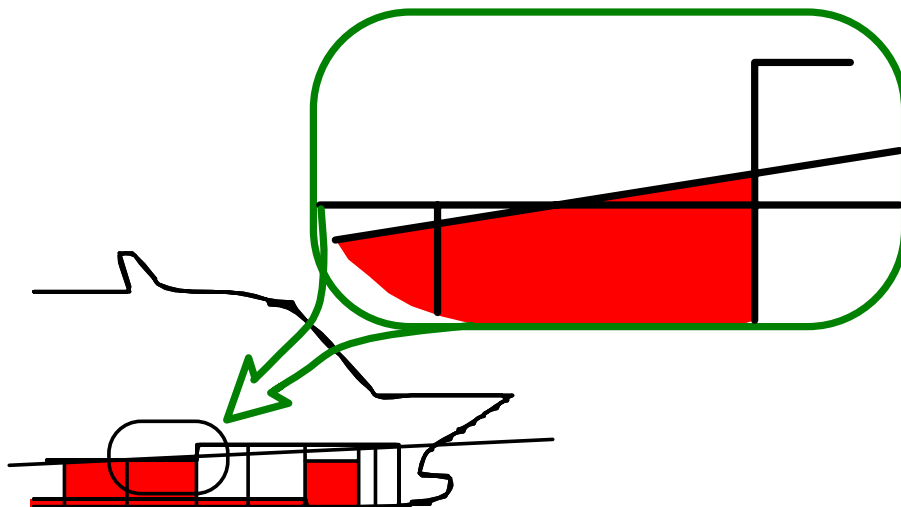
Note: The "stepped bulkheads" forward of pump room no. 1 were a primary reason why the ship stayed afloat.

Diagram indicating the stepped bulkheads.

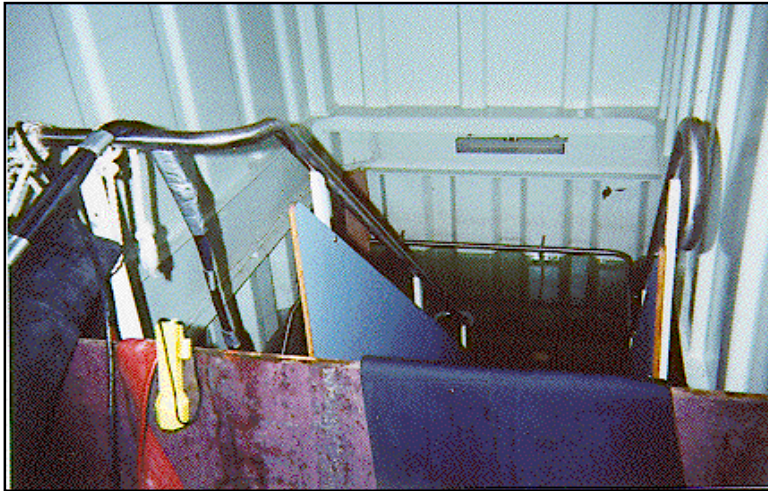
Deck 1, port side passageway. Note welded plate across stairwell put in place to limit the chance of progressive flooding.

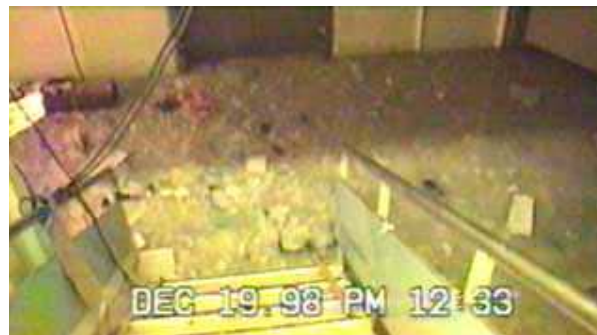
Flooded storage room with paper waste slurry.

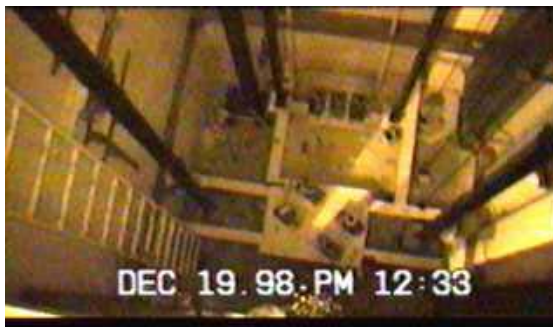
Top down view of a flooded elevator shaft and top of elevator.

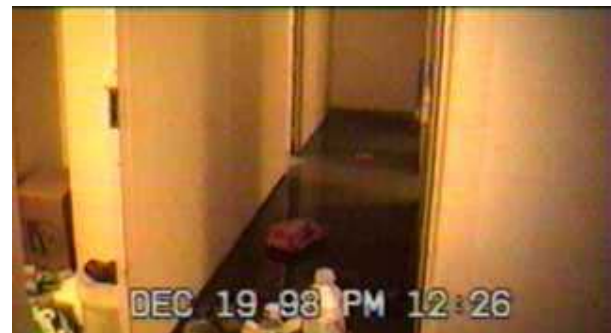
Flooding of crew staterooms.

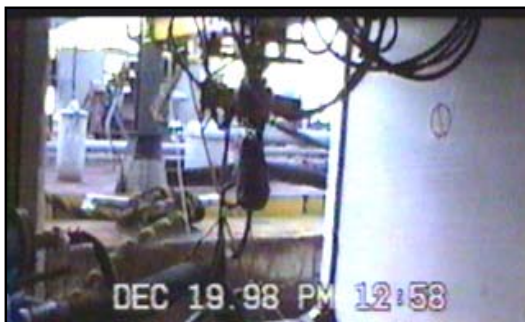
View from just inside side shell port used in the evacuation of the vessel. Note overhead obstructions

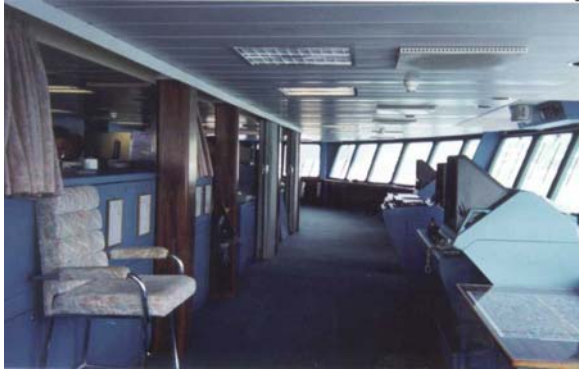
Starboard side of bridge looking toward centerline.
ARPA used by OOW is to the right in photo.

The OOW's decision to use the ARPA to plot Proselyte Reef lighted buoy as the **sole** navigational instrument and reference point was contrary to the rules of good seamanship, his training as a navigational officer and the vessel's established standard operating procedure. This routine violation can be attributed to a human tendency to take the path of least resistance and accomplish the easiest job function deemed appropriate at the time in order to get the job done.

The ARPA unit was located on the forward, starboard side of the bridge, which provides a navigator the optimal location to view radar information as well as any vessel traffic on the starboard or burdened side of the vessel. Further, the ARPA display provides the navigator with a myriad of critical radar information. For these reasons it is reasonable that a watch officer would take up station near or at the starboard ARPA. However, the layout of navigational equipment on the bridge failed to allow easy access to the chart table or the output information of other electronic navigational instruments such as the GPS receiver and thus would serve to hamper a navigator's efforts to verify and plot the vessels position by other navigational means. All navigational charts and navigational instruments were located to the rear of the bridge and required a navigational watch officer to physically step around the vast chart table and move to the aft end or rear of the bridge away from the ARPA; a valuable and easy to use navigation aid.

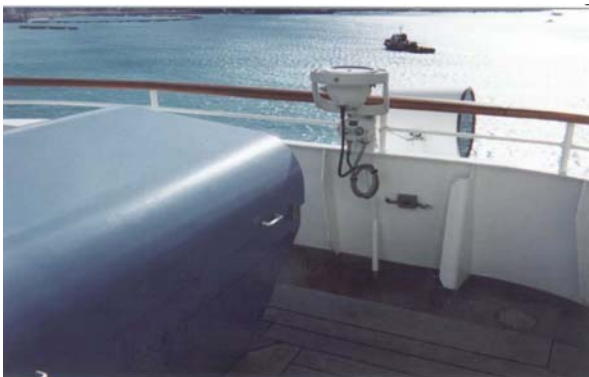
Starboard bridgewing gyro repeater. Note the obstruction in the left foreground.
