**Office of Investigations and Casualty Analysis**

Findings of Concern 001-23

***ENGINE ORDER TELEGRAPH (EOT) BELT PREVENTATIVE MAINTENANCE***

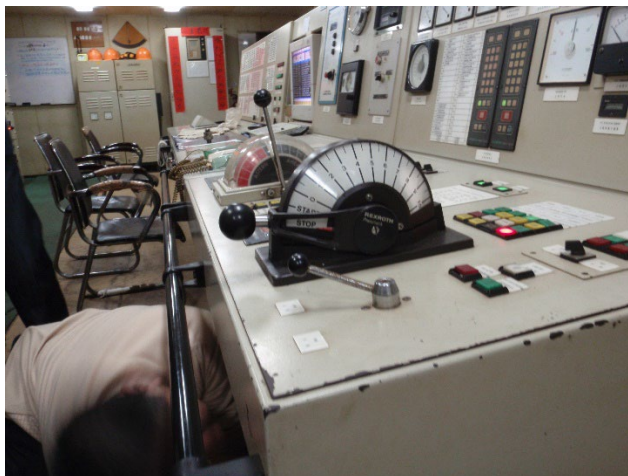
Photo shows Engine Order Telegraph control head.

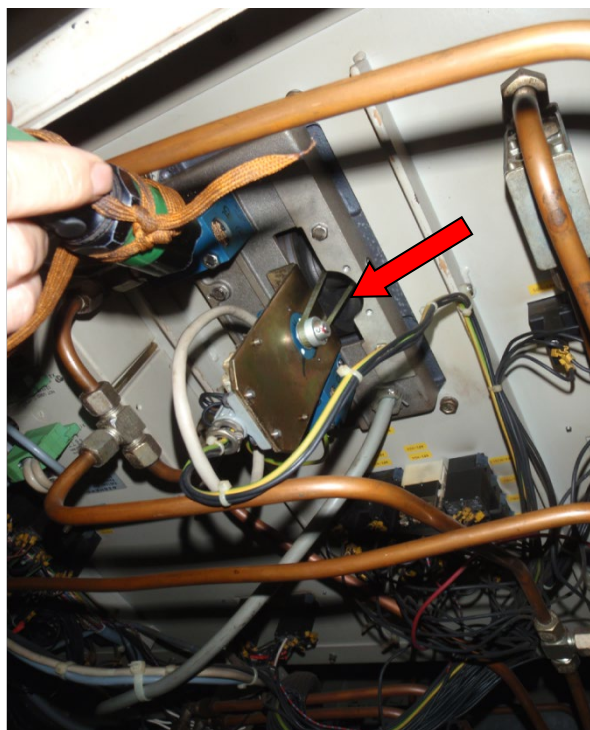
The Incident. An Engine Order Telegraph (EOT) transfer belt failure occurred aboard a 225-meter container ship whereby the ship was without normal propulsion control for approximately 30 minutes. Fortunately, the casualty occurred while the vessel was preparing to get underway rather than while transiting a busy traffic lane where maneuverability would have been critical to avoid risk of collision or grounding. The investigation into the incident revealed that inspection and replacement of the transfer belt was not included in the ship's preventative maintenance program and that the transfer belt was original and had been in service for approximately 15 years. The EOT transfer belt may be contained within a sealed component underneath the EOT control head and may not be included as an inspection or replacement item in the ship's preventative maintenance program. Because the potentiometer electronically controls the speed and direction of the engine, failure of the belt can render a vessel without normal propulsion control from the engine control room until the problem is diagnosed and a spare belt is installed. Propulsion control will be delayed longer if the crew struggles to diagnose the problem, or a replacement part is not on board.

- Age of the EOT transfer belt.
- Lack of preventative maintenance procedures for the inspection and maintenance of the EOT transfer belt.

Photo shows location of transfer belt underneath EOT control head.

- Perform immediate inspection of the EOT transfer belt.
- Update Safety Management Manuals, technical manuals, and/or preventive maintenance schedules to include regular inspection, maintenance, and/or replacement schedules, and

recommended spare part requirements. Specifically, review preventative maintenance procedures regarding the inspection and/or replacement of critical parts and components within their vessels' Engine Order Telegraph (EOT) control system.
