## **FINDINGS OF CONCERN**

### **Ninth Coast Guard District**

Findings of Concern 003-23

## **REPAIR HISTORY VERIFICATION OF PROPELLER BLADE(S)**

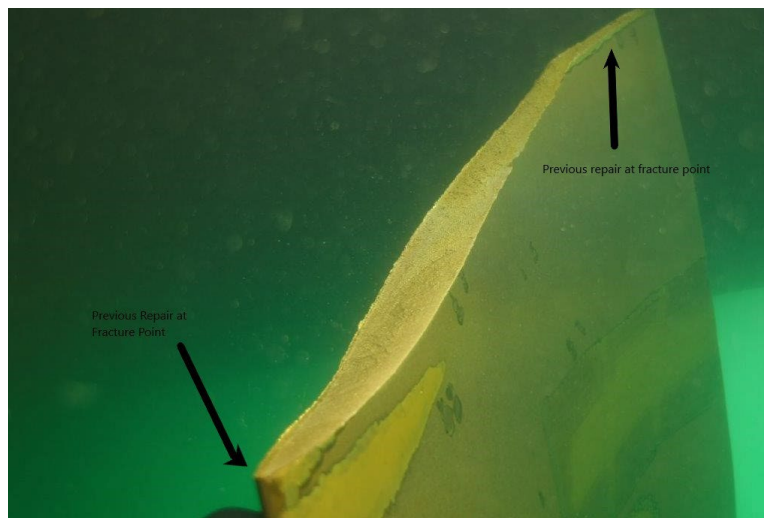
The Incident. On August 31, 2022, while underway in Lake Huron, a U.S. Flagged Freight Ship suffered a reduction in the vessel's ability to maneuver after two of the vessel's controllable pitch propeller blades fractured. One blade (Blade "1") suffered a complete brittle fracture across the blade (in a leading to trailing pattern) three feet from the tip. Investigators noted that the fracture apparently occurred within a previously repaired area, which was completed within zone A and B of the propeller blade. It is suspected that the second blade (Blade "2") fractured after the fractured tip of Blade "1" contacted Blade "2".

Contributing Factors and Analysis. Blade “1” was manufactured in February 1984. There is evidence that Blade “1” underwent repairs at some point in its 38-year service life; however, Blade “1” was not marked with relevant repair data, as required by Class. Further, neither Class nor the Operator/Owner had records related to Blade “1’s” repair history. Class rules generally do not permit welding repair in Zone A due to highest operational stresses and is only allowed after special consideration. Similarly, welding repair in Zone B should be avoided but may be allowed subject to prior approval. In the present case, there is no record that Class knew of or approved the repair. Further, neither the Owner/Operator nor Class were monitoring Blade “1”, as both were unaware that Blade “1” was especially vulnerable to fractures.

*Figure 3: A photo of damaged Blade 1, with approximately three feet of the tip sheared from the propeller assembly. Arrows indicate previous repair at fracture point.*

- It is imperative that Coast Guard Marine Inspectors, Class Surveyors, and vessel Owners/Operators track repair histories on propeller blades and associated equipment to provide historical context and ensure repairs and vulnerable areas can be tracked, and as appropriate, monitored.
