FINDINGS OF CONCERN

Marine Safety Detachment New Bedford

Findings of Concern 004 - 21

UNSAFE CONDITIONS WHILE WORKING ON COMMERCIAL FISHING VESSELS

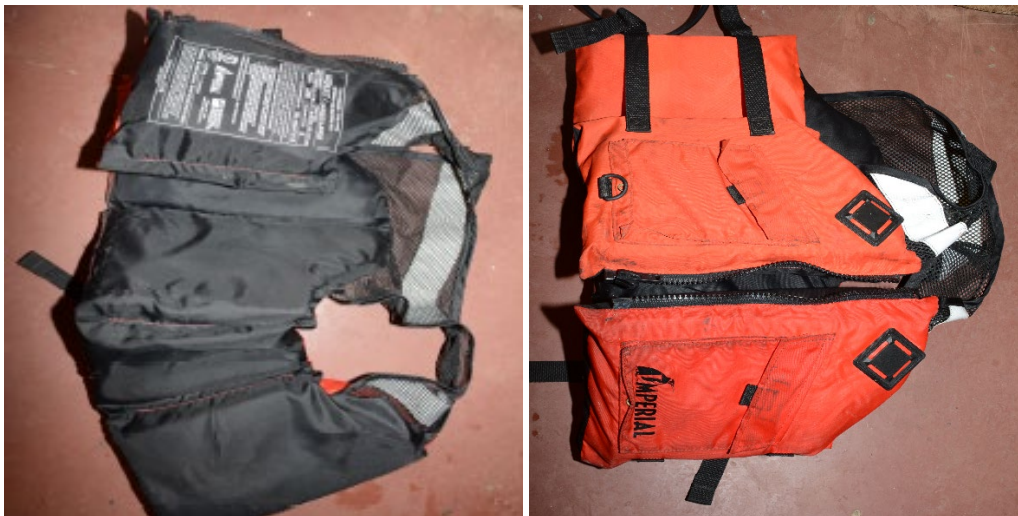
Figure 1: Type III Personal flotation device (PFD) worn by deckhand during incident without securely attached light.

Contributing Factors and Analysis. The U.S. Coast Guard determined the cause for the deckhand entering the water, was the lack of fall arrest gear utilized while working aloft. Additionally, the vessel's company did not have a policy regarding the use of fall arrest gear while working aloft. The investigation also revealed that the deckhand's PFD did not have a light securely attached, as required by 46 Code of Federal Regulations (CFR) Part 25.25-13(b).

- Owners/operators of commercial fishing vessels should evaluate operations conducted on board their vessels to determine the need to establish safety policies/procedures for crewmembers working aloft including the addition of fall arrest gear to secure crewmembers to the vessel and the posting of lookouts for crewmembers who are working aloft.
- Confirm each PFD on board has a PFD light securely attached in accordance with 46 CFR Part 25.25-13(b).

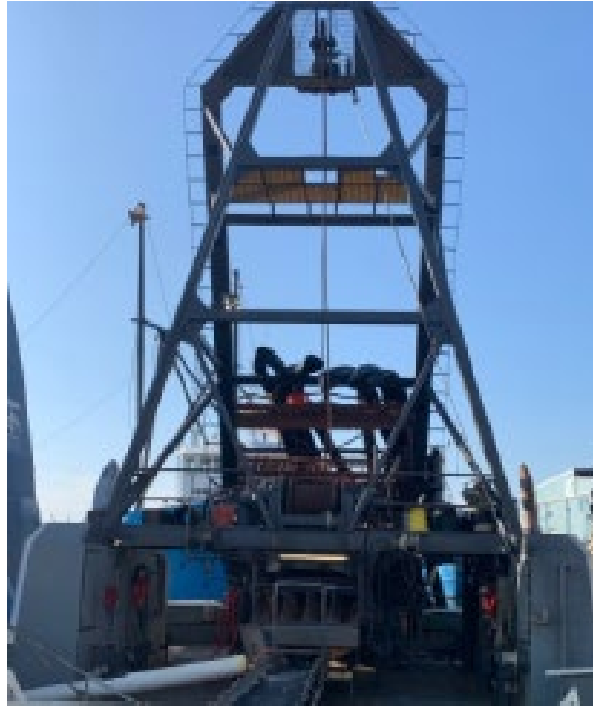
The Incident. On January 21, 2020, at approximately 0405, off the coast of Nantucket, MA, a deckhand was disconnecting the water supply hose from the clam-dredging unit, at a height of approximately 30 feet above the main deck, when he fell into the water. The vessel crew had difficulty locating the overboard deckhand due to extreme darkness. The deckhand was subsequently recovered after 40 minutes in the water, but was unresponsive and later determined to have drowned. At the time of the incident, the deckhand was wearing a Coast Guard approved Type III personal flotation device (PFD); however, it was not equipped with a PFD light.

Figure 2: Standard clam dredging unit on a commercial fishing vessel
