FINDINGS OF CONCERN

Marine Safety Unit Portland

Findings of Concern 004-22

DON'T REPLACE LOCKNUTS WITH STANDARD HEX NUTS

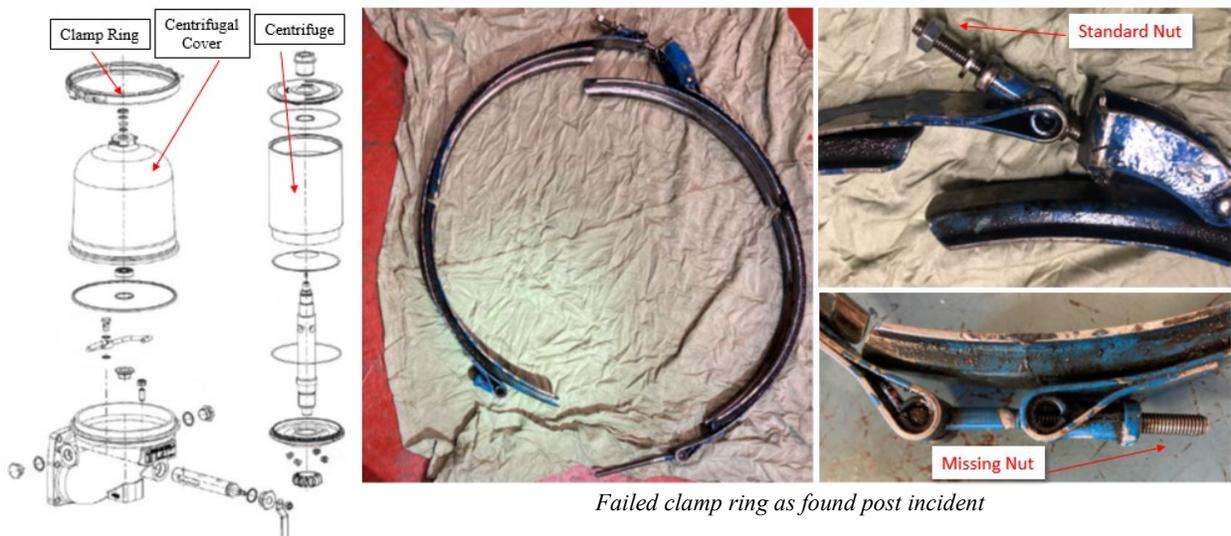
Contributing Factors and Analysis. The main propulsion engines involved were Wartsila 8L32s with centrifugal filters for lube oil. The filters had a cover that encapsulated the system, held in place by a clamp ring. Sometime prior to the incident, the manufacturer recommended nyloc nuts intended to secure the clamp ring had been replaced with standard nuts and lock washers. The use of standard nuts and lock washers in lieu of nyloc fasteners resulted in the nuts and lock washers vibrating off the centrifuge clamp ring while the engine was in operation.

Failed clamp ring as found post incident

- Scheduled preventative maintenance procedures should be periodically reviewed by shipboard personnel to ensure completeness and adequacy of instruction.
- Written preventative maintenance procedures should specifically identify replacement parts in accordance with manufacturer recommendations.
- Maritime Operators should never replace locking nuts and parts intended for use under vibration with standard metal hex nuts.
- When possible, maintenance should be conducted on equipment that has been secured.
- Ensure equipment manuals are kept up to date referencing the latest Service Bulletins.
