FINDINGS OF CONCERN
Sector New Orleans

March 3, 2023
New Orleans, LA

Findings of Concern 006-23

**DON'T FORGET TO NOTIFY THE COAST GUARD WHEN A
BRIDGE IS NOT FULLY OPERATIONAL!**

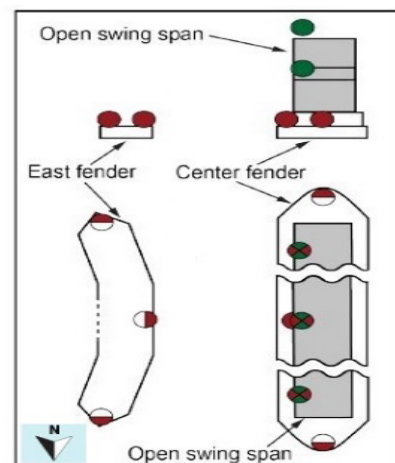
Contributing Factors and Analysis. The USCG investigation identified that the navigation lights on the bridge's east fender system had been removed for repair in the days prior to the allision. Their removal was not reported to the U.S. Coast Guard to allow for mariner notification and was a contributing factor to the allision. For swing bridges over navigable waterways, red navigation lights are prescribed on each end and in the middle of fender systems (Figure 1). In darkness, the lights are the primary means to visually identify the navigable channel through an open swing span. The investigation also identified a recurring issue of the bridge's rotational limit switch inaccuracy and the failure to report the issue to the U.S. Coast Guard and bridge tenders in order to notify mariners. Many swing bridges, including the incident bridge, use limit

Figure 1: Prescribed navigation lights for a swing bridge with a single navigation channel.

- Notify the U.S. Coast Guard District Commander when bridge navigational lighting will be inoperable during required times of operation and expeditiously commence/complete repairs. If impossible to effect repairs such that bridge lighting will be inoperable during required times of operation and during which navigation conditions will be affected, owners/operators are required by 33 CFR 115.40 to request a temporary deviation from bridge permit conditions and install appropriate temporary lighting to ensure safe navigation.

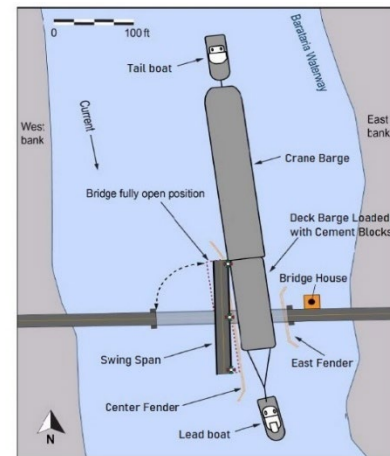
switches to send an electric signal to interlocked components when the bridge is in the proper open or closed position. Wear and fatigue of, damage to, or malfunction of these switches can lead to over/under-rotation of the bridge's swing span. The over-rotation allowed the bridge to impede the navigation channel beyond the fender thus increasing the risk of bridge allision (Figure 2).

Figure 2: Diagram of over-rotated bridge swing span contributing to allision.

- Notify the U.S. Coast Guard as required by 33 CFR 117.36 when bridges fail to open or close as designed or when they impede safe navigation and expeditiously commence/complete repairs. When impracticable to expedite repairs, owners/operators must report intentions to temporarily halt bridge operation to the U.S. Coast Guard District Commander so that mariners can be notified.
