### **Marine Inspection Detachment Singapore**

Findings of Concern 009-22

## **AUTHORIZED MAINTENANCE OF LIFESAVING SYSTEMS**

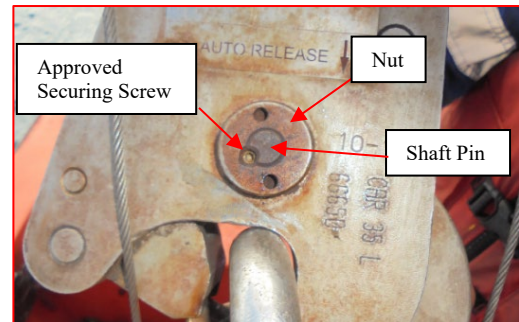
Figure 1

Causal Factors and Analysis. The primary cause of this casualty was improper release gear configuration (see figure 1 for basic nomenclature). Specific causal factors were determined to be an improper securing screw replacement, thread wear on the shaft pin, and the addition of two shackles between the spliced cable eye and the release gear (see figures 2 and 3).

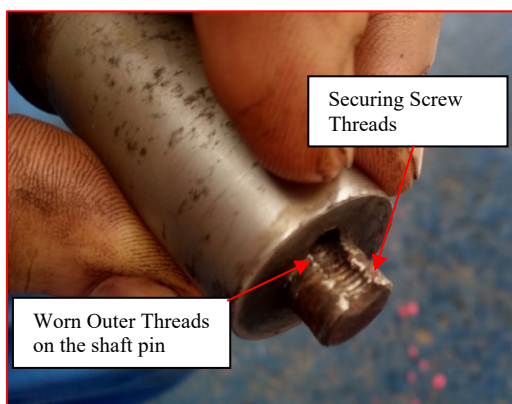
Figure 2

The torsional stresses created during the rescue boat recovery combined with the two shackle configuration created sufficient outward force on the release gear side plates to cause mechanical failure of the nut that secures the shaft pin to the release gear. Subsequently, the dynamic forces in play during the rescue boat recovery caused the shaft pin to back out of one of the release gear side plates. This created an uneven loading condition causing the side plate to deflect outward and the rescue boat to hang from the release gear at an unconventional angle. As the angle continued to open (i.e., the shaft pin becomes parallel with the wire rope) and the side plate continued to

- Objective evidence indicates that the securing set screw was a generic aftermarket machine screw and not approved by the Original Equipment Manufacturer (OEM).
- The most recent release gear servicing was not completed by an authorized service provider<sup>1</sup>.
- Objective evidence indicates that two shackles were added at some point between the spliced cable eye and the release gear shaft pin. According to the OEM, the release gear was designed to be directly connected to the shaft pin with the spliced cable eye without the use of shackles.

- The Company should ensure that servicing of lifesaving appliances is completed by an authorized service provider for the specified lifesaving appliance.
- There should be no modifications to lifesaving appliances without consulting the OEM or an authorized service provider (e.g., components, configuration, complex repairs, etc).
- The Company's Safety Management System (SMS) should contain provisions for thorough risk assessments and equipment inspections prior to use of lifesaving appliances, particularly after servicing is performed.

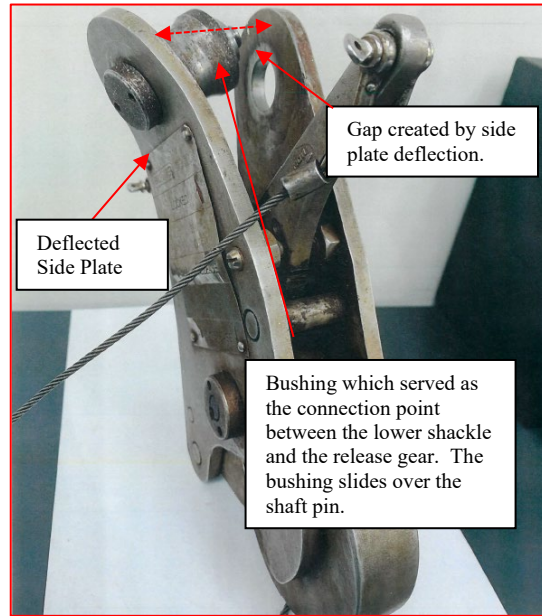
Figure 4

deflect, a sufficient gap was created to allow the cable and bushing to slip free of its connection point on the release gear. (see figure 4). Throughout the incident, the release gear hook never disengaged and remained firmly secured to the lifting stanchion of the rescue boat (see figure 5).
