Office of Investigations and Casualty Analysis

Findings of Concern 014-23

**SEACOR POWER CASUALTY: FINDINGS OF CONCERN
REGARDING LIFTBOATS**

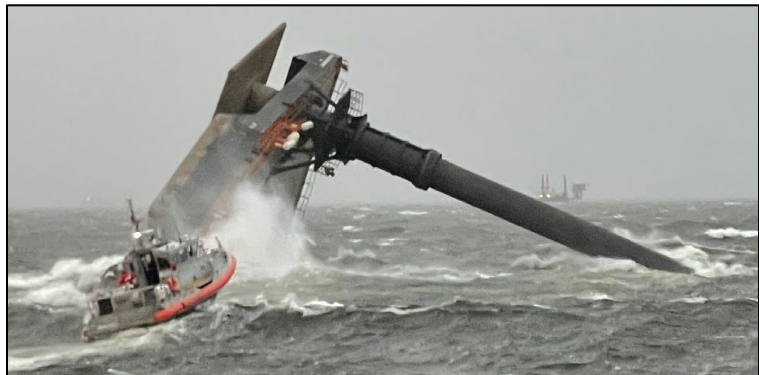
The Incident. In April 2021, a commercial liftboat carrying 19 individuals departed Port Fourchon and headed offshore in the Gulf of Mexico. Approximately seven nautical miles offshore, the vessel encountered unpredicted weather conditions that exceeded the vessel's operating limits. The winds were over 80 knots, and gusted up to 99 knots, which capsized the vessel and caused the tragic loss of 13 lives.
