# UNITED STATES COAST GUARD

## FINDINGS OF CONCERN

Findings of Concern 015-22

## WASTED FIXED CO<sub>2</sub> MOUNTING RACKS

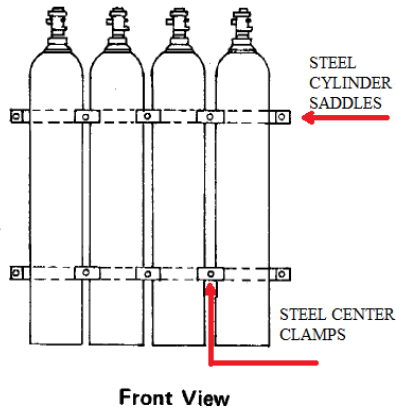
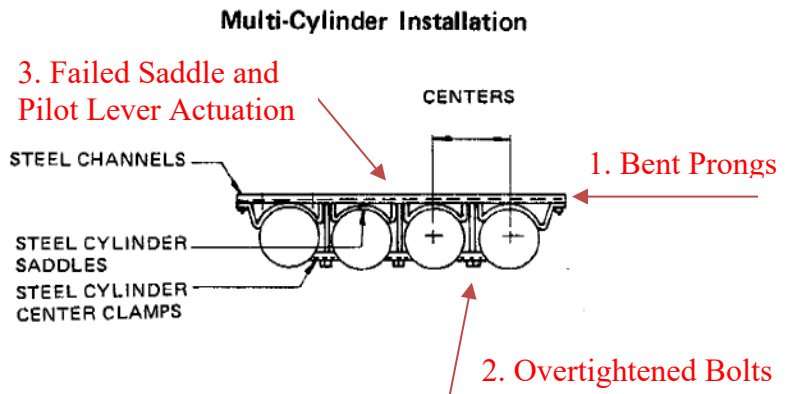
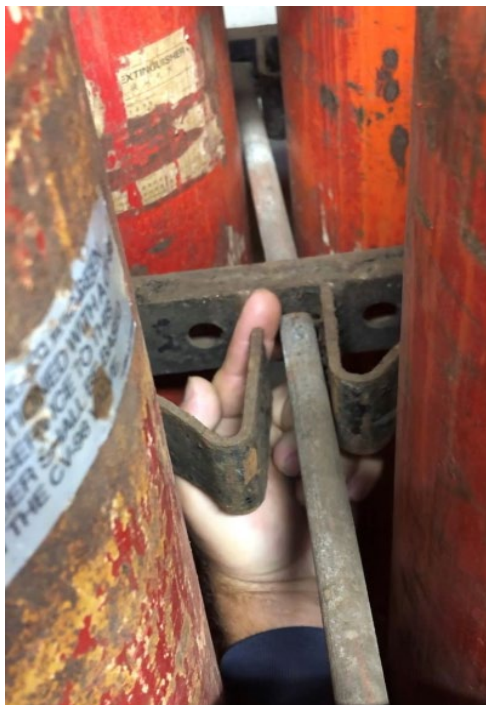
Contributing Factors and Analysis. The fire extinguishing system implemented a combination of steel saddles and center clamps to mount each cylinder to the storage rack. The saddles supported the back of each bottle; the steel clamps were used to sandwich the cylinders within their saddle to the rack. The interior cylinders were secured on either side by steel clamps; however, the end cylinders, including the pilot bottle, were only clamped on their inner side while the outer side of each was held in place by two 1 inch by 3/16 inch prongs.

The investigation identified that there were multiple unsafe storage conditions that enabled the pilot cylinder to become dislodged. First, the prongs for the exterior cylinders were bent. Second, the welds for the pilot cylinder's steel saddles had failed. The bent prongs no longer provided adequate support against lateral movement, thus the center clamps needed to be overtightened to compensate. The additional stress placed on the rack by the overtightened clamps likely caused the prongs to bend further and the steel saddles to fail.

*Failed Cylinder Bottle Brackets*

- Create a Standard Operating Procedure (SOP) to include inspecting storage arrangements at regular intervals.
- Re-evaluate current storage arrangements and consider if any changes to existing supports or additional supports are needed. Cylinders shall be securely fastened and supported in accordance with 46 CFR 34.15-20 (d) / 76.15-20(d) / 95.15-20(d) / 118.410 (c) (4) / 181.410 (c) (4).
- When conducting required annual testing, ensure that time delays, alarms, and automatic shutdowns function properly.

In addition, these Findings of Concern act as a reminder for local Coast Guard vessel inspections offices to ensure that these types of fixed CO2 system mounting arrangements are inspected for metal wastage, weld failures, and improperly modified components.

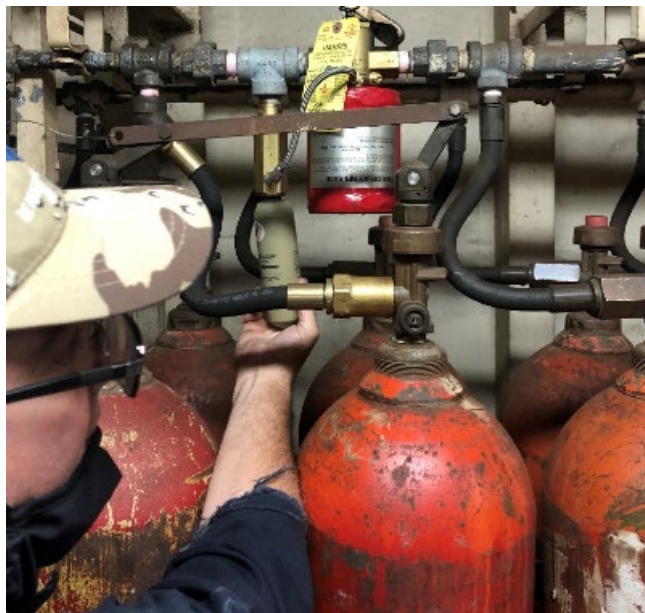
The Incident. On August 13, 2021, a U.S. Coast Guard Certificated Industrial Vessel, inspected in accordance with Title 46 Code of Federal Regulations, Subchapter I, experienced an unintentional discharge of its 5,600 lb. fixed CO<sub>2</sub> fire extinguishing system. The vessel was underway when the fire extinguishing system's pilot cylinder bottle became dislodged from its mount. The weight of the cylinder generated enough force to discharge the bottle by activating the operating wire and linkage. The agent was released through the system's audible alarm and not into any protected spaces. The secondary operating control for the system was not activated. In addition to these findings, this incident revealed that several of the system's automatic shut-down pressure switches failed to operate upon the pilot cylinder's discharge. The system did not shut-down ventilation to the protected space or the fuel booster pumps as designed.

*Pilot Bottle Actuation Lever Under Load and Activated*
