FINDINGS OF CONCERN

Sector Corpus Christi

Findings of Concern 020-22

MAINTENANCE & OPERATION OF UNINSPECTED TOWING VESSELS

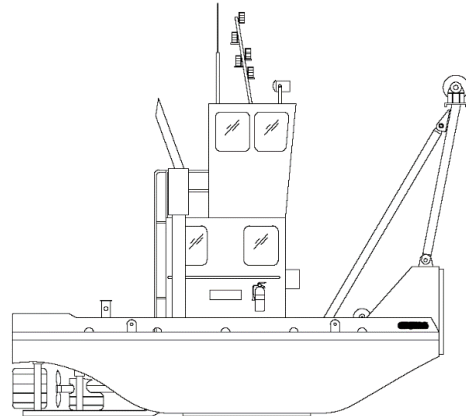
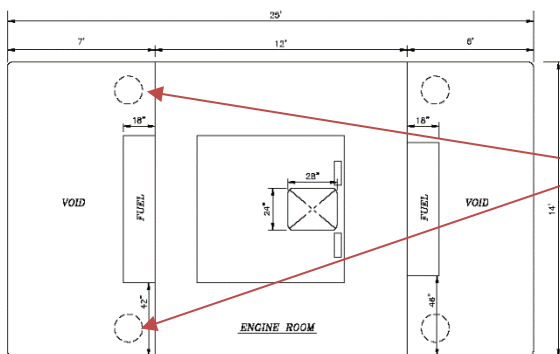
The vessel's bottom deck was divided into 3 watertight spaces, the stern void space with the two hatches open, the middle engine room space with the hatch open, and the remaining forward void space that remained intact and caused the bow to bob along the channel floor.

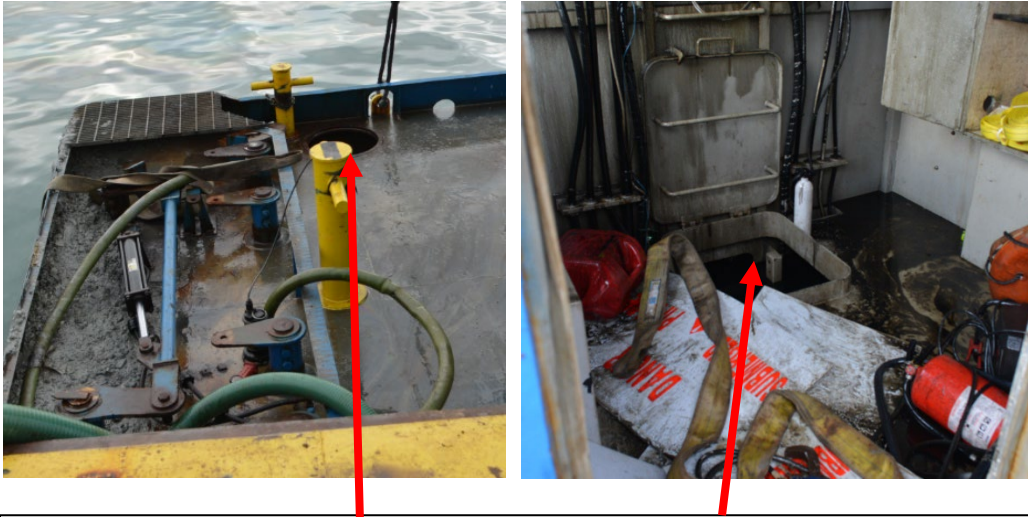
Both stern hatches (port stern hatch pictured) which open to the same compartment were found open. The right picture depicts the engine room hatch open which would have accelerated the downward flooding.

- **TRAINING** – Ensure all personnel onboard receive training on the safe operation of their vessel including proper communication, mitigation measures during inclement weather, how inclement weather can impact a vessels stability, and the importance of maintaining the vessel’s watertight integrity.
- **MAINTENANCE** - Ensure that vessel communication systems and watertight hatches are properly maintained and are secured during transit.
- **OPERATION** – Ensure vessel operators and crewmembers are familiar with the relevant characteristics of the vessel, including maneuvering characteristics and vessel stability.
