FINDINGS OF CONCERN

Marine Safety Unit Lake Charles

Findings of Concern 021-22

THE DANGERS OF TAGLINES: ENSURE SAFETY MANAGEMENT SYSTEM PROCEDURES ADDRESS SAFETY OF KEY SHIPBOARD OPERATIONS

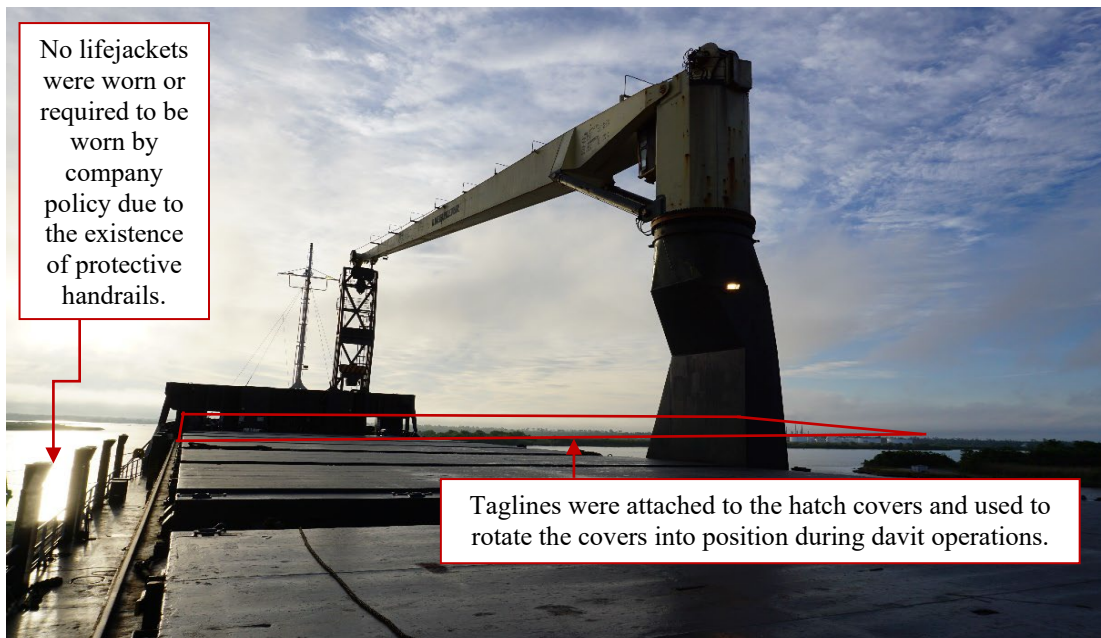
The Incident. A bulk carrier was anchored approximately 10 nautical miles offshore conducting davit operations to shift its cargo hatch covers into its cargo holds. While doing so, an Able Seaman (A/B) became caught in one of the taglines as a cargo hatch cover was being shifted. Consequently, the A/B was pulled over a handrail where he hit his head, fell into the water, and drowned.

Contributing Factors and Analysis. The investigation identified one of the causal factors of this incident as failure of the owner/operator to implement safe and effective procedures for cargo hatch handling.
