## SERVICE BULLETIN

Number 001/2012

<b>Product</b>	HI-FOG® Sprinklers
<b>Subject</b>	Contamination of HI-FOG sprinklers which may prevent activation.
<b>Summary</b>	This Service Bulletin describes potential reasons and methods for identification of contaminated sprinklers and actions to be taken in case contamination is found to ensure reliable operation.
<b>Date</b>	20 June 2012

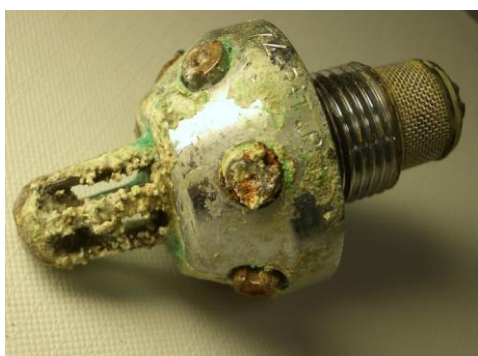
**External contamination** [Picture 2 &3] is typical in areas with an aggressive atmosphere (e.g. spas, pool areas, pool equipment rooms, kitchen areas, outer decks and similar). External contamination is easily detected by visual examination.

Picture 2 Severe contamination

- Regular testing and examination of all sprinklers is to be done in accordance with instructions and manuals, Authority requirements and Service Bulletin 002/2012. For sprinklers in spaces with an aggressive atmosphere (e.g. spa's, pool areas, saunas, pool equipment rooms, kitchen areas, outer decks and similar) more frequent testing and examination is required (see Service Bulletin 002/2012)
- The whole HI-FOG system is to be regularly tested and maintained in accordance with instructions and manuals

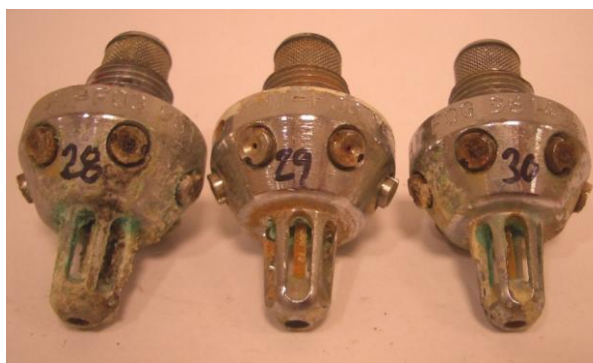
Picture 3 Various external contamination
