## **Drowning of a passenger on *Pacific Dawn***

### **Coral Sea, South Pacific Ocean**

**9 November 2015**

### **SUMMARY**

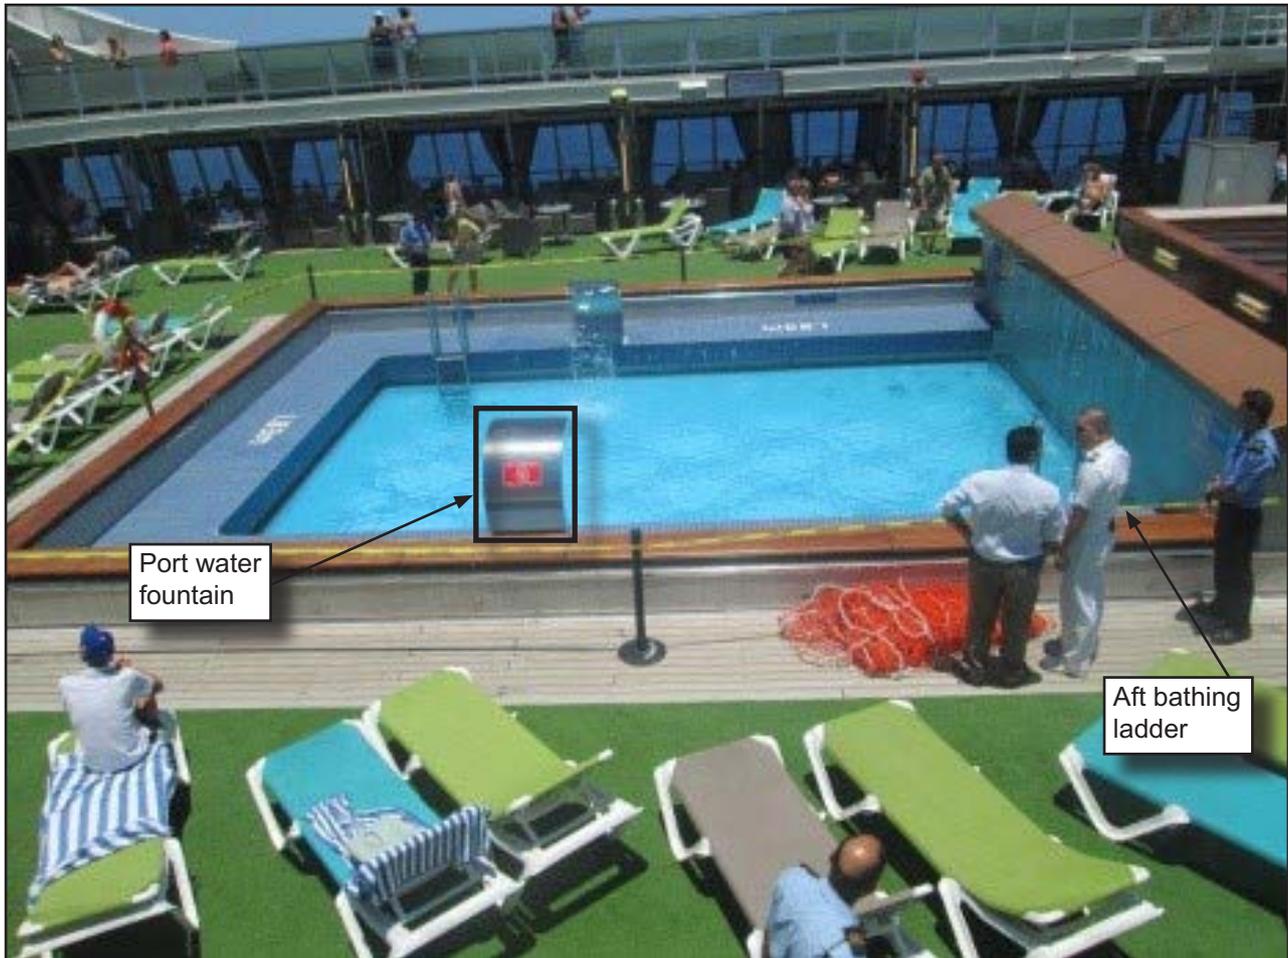
**Figure 2 - Forward swimming pool viewed from port side**

On the morning of 9 November, one of the passengers, Mr Oh, proceeded to the forward swimming pool on deck 12 (**Figure 2**). The ship's CCTV<sup>3</sup> recording showed Mr Oh completing some brief stretching exercises before he entered the pool. At 1037, he slowly climbed down the pool's aft bathing ladder and entered the water. The pool's temperature was 30°C. He gently swam in the vicinity of the ladder and then moved under the port water fountain, allowing the water to flow over his head. He then swam away from the fountain for a longer period towards the centre of the pool before returning to the spot directly under the water fountain and, at one stage, appeared to briefly touch the side of the pool with his hand.

At this time there were at least four other passengers in the pool. At 1042, Mr Oh's head appeared to sink below the water and did not resurface. He then sank to the bottom of the pool unnoticed by the other pool users.

Mr Oh was lying on the bottom of the pool for 10 minutes before he was spotted, rescued, and attempts to revive him commenced. It is unknown whether or not Mr Oh's life could have been saved had an emergency response been initiated sooner, but as the primary cause of death was drowning it must be considered possible. Once the alarm had been raised, the medical team's response was swift. If a dedicated pool attendant had been monitoring passengers in the pool, Mr Oh's situation could have been identified and an emergency response initiated at the earliest possible opportunity.

Although a security patrolman was on deck 14 looking down onto the pool area, he remained unaware that Mr Oh required assistance until another pool user raised the alarm approximately 10 minutes after Mr Oh had sunk below the water surface. While security patrolmen periodically provided a degree of swimming pool supervision, this accident demonstrates that the monitoring of passengers in a pool ideally needs to be provided on a constant basis to effectively identify and respond to a passenger in immediate risk of drowning.

P&O Cruises Australia has since completed a formal documented risk assessment for swimming pool usage, and has planned a number of actions aimed at preventing a recurrence, including:

- updating its guest safety video to include pool safety information;
- providing flotation devices as an option for weaker swimmers;
- developing enhanced standard pool safety signs; and
- developing a pool safety guide for guests.

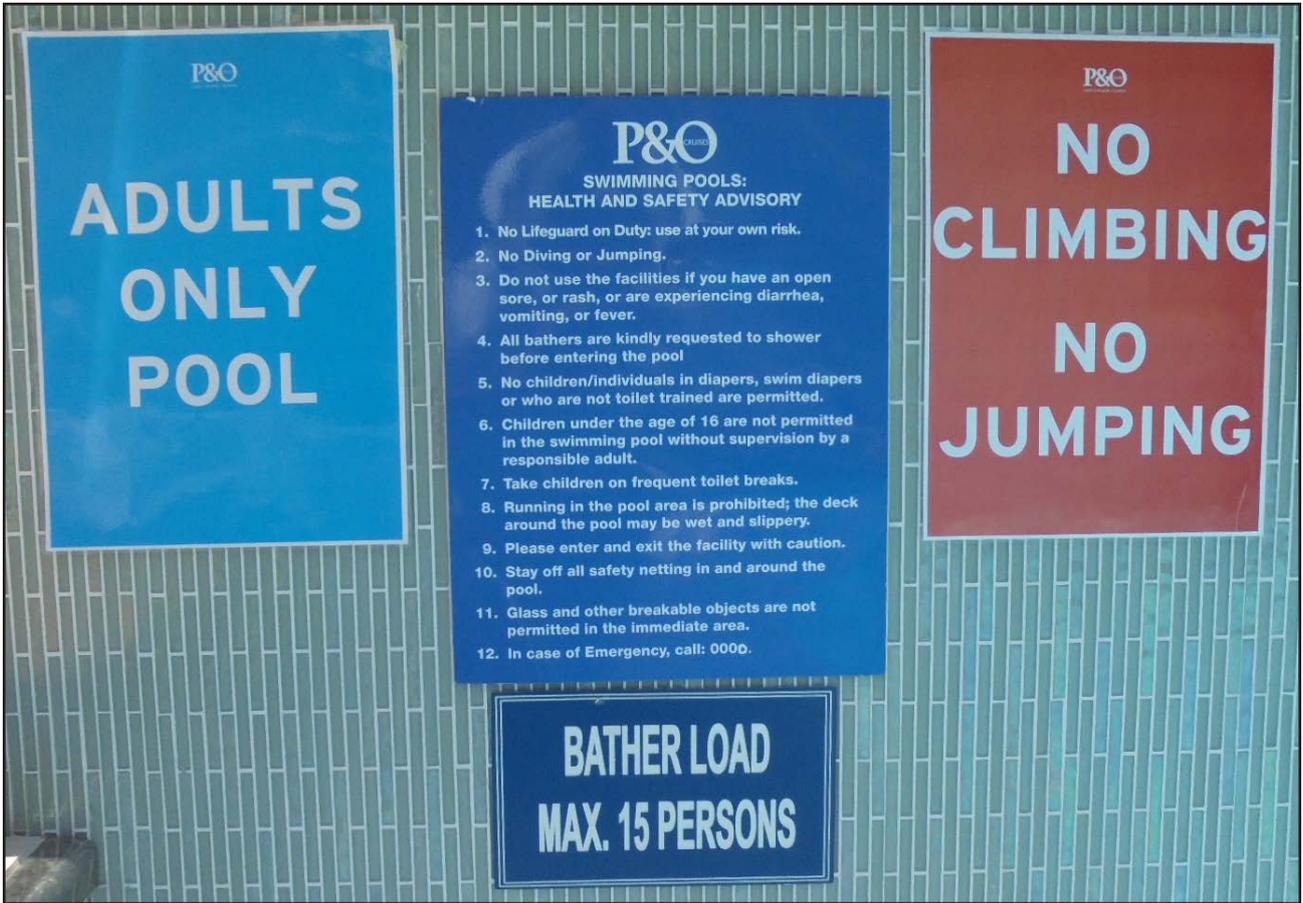
Figure 3 - Signage adjacent to forward swimming pool

*Pacific Dawn* had two swimming pools on deck 12. The forward pool was dedicated to adults only. Neither of the pools had designated attendants, and signage next to each pool stated that pool use was at the individual's risk (**Figure 3**). A sign indicating a bather limit of 15 was posted next to the pool. The depth of water in the pool was constant throughout at 1.83m, and this was indicated on the pool's side (**Figure 4**).

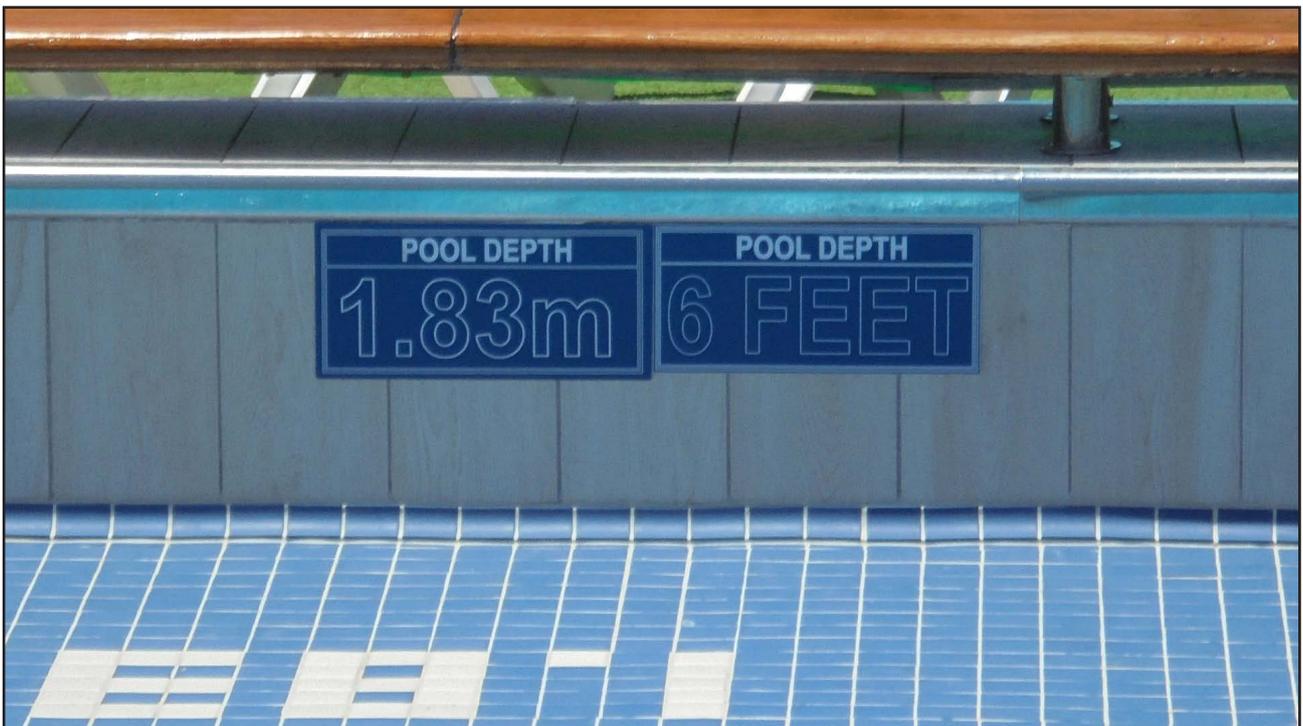
Figure 4 - Poolside indication of water depth

The HSE guidance on managing health and safety in swimming pools ashore strongly indicates that constant poolside supervision provides the best assurance of pool users' safety. However, it also recognises that a risk assessment may determine circumstances where the balance of cost and risk makes it possible to provide a safe swimming environment without constant poolside supervision. Many factors need to be considered. The guidance specifically recommends constant supervision if the water is deeper than 1.5m and if food and drink are available to pool users, both of which applied to the forward swimming pool on board *Pacific Dawn*.
