# Safety Alert for Schat-Harding Winch W80(W Series)

# **W80 SAFETY ALERT KNOWLEDGE**

### Failure of Large Planetary / Reduction Gear Components of LSA Winch Equipment

# Millom West and Calder

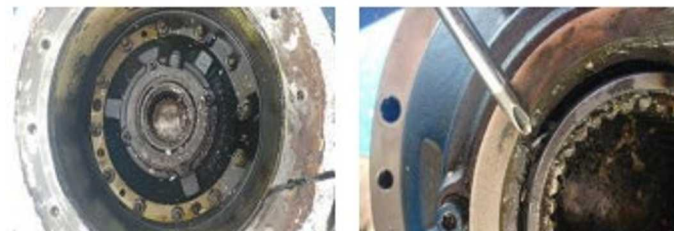
The reason for this is understood to be due to the planetary gear fill plug either falling out or leaking, leading to the gears running in a dry condition. These large Planetary/ Reduction gears are located in an inaccessible area and oil levels can only be monitored by either fully dismantling the winch or performing an internal video inspection of the drum.

Figs. 5 and 6: Interior of above reduction gears after running in a dry condition leading to overspeed damage

Ship Owners/Operators whose ships are fitted with the above listed winch model numbers should ensure that the winches are inspected and maintenance carried out in accordance with OEM's instructions.

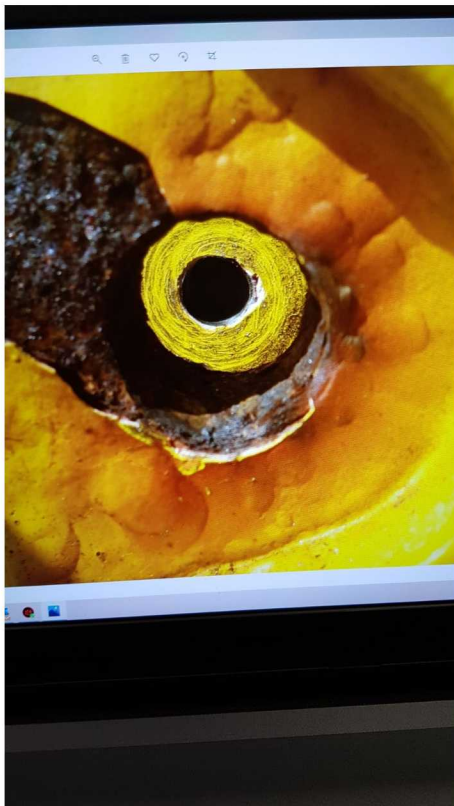
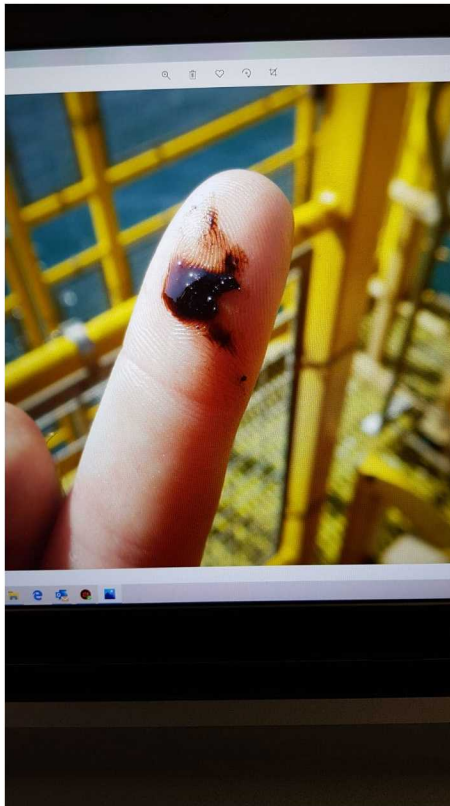
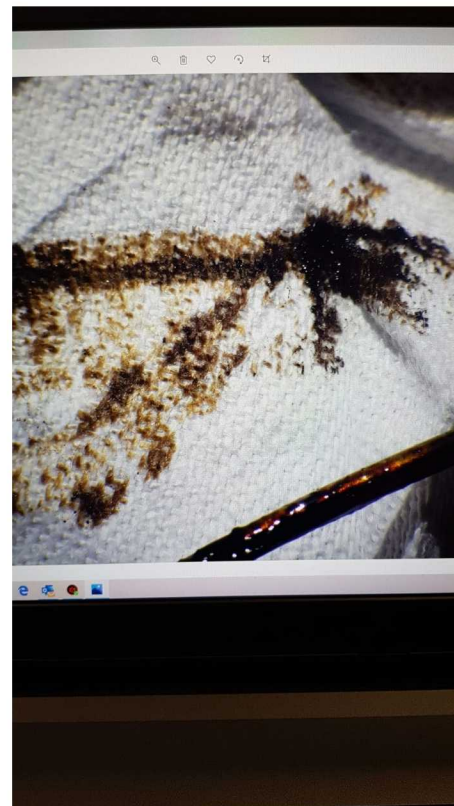
## Example of Leaking Brevini Gear Unit

Photos taken on another customer's asset on a larger model winch (W120) 02 June 2020, indicating oil bung compromised and oil leaking from the planetary gearbox. Winch subsequently taken out of service
