December 21, 2010
Washington, DC

Alert 10(a) -10

WRONG DIRECTIONS: A RECIPE FOR FAILURE

Safety Alert 1 of 2

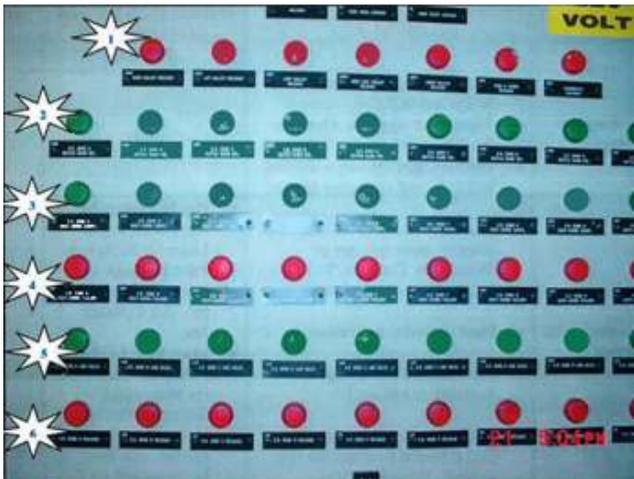
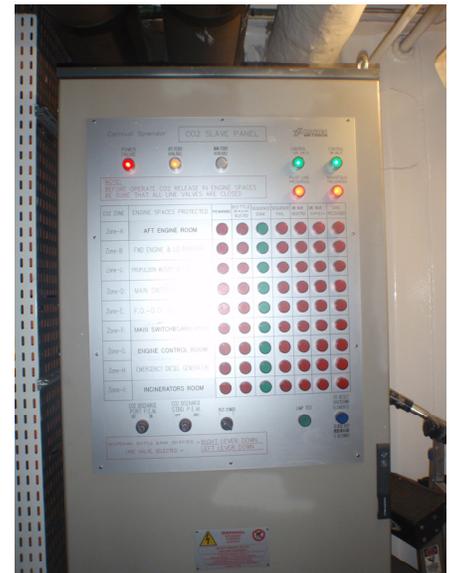
- Shipyard commissioning test procedures appear to differ from procedures documented in the vessel’s Firefighting Instruction Manual (FIM). Commissioning procedures indicate that the discharge line selection to a specific protected zone should be made prior to releasing the gas contrary to the directions in the FIM.
- The FIM refers extensively to a Control Panel (left following image) that differs vastly from the one onboard the vessel (right following image).

- Ensure that all supporting documentation, piping schematics, plans, manuals, component labeling and instructions are consistent with each other and relevant to the systems, equipment, and components installed onboard the vessel.

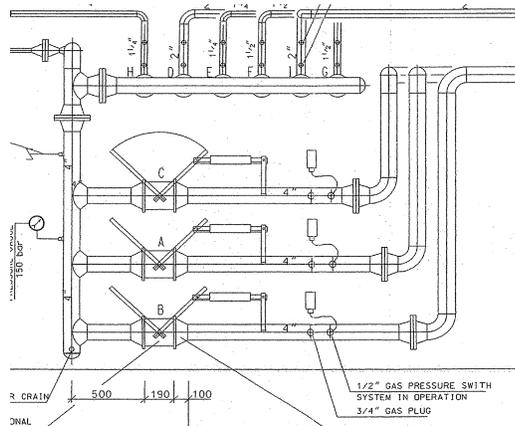
- Shipyard piping schematics and drawings do not appear to match the actual installation. The schematic at the right shows the “A valve” for the Aft Machinery Space in the center position vice the bottom position as it is installed on the vessel.
