MARINE SAFETY ALERT

Alert 10(b)-10

SIMPLE FAILURES RENDER CO2 SYSTEM INOPERATIVE

Safety Alert 2 of 2

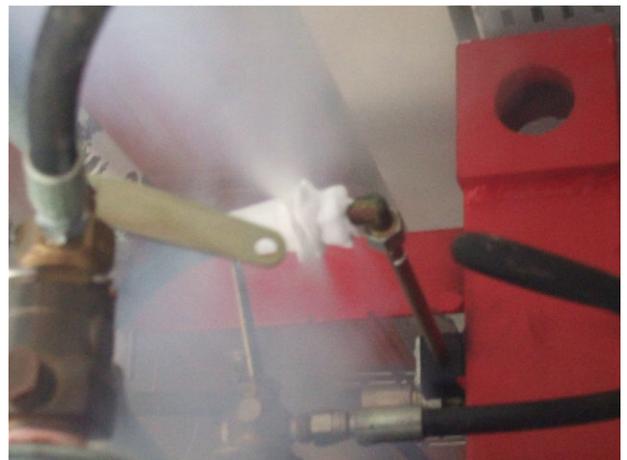
- Numerous piping and hose connections leaked extensively. When the system was activated, on scene video taken by the firefighters showed numerous leakages into the CO2 room. Post casualty, while pressure was still on the system, some of these leaks continued even after the connections were tightened. (Photograph at right.)

- Carefully and critically review, routinely inspect and maintain, verify and test their Fixed Fire Fighting installations to ensure that they will operate correctly during an emergency.

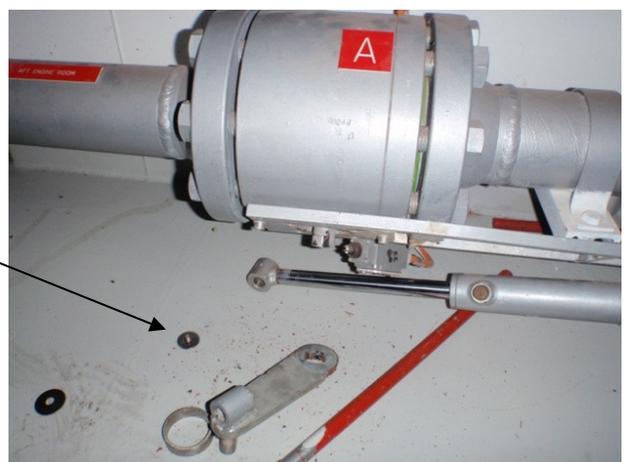
- The zone valve for the aft machinery space which admits CO2 from the bottle bank manifold to the space failed. Specifically, the ball valve's opening actuating arm fell off the valve when the gas powered piston actuator attempted to move it. The ball valve actuating arm was held in place by a very small machine screw and washer. When firefighters attempted to open the valve manually using the provided hardware it could not be moved. The valve was only able to be moved after the gas pressure was relieved from the inlet side of the valve. (Photograph at right.)

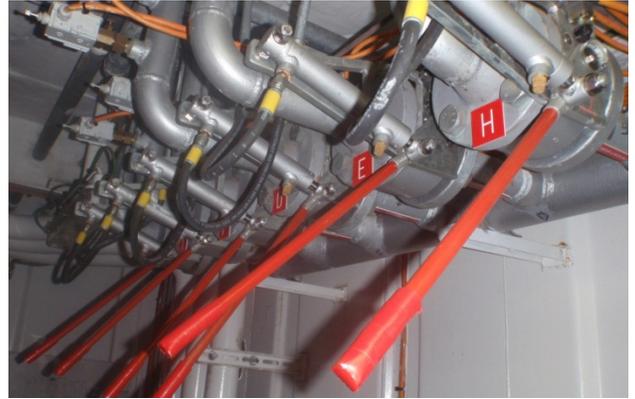
- Actuating arms to five of the six other zone valves were found loose. They were also attached by small machine screws. (Photograph at right.)

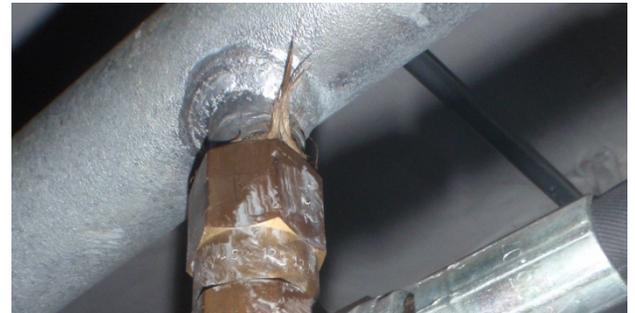
- Hemp type pipe sealant was used extensively on pipe threads throughout the system and in some instances seems to have entered the system. (Photograph at right.)

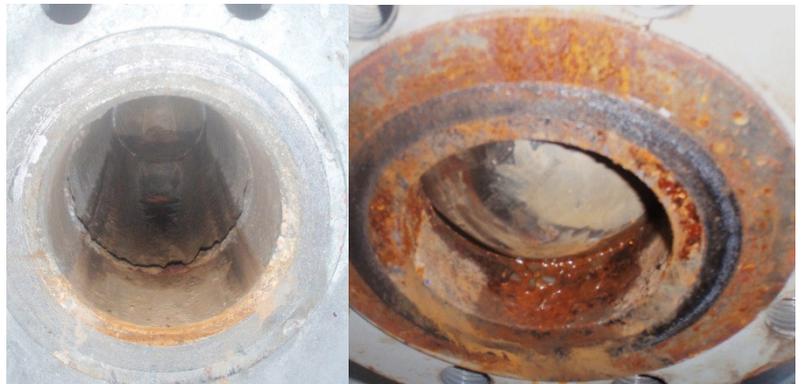
- Certain elements of the distribution manifold contained low points which allowed the accumulation of water within piping that could not be drained. Such a circumstance could cause corrosion that could possibly negatively effect operation of other components. (Photographs at right.)
