MARINE SAFETY ALERT

Safety Alert 13-17

Fixed CO₂ Fire Extinguishing Systems

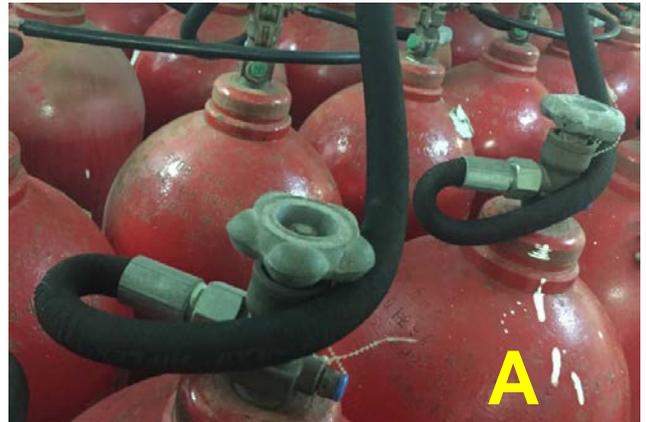
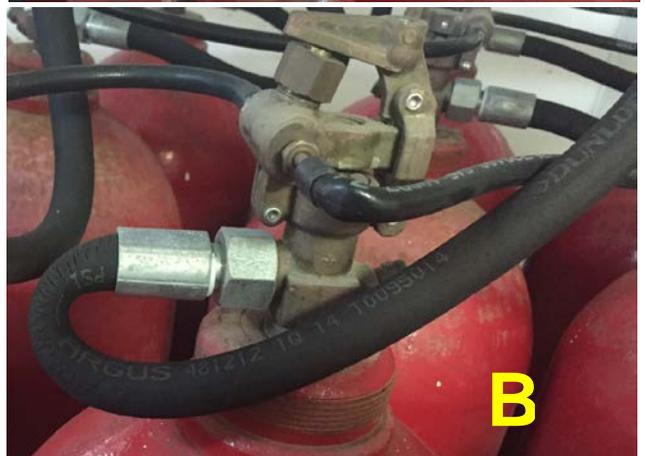
During the inspection, it was noted that some of the hoses which connected the large CO₂ cylinders to the manifolds were wrapped around the bottle valve handles as shown in photographs A and B. The bottles could have been in place for a long period of time, in their original positions without regard to the stresses placed on the connecting hoses. However, experts in Fixed CO₂ System Servicing have indicated that service personnel routinely find loose bottles which have rotated over a period of time. The experts expressed that photographs A and B represented extreme cases of rotation. The service personnel also stated that "four bottle deep" manifold systems were atypical and may have contributed to an inability to maintain tightness.

As a result of the inspection the vessel was detained until these and other identified deficiencies identified were corrected. During a reinspection of the vessel to clear the deficiencies, it was discovered that the servicing organization that replaced the hoses, installed several new hoses in a similar orientation that maintained excessive stress on the hoses. That issue was subsequently rectified by rotating the bottles.

- Bottle installation must be accomplished carefully considering hose and actuator positioning in addition to ensuring stress is minimized for each hose. Securing devices must be inspected for effectiveness.
- Vessel crewmembers should check for bottle rotation, loose bottles, and excessive stress on discharge hoses during periodic inspections of fixed CO₂ systems. All appropriate safety precautions should be completed prior to taking any actions to re-secure or reposition CO₂ cylinders.

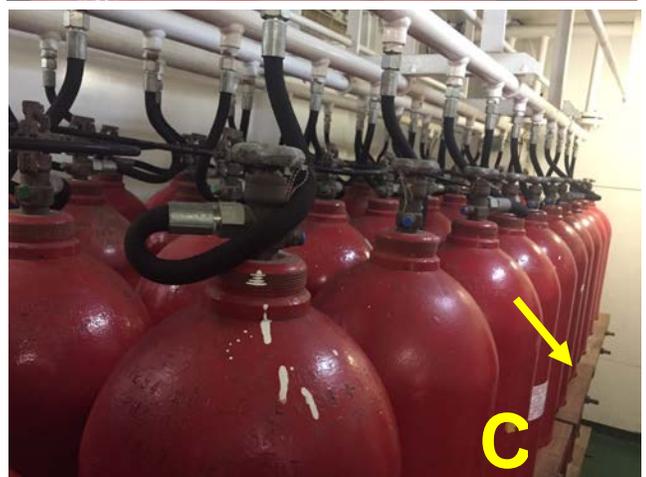
These bottles should have been clamped tightly in place by the use of wooden brackets as displayed in photograph C. Wooden spacers in between the rows of bottles can also be used to ensure proper securing of all the bottles.

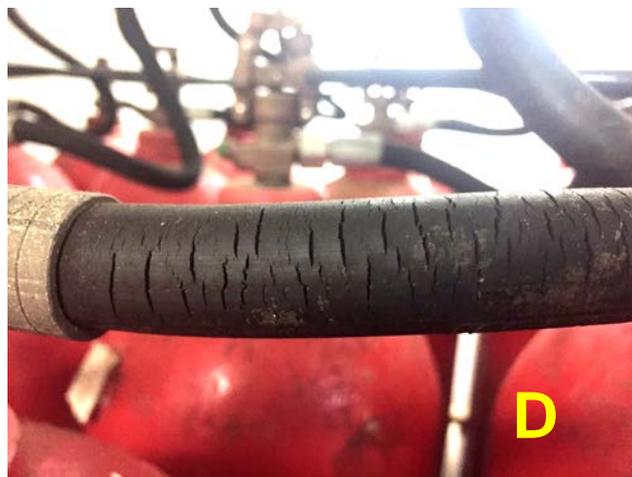
Inspectors also found significant cracking of the CO₂ discharge hoses which were under tension as shown in photograph D. This condition is known as ozone cracking and occurs when very small amounts of ozone in the atmosphere interact with the polymers that compose rubber products and certain other elastomers when those products are under tension.
