PROCEEDINGS OF THE MERCHANT MARINE COUNCIL UNITED STATES COAST GUARD

September 1952

LESSONS FROM CASUALTIES

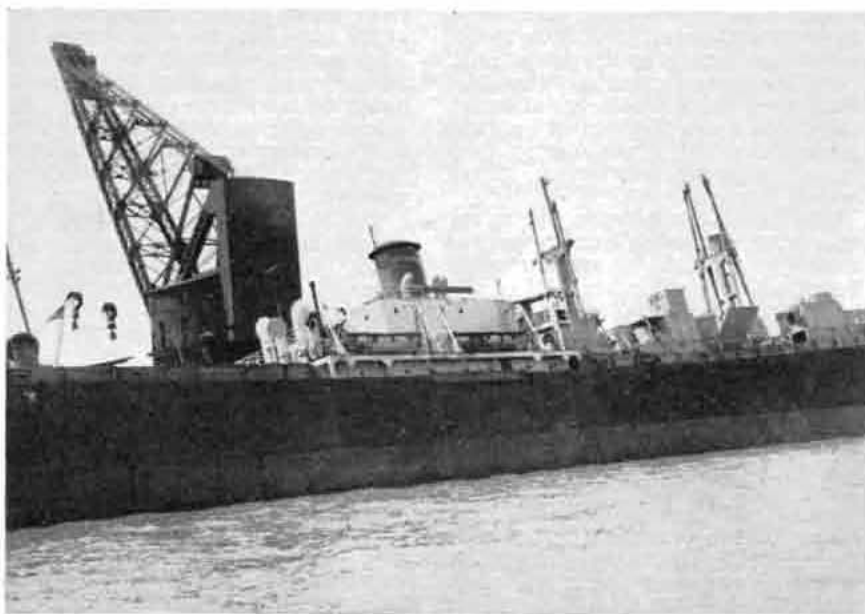
SLACK TANKS

The above photograph depicts a vessel after her arrival at Newport News, Va., with a 12° list to port which attracted considerable attention.

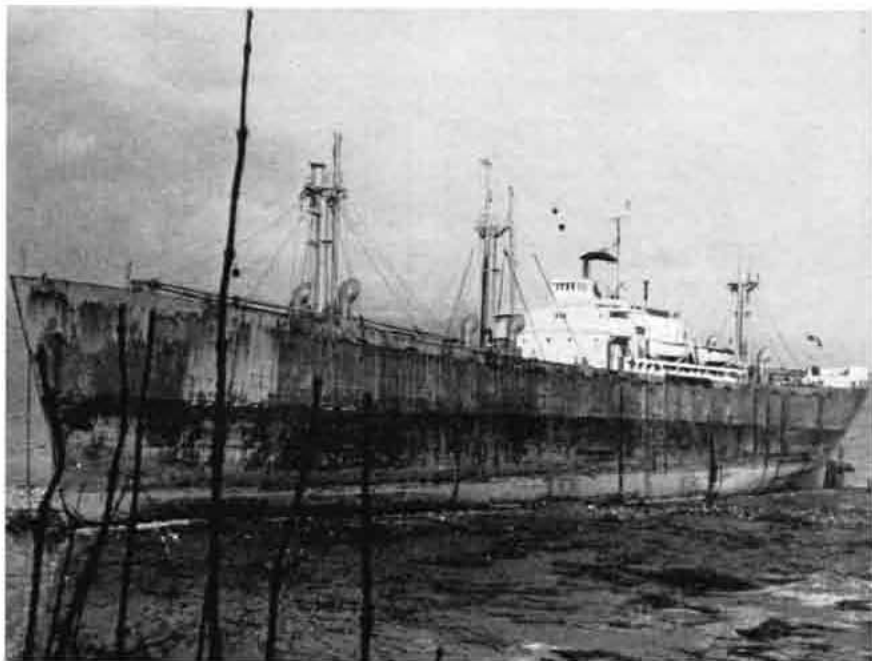
When the vessel approached a severe right bend in the river, the pilot ordered full speed in order to negotiate the turn. Simultaneously, a hail squall struck and set the vessel to port. Hard right rudder failed to counteract the effect of the wind as high seas and current hit the bow of the unballasted vessel, and the vessel commenced to go aground. As soon as she touched, the wind and seas pushed her far up on the beach. Settling high and dry, the ship could not be refloated by her own power.

Fortunately, subsequent drydock examination disclosed little bottom damage.

The grounding taking place during the peak of a spring tide, the vessel appeared as shown at the ebb.

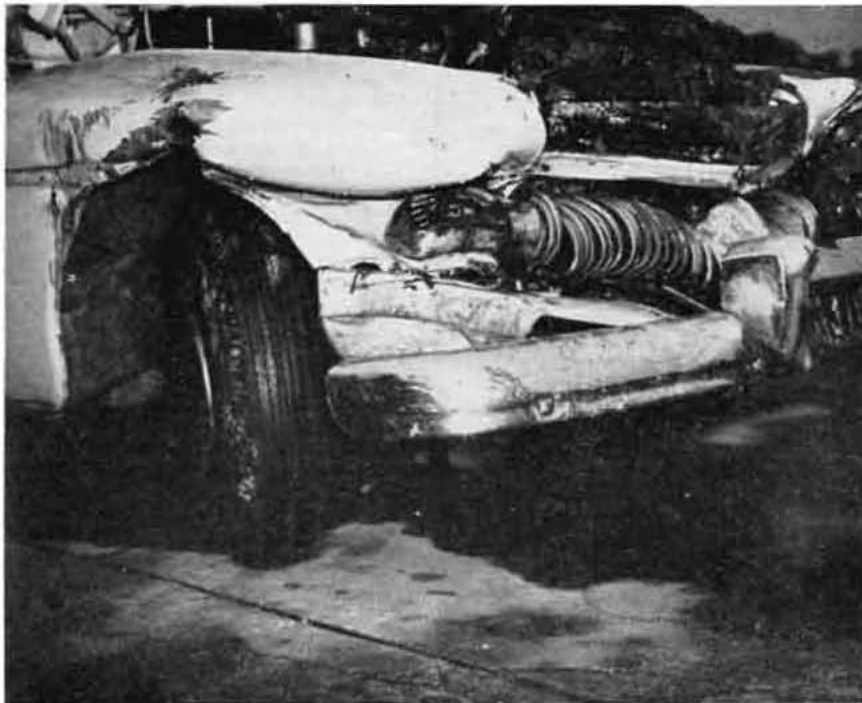
SLIGHTLY USED CAR DEPARTMENT

Pictured alongside is the No. 3 lower hold of a victory-type vessel.

The chief officer made an inspection of the holds, and in No. 3 lower hold, he found that the vehicles had come adrift. The timber flooring was broken up and submerged in the muddy ore. The vehicles were crashing into each other and against the overhead beam.

moisture which tends to "settle out" at the surface, thus raising the percentage of moisture near the surface until the ore has consistency of mud. Moreover, this excess moisture was obvious.

Needless to say, heavy shifting boards should have been erected. Iron pyrite concentrates contain

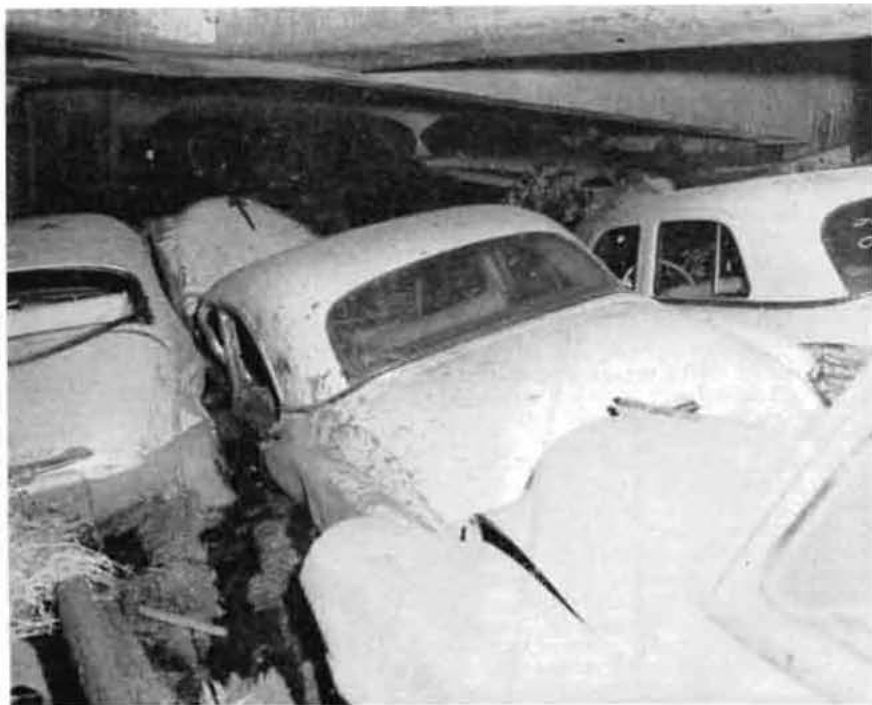
SEAGOING MOTORISTS

Every now and then we come up with a death or two, which may be termed the result of experiments to determine the buoyancy of passenger cars and trucks. If an automobile were ever successfully navigated from, say, Jersey to New York we might award it a number and thereby place it and the operator under certain marine regulations, but there is little time to consider hypothetical situations from the instant the vehicle is water-borne until it sinks below the surface carrying with it the "skipper" and his guests.

The damage to the car shows that a tremendous stress was placed upon it by the restraining cable before it parted. Quite possibly, the driver was confused and emotionally upset. There was, however, no member of the ferry's crew on the river end to direct or assist the loading of vehicles.
