PROCEEDINGS OF THE MERCHANT MARINE COUNCIL UNITED STATES COAST GUARD

November 1954

LESSONS FROM CASUALTIES

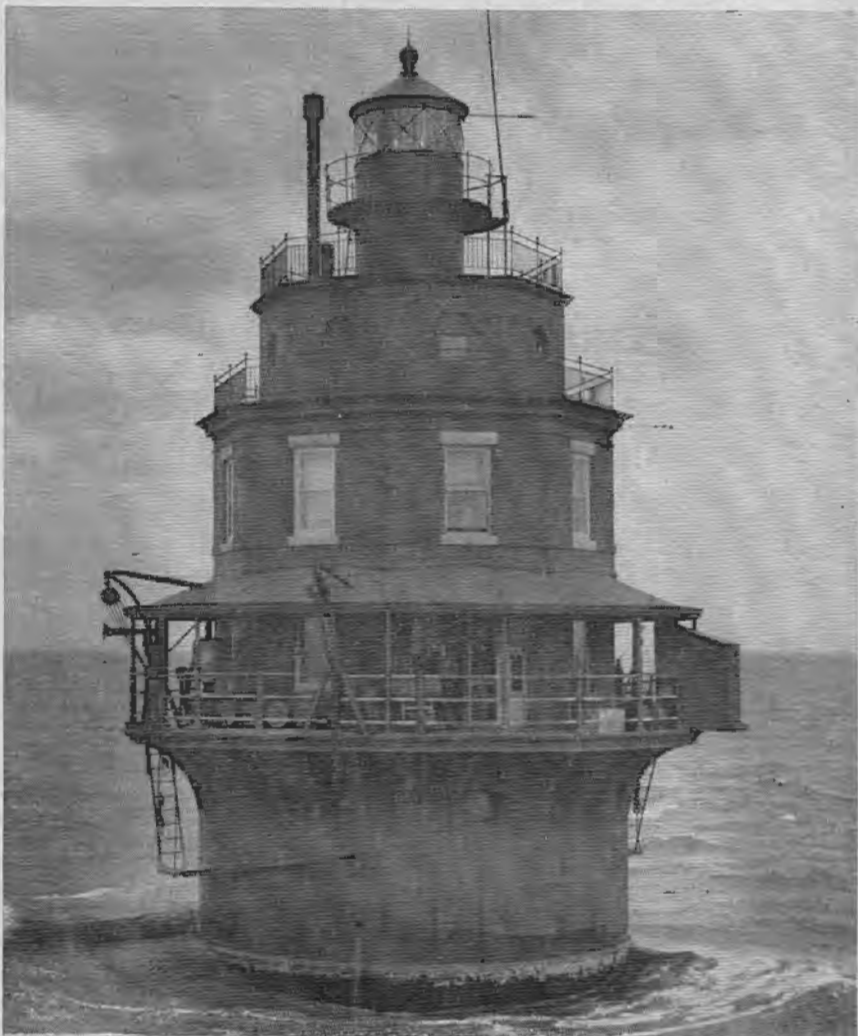
Figure 1

Before

to repeat is the sudden terrifying feeling of being swept helplessly sidewise toward a solid object in the influence of a cross current. It is the abruptness with which the realization strikes the navigator that causes the anguish. The cross current may have caused leeway for a considerable period before nearing the solid landmark and being compensated for by course corrections, the sense of sidewise motion is not felt, since there is no range or stationary object nearby to emphasize the drift, until—suddenly a solid object such as a lighthouse or the abutment of a bridge seems to sweep at the navigator. At this moment the need for a radical change of course to avoid collision becomes, belatedly, drastically obvious. Fortunately, most navigators who have experienced this awesome last minute slide or "skidding" feeling have pulled their ship clear. In the case portrayed by the accompanying photographs (see figs. 1, 2, and 3) the pilot was not so lucky.

A course correction of 2° to the left had been made before the sudden onset of thick fog, to allow for the set of the current. Since the light structure which was struck was almost directly on the edge of the channel, it is apparent that this correction was almost enough. But a most expensive *almost*.

Piloting in a narrow channel of this nature is fraught with hazard when the visibility closes in. Allowing ample clearances for points of danger such as an object as solid as this lighthouse is absolutely essential and is not difficult of performance when visibility is good. Piloting to allow these safe clearances in pea soup fog and in a busy channel depending only upon radar, dead reckoning, and the pilot's judgment is a superhuman task and has produced many a gray hair. The finest judgment and skill will delay the moment when you suddenly find yourself and your ship "skidding" sidewise toward danger, but sooner or later, it may happen to you. Be ready!

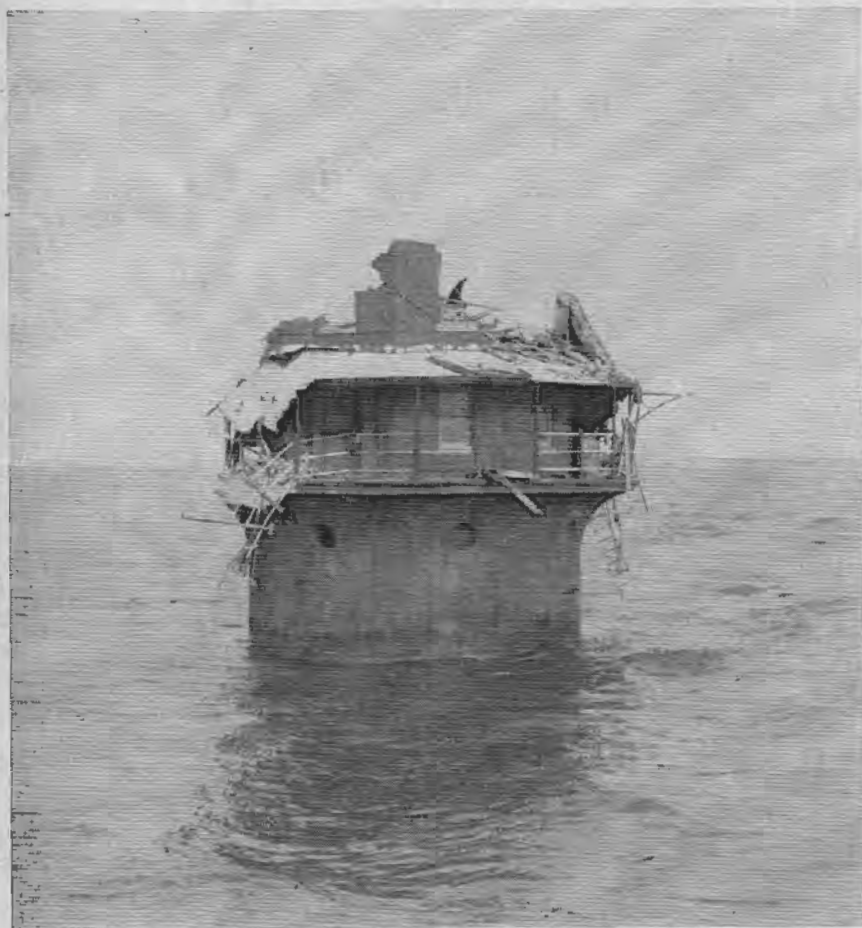
Figure 2

After

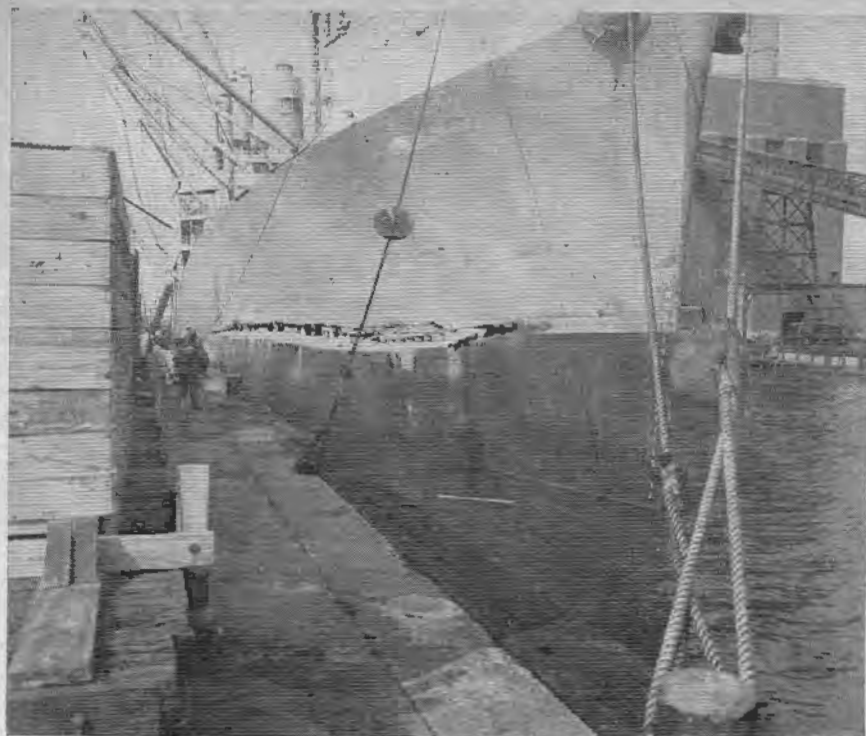
Figure 3

Cause
