PROCEEDINGS OF THE  
**MERCHANT MARINE COUNCIL**  
**UNITED STATES COAST GUARD**

December 1956

# SIGNIFICANT MARINE CASUALTIES OF THE PAST YEAR

By Commander R. F. Barber, USCG

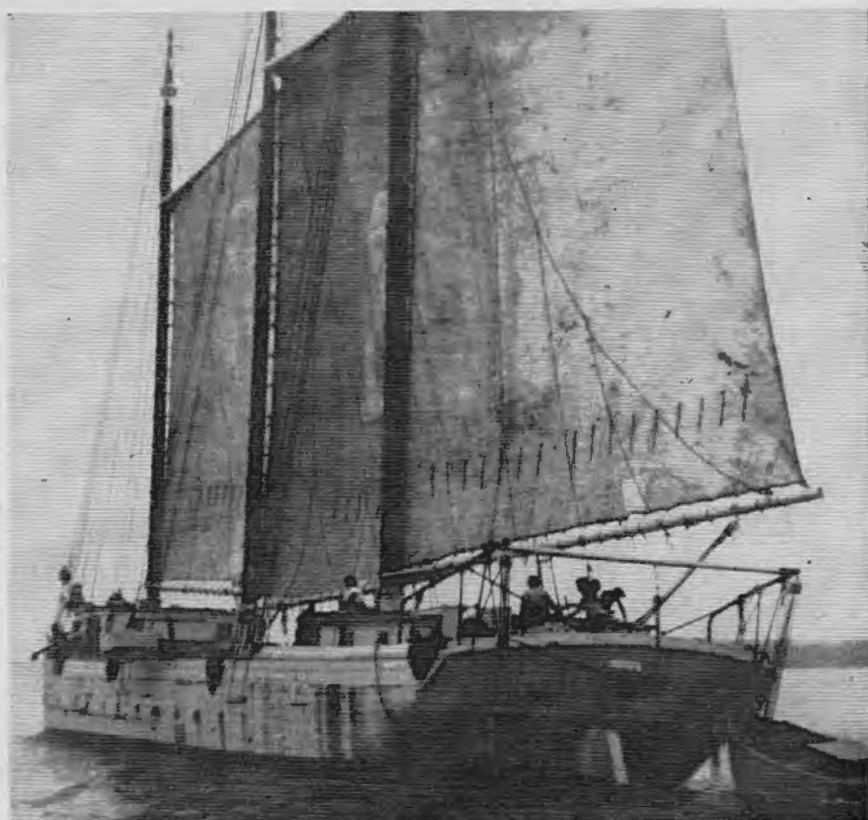
Figure 1. Last known picture of the wooden sailing schooner *Levin J. Marvel*.

As the fateful morning wore on, considerable quantities of water entered the old wooden hulk being buffeted by heavy seas. The anchor held, but leakage through ancient bottom seams and flooding through defective airports could not be controlled. A radiotelephone on board was defective and the plight of the 27 souls facing the perils of the tempest remained unknown to the outside world. There were no lifeboats or rafts on the vessel. By 2 p. m., with the bow almost awash, the master gathered the passengers aft and prepared to abandon ship. There was no panic as the 27 strapped on life preservers and eyed the distant shore, where the crashing surf could be seen intermittently through the gale. About 2:30 the *Marvel* suddenly rolled heavily and lay on her beam ends. The ship's company was now at the door of eternity, tossed shoreward by heavy seas with the slender thread of life held only by 27 pieces of cork and canvas. It was certain that not all would reach the shore alive.

In approving the bill which was signed into law on May 10, 1956, as Public Law 519, 84th Congress, and familiarly termed the Ray bill after Congressman John H. Ray of New York State, the House Committee on Merchant Marine and Fisheries emphasized that the new law, in addition to requiring Coast Guard inspection of most small vessels carrying more than 6 passengers, would also require such inspection of sailing vessels carrying more than 6 passengers. It is to be expected that the tragedy of the *Marvel*, which at the time of her sinking was not subject by law to any Government inspection requirements, will never be repeated.

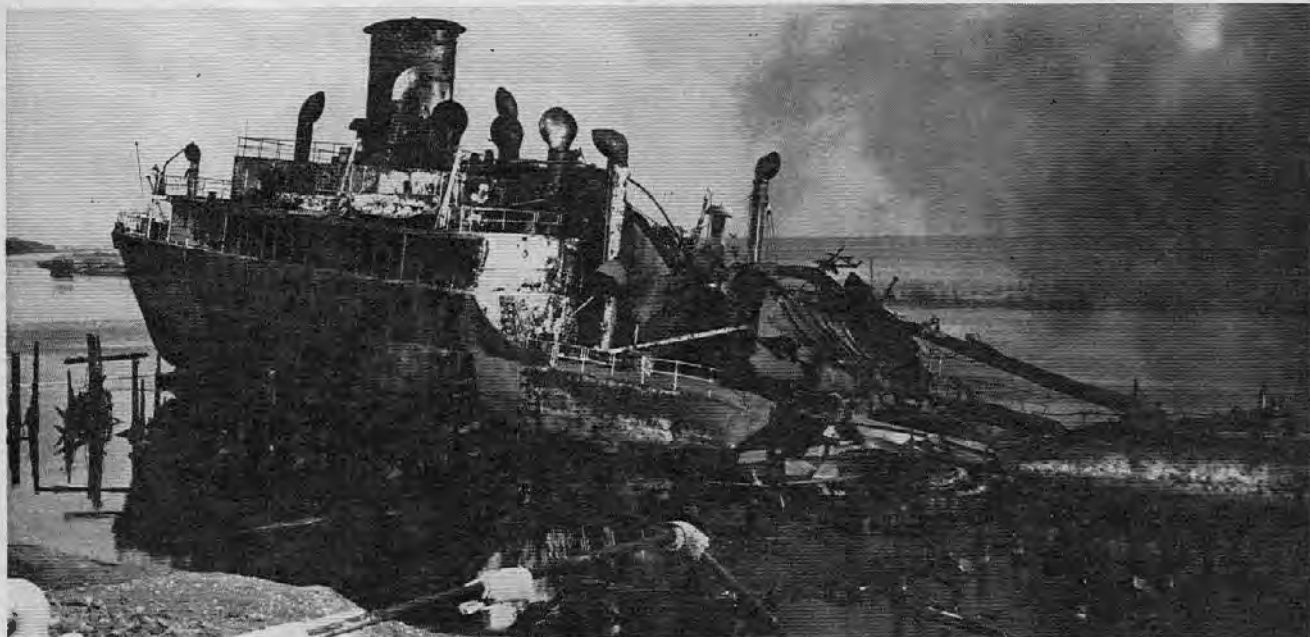
Service refinery docks near Lake Charles, La., on January 17, last winter. The war-built T-2 tanker *Salem Maritime*, lying peacefully at the terminal loading a mixed cargo of No. 2 heating oil, kerosene, and gasoline, was transformed suddenly into a raging inferno, a molten steel pyre for 18 members of her crew and 3 terminal employees. Before this holocaust was finished, the ship lay in ruins, a sunken hulk of a ship, 3 nearby tank barges were badly damaged, damage to the adjacent docks and shore property was estimated between \$1 million and \$2 million, and 21 men were dead or dying. (See Figure 2.)

The most logical conclusion as to the source of ignition of this costly fire was static discharge on or near the surface of the kerosene, caused by splashing and turbulence and the

Figure 2. Remains of the *Salem Maritime* after her catastrophic explosion and fire.

presence of small amounts of water left over from Butterworth, with gasoline vapor probably supplying most of the original explosive charge.

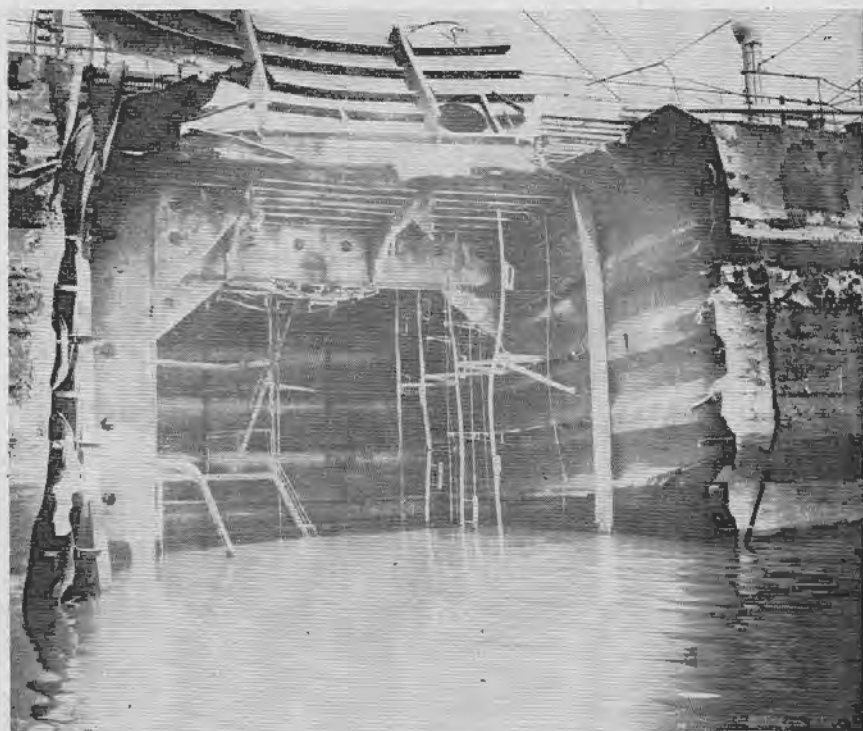
Another explosion on a T-2 tanker did extensive damage to the ship but, fortunately, took no lives. The *Esso Paterson*, built in 1942, was rent by a terrific blast on the evening of March 29, 1956, as she was being loaded at the *Humble Refining Co.* docks, Baytown, Tex. The explosion originated in No. 8 port wing or No. 8 center tank, ripping out the weather deck and side plating, and structural parts. (See Figure 3.) The bulkhead between No. 8 port and center tanks was found 100 feet from the ship. Excellent fire-fighting by the ship and the terminal confined fire damage to the immediate area. Studies of this casualty are not yet complete. However, it is apparent that the explosion occurred in a tank into which kerosene had begun to flow under pump pressure, which had contained gasoline on the last voyage, and which had not been gas freed although filled with salt-water ballast, prior to loading at Baytown.

Figure 3. Inboard view of the *SS Esso Paterson* showing extent of explosive force which catapulted bulkhead between No. 8 port and No. 8 center tanks almost 100 feet from the ship.

The Coast Guard and the entire petroleum transportation industry have become increasingly concerned with the inherent hazards involved in handling kerosene and similar products, such as JP4 jet fuel, as evidenced by the two disastrous explosions on tank vessels this year and other similar explosions in recent years. The preliminary report of an oil industry committee now studying, at the request of the Coast Guard, the special hazards of loading and discharging kerosene and jet fuel indicates that additional precautions may be required. Although the study has not been completed, it would appear that a very real problem of static electricity discharge may exist on or near the surface of kerosene under certain conditions of turbulence and the presence of water. To avoid the possibility of the static discharge triggering an explosion, the committee suggested that any tank which previously contained a low flashpoint product should be gas freed or inerted before loading kerosene. In addition, contamination of kerosene with gasoline or other low-flash product should be avoided since contamination will probably result in greater explosive vapor generation during loading. More complete information on the avoidance of kerosene and jet fuel explosions and fires is to be expected during the coming year.

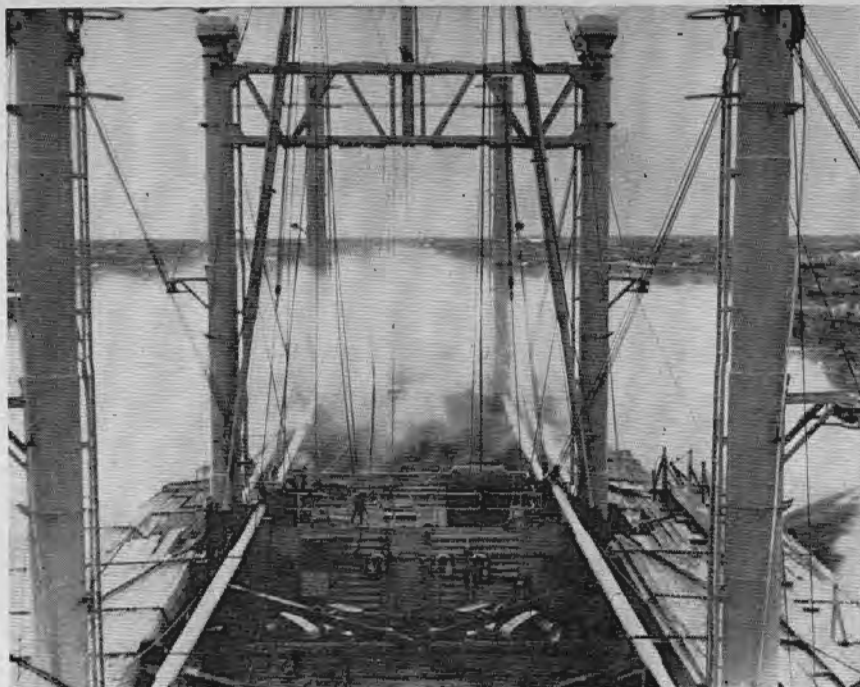
A dramatic casualty involving the total loss of an 8,000-ton freighter in the Gulf of Alaska occurred on March 3 this past winter. Happily there were no lives lost and no serious injuries. The *SS Washington Mail*, a C-3 freight ship, built in 1945 at Pascagoula, Miss., was en route to the Orient from Seattle with a full load of general cargo including a deck load of lumber. At 1:15 p. m. on the 3d of March, with the vessel turning up approximately 13 knots into a moderately rough head sea (see figure 4), a loud deep rumbling sound from the vicinity of No. 3 lower hold was heard accompanied by a distinct sagging amidships. Moments later, a fracture appeared completely across the weather deck directly along the after section of No. 3 hatch, and the vessel broke in two.

Figure 4. Dramatic picture snapped just seconds before the SS *Washington Mail* broke in two.

This was the first structural failure with serious consequences of a C-3-S-A2-type vessel in almost 13 years' operation of this class. As a result of a study by the Coast Guard and the American Bureau of Shipping based largely on the probable fractures which occurred on the *Washington Mail*, action has recently been taken to reinforce the upper part of the hull girder on all all-welded ships of the C-3 class by conversion to rounded hatch corners on hatches Nos. 2, 3, and 4 and by the installation of crack arrestors or riveted straps on the weather deck and the sheer strake abreast these three hatches.

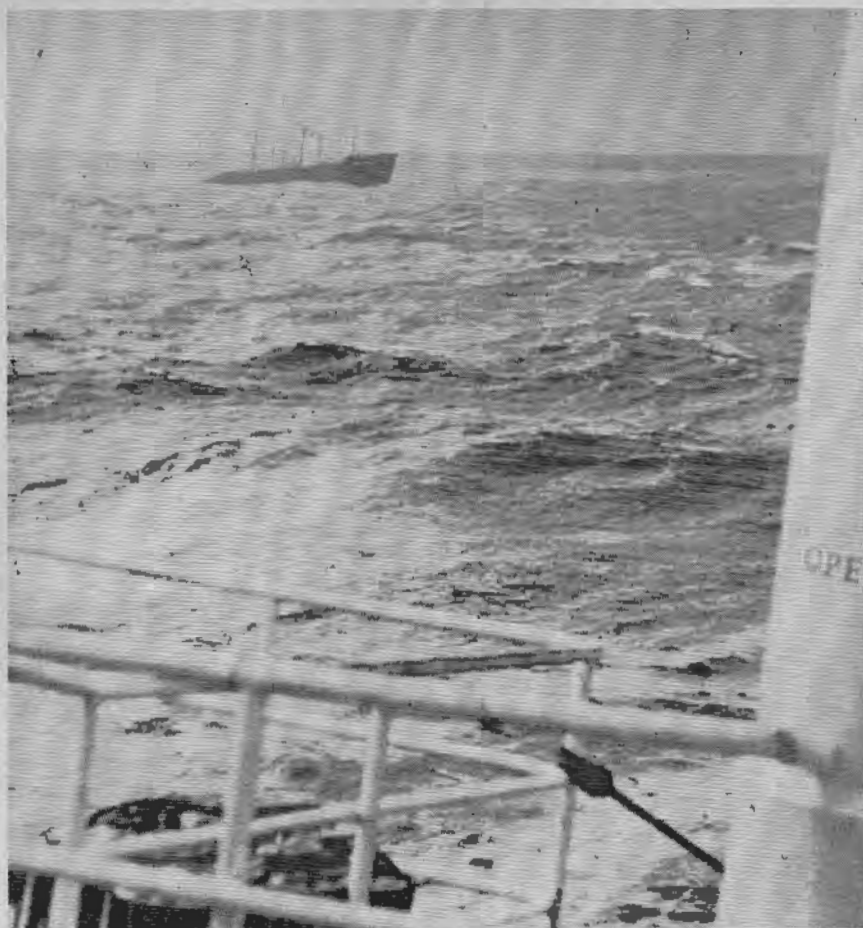
The bow section, with no persons on board, soon capsized and sank. (See Figure 5.) The after section, with 51 crew members and 9 passengers on board, remained afloat for 8 hours, largely due to the commendable and energetic efforts of the officers and crew in controlling the damage and flooding. Every person on board safely abandoned the after half in the *Washington Mail's* lifeboats and were taken on board the *USNS General Freeman* about 1 hour

Figure 5. Forward section of SS Washington Mail seen in background just before sinking. Picture taken from after section still afloat.

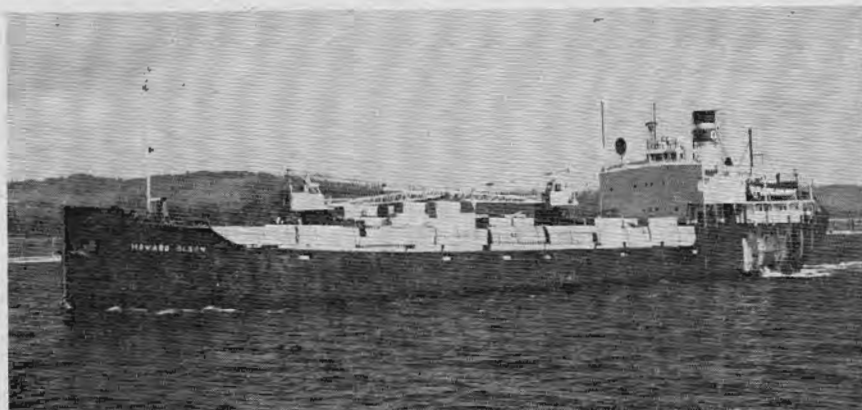
Figure 6. The 39-year-old SS Howard Olson taken in a happier day.
