# PROCEEDINGS OF THE MERCHANT MARINE COUNCIL

Vol. 13

May 1956

# HARD STARBOARD—FULL ASTERN!

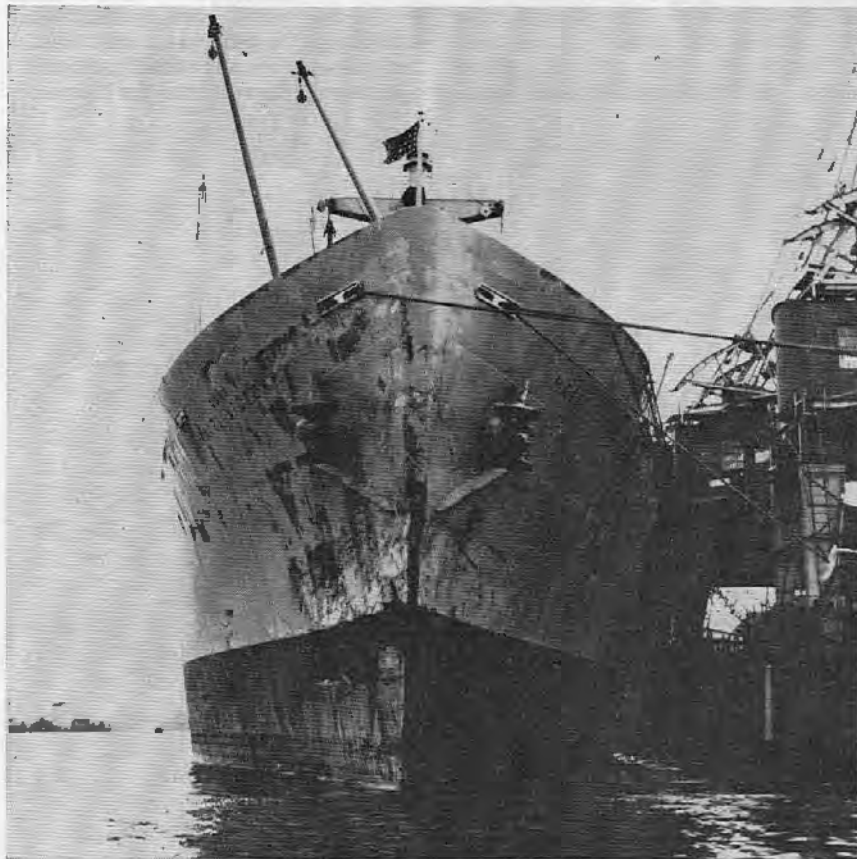
The *Haiti*'s bow made contact about 25 feet forward of the *Duke*'s bridge, on the port side at an angle of about 80°. The relative speed of the *Duke* was between 2 and 4 times the speed of the *Haiti* at the moment of collision.

Figure 2. Bow of *Haiti Victory* following collision.

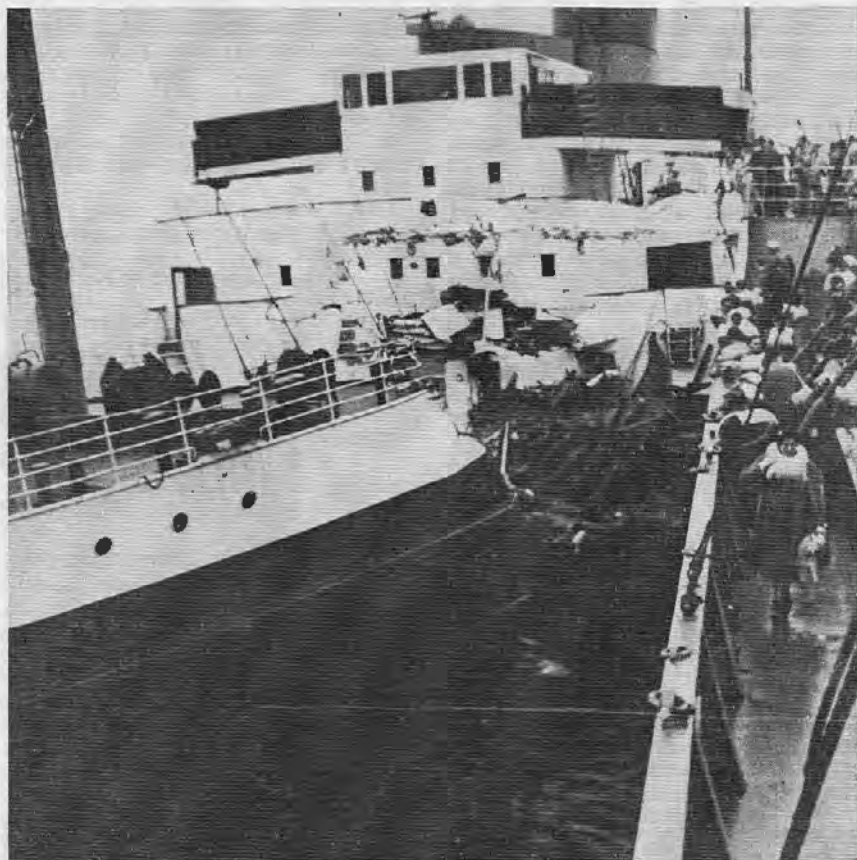
The *Duke* suffered extensive damage—the bow section forward of the point of collision broke off and sank in 25 fathoms of water. Seven persons were lost. The after section remained afloat and was towed to England.

Figure 3. View of forward section of *Duke of York* shortly after collision. The section forward of the point of impact broke off and sank. Survivors can be seen on the foredeck of the *Haiti Victory*.

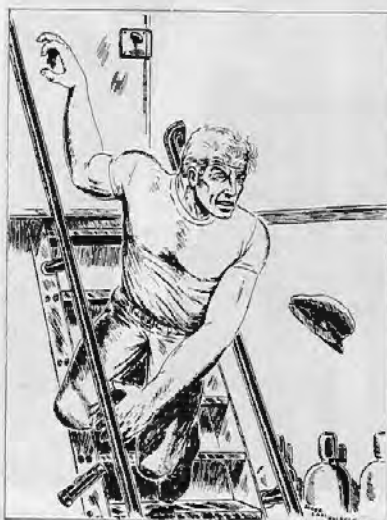
Figure 1.

Mr. Holquin pointed out that not all of the blame should be placed on the oiler and contends that the hand-rail arrangement on the ladder, as in many other C-3's, could be made safer. The ladder is constructed with one handrail extending the full length of the ladder while the other is several feet shorter (see Figure 1), thus making a descent hazardous because a man must descend at least 3 steps with only 1 handrail.

This situation is now being investigated by the Coast Guard and it is quite possible that a minor alteration is all that will be required.
