# PROCEEDINGS OF THE MERCHANT MARINE COUNCIL

June 1956

Towing Casualties.....	95
Side Light Screens.....	103

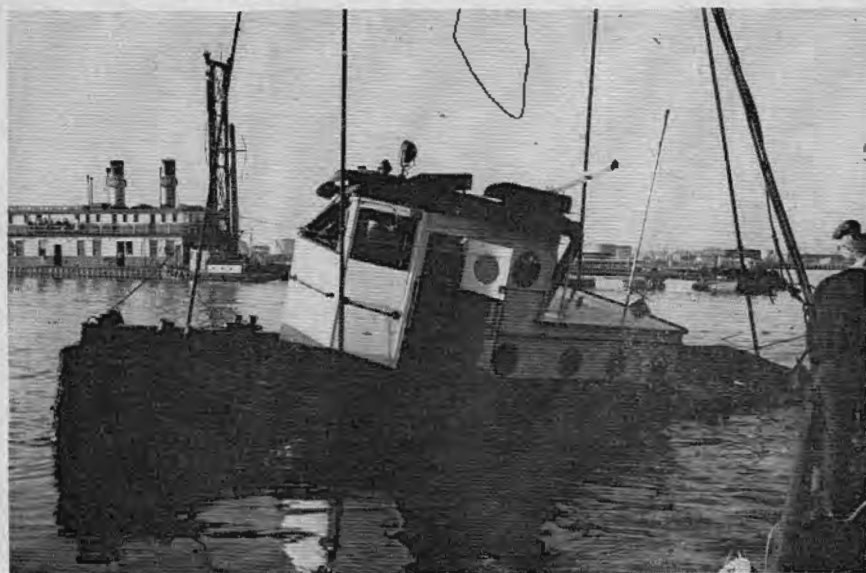
Figure 1. Small tug being brought to the surface after capsizing and sinking.

the operations of these specialized towboats. Men who are killed in fires or explosions, when a nondescript motor craft sinks (see Figure 1), are just as dead as those killed or drowned on any other vessel. In addition, Coast Guard casualty records indicate that the death rate on this type of towboat is much higher, proportionately, than on the established towing routes. What better proof is necessary to point out to the operators of these miscellaneous limited-purpose tugs that they should keep them as safe, and manned with as well-qualified personnel as the towboats on established routes? A safety record speaks for itself.

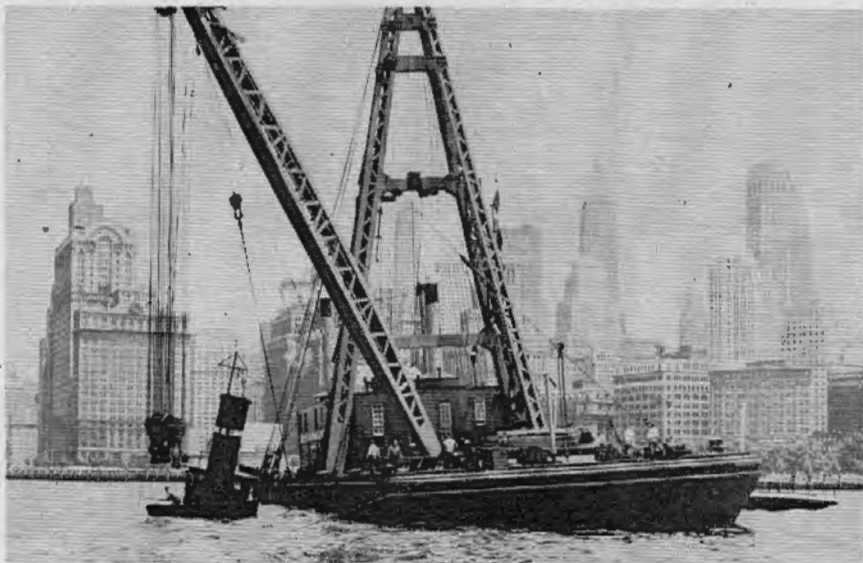
Figure 2. Another tug being salvaged after capsizing off the Battery in New York harbor.

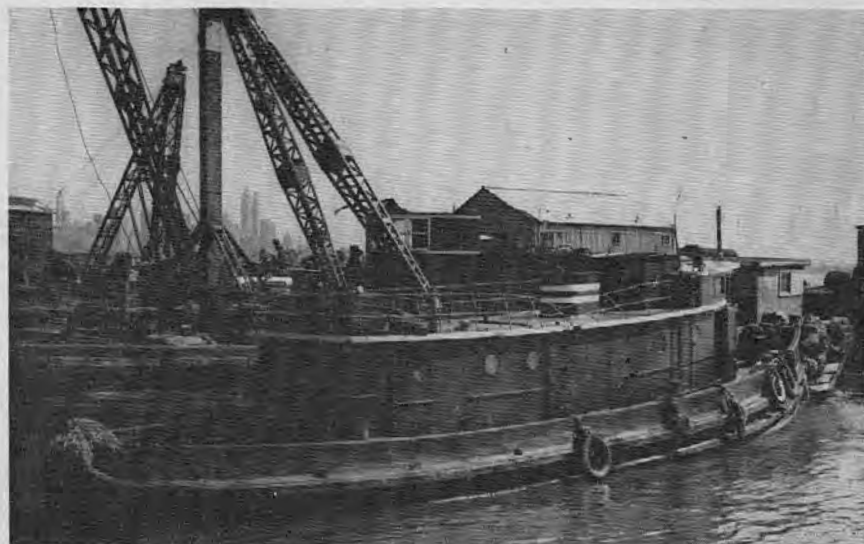
Figure 3. View of tug a short time after it was refloated. Note the low center of gravity—nevertheless she capsized, mainly because she was underpowered.

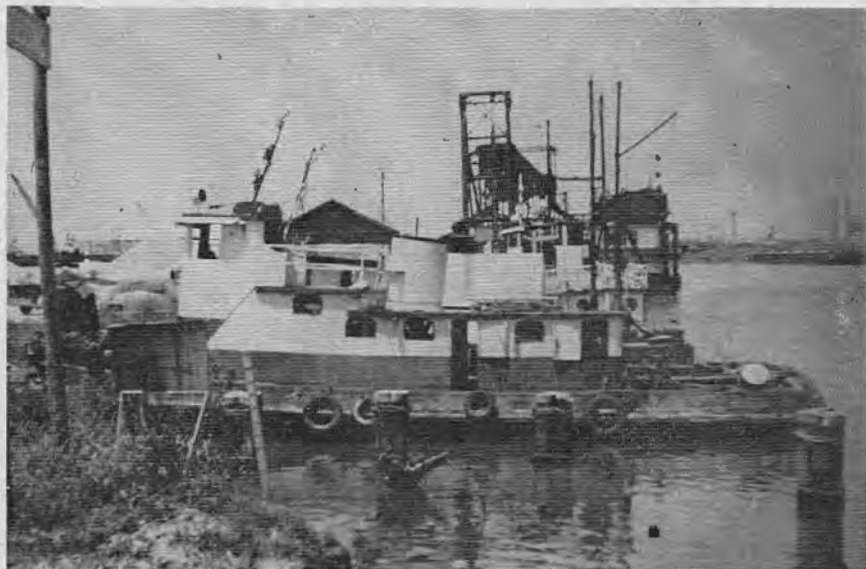
In the second case, which occurred last summer, another small diesel tug measuring 54 feet, of 47 gross tons and 270 hp. (see Figure 4) was sunk when overwhelmed by rough seas during a towing operation. The towboat had gone after a drifting barge which had broken loose from a mooring during a storm. With the stray barge in tow, the tug headed for a nearby inlet. Strong northerly gales pounded the blunt-nosed craft and seas broke continually over her bow.

It became obvious that water was entering the hull, probably through vents, as the bow rode lower and lower. Water was noticed entering the engineroom around the doors, and the engineers found water in the fuel. Since the tug's bilge pump had been removed from the vessel, the crew attempted to use a portable gasoline pump. During a particularly heavy roll, the pump slammed against a bulkhead, the spark plug shattered, and the magneto was soaked—it was inoperative.

You would think that the owners would have taken every reasonable precaution to avoid a repetition of such a casualty after the vessel had been raised and repaired. Yet, in April of this year, the very same tug foundered in the very same locality, and 8 of the crew of 9 were rescued and transferred ashore by 2 Coast Guard helicopters—one of which was the same helicopter with the same pilot that participated in the previous rescue.

Figure 4. View of tug after being refloated and pumped dry. A short time after this picture was taken she was involved in a similar accident and sank again.
