PROCEEDINGS OF THE MERCHANT MARINE COUNCIL

UNITED STATES COAST GUARD
Vol. 23, No. 12 • December 1966

Lifeboat Launching Gear Failures

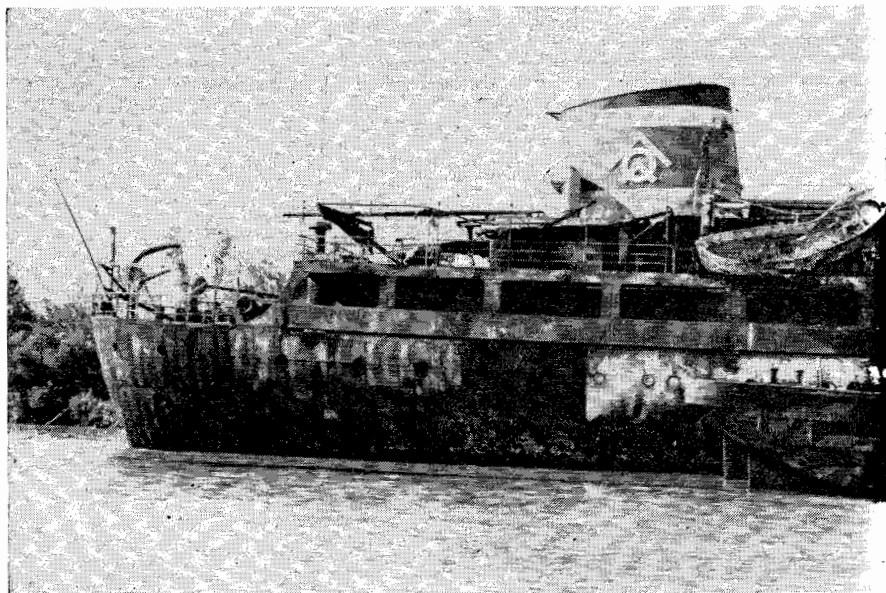
The blackened Boheme shows results of collision and fire.

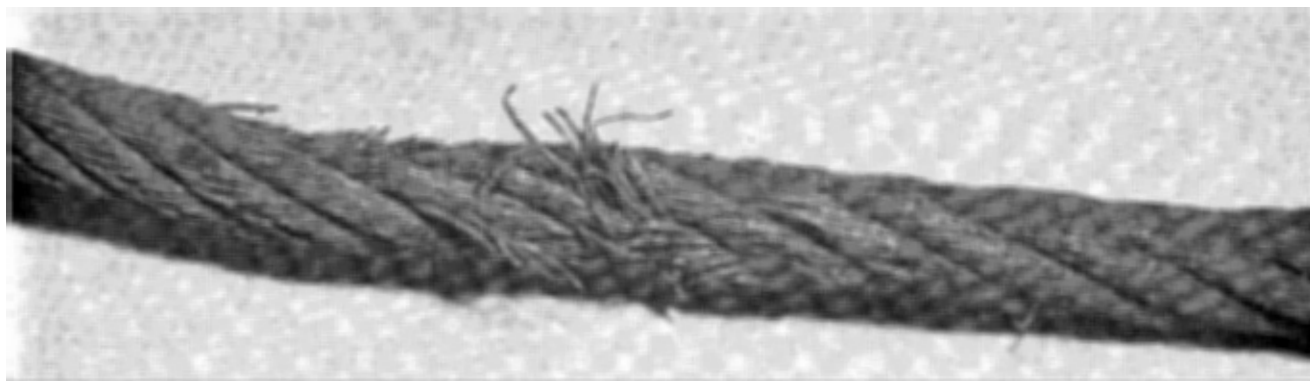
And this was the wire rope fall that didn't break!!
