PROCEEDINGS

OF THE MERCHANT MARINE COUNCIL

UNITED STATES COAST GUARD Vol. 24, No. 11 • November 1967

INFLUENCE OF PERSONNEL FAILURE ON CASUALTIES

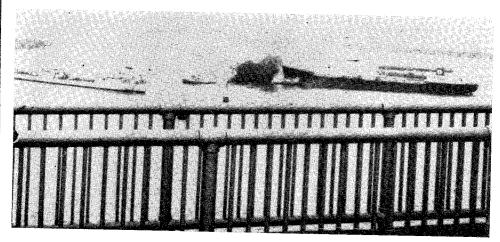
Figure 1.

At this time, let us take a look at some of the casualties of the recent past which indicate personnel fault as the primary cause. In June 1966, New York Harbor was rocked by an explosion and fire following a collision of the tankers Texaco Massachusetts and SS Alva Cape. The record of the Marine Board of Investigation indicates that the casualty occurred on a clear day, with both vessels in sight of each other in a crossing situation, with the Alva Cape the burdened vessel on the Texaco Massachusetts' port bow. The investigation revealed that there was no mechanical failure or any other special circumstance to justify lack of compliance with the Rules of the Road. The Alva Cape, burdened in a crossing situation and duty bound to reduce speed or to avoid crossing ahead, was struck on the starboard side releasing her cargo of naphtha. The resultant explosion and fire caused the death of 33 persons. Here is a dramatic sequence of pictures taken a few minutes after the collision by a witness watching the casualty from a nearby bridge. Figure 1 shows the Alva Cape and the

Texaco Massachusetts adjacent to each other a few minutes after the collision and just prior to the ignition and explosion of the naphtha fumes. Figure 2 depicts the rapid spread of the fire about one minute after ignition, when the fumes from the cargo flowing out of number one tank have been ignited by the adjacent tugboat. Figure 3 shows the Alva Cape engulfed by smoke and flame. The Board concluded that the primary cause of the casualty was personnel fault—the failure of the person in charge of the Alva Cape to reduce speed and comply with the statutory Rules of the Road. Through heroic efforts of the firefighting forces on the scene, the fire was extinguished, but, unfortunately, the tragedy of the Alva Cape was not ended.

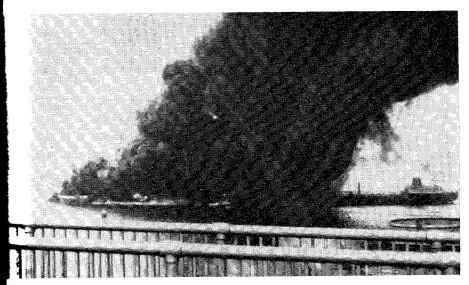
Figure 3.

The vessel was towed to lower New York Bay where salvage efforts were commenced to remove the remaining naphtha cargo still aboard the vessel. In the course of discharge operations the vessel was wracked by another violent explosion and fire resulting in the death of four members of the salvage crew. Personnel fault and human error again played their part. The investigating officer deter-

mined the cause of the casualty to be an improper and inadequate attempt to inert the cargo tanks using carbon dioxide gas. The inerting process should have been under the supervision of a certified marine chemist. Had this been done, the personnel performing the operation might have benefitted from a warning of the hazardous possibility that a static spark could be generated. This warning was conveyed to the purchaser of the carbon dioxide gas, but, unfortunately, it was not relayed and translated into the necessary action to benefit those aboard the vessel. The investigator concluded that the source of ignition was a static spark generated by the discharge of carbon dioxide. Both casualties were attributed to personnel fault: The former was failure to operate the vessel in compliance with the statutory Rules of the Road; the latter was failure on the part of those involved to be made cognizant of the known procedure and hazards that inerting and controlling gaseous compartments involve.
