OF THE MERCHANT MARINE COUNCIL

Vol. 24, No. 1 * January 1967

SS Smith Voyager Investigation

Commandant's Action on

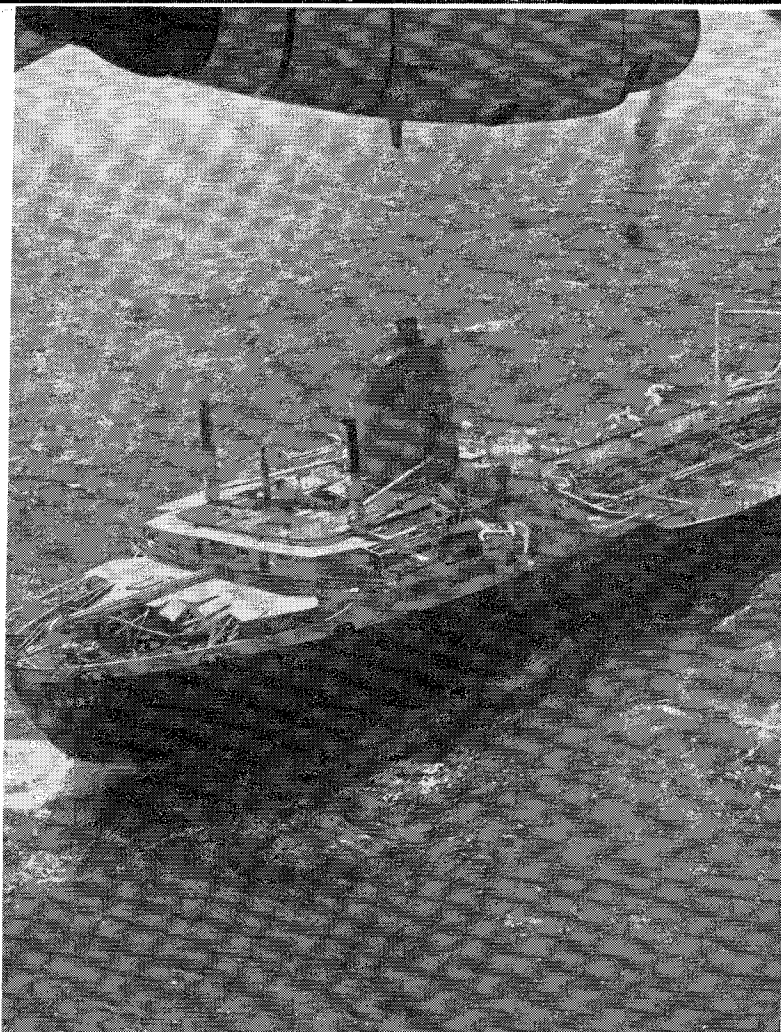
The storm battered stern of the tankship Alberto Bennati as viewed from Coast Guard rescue aircraft.

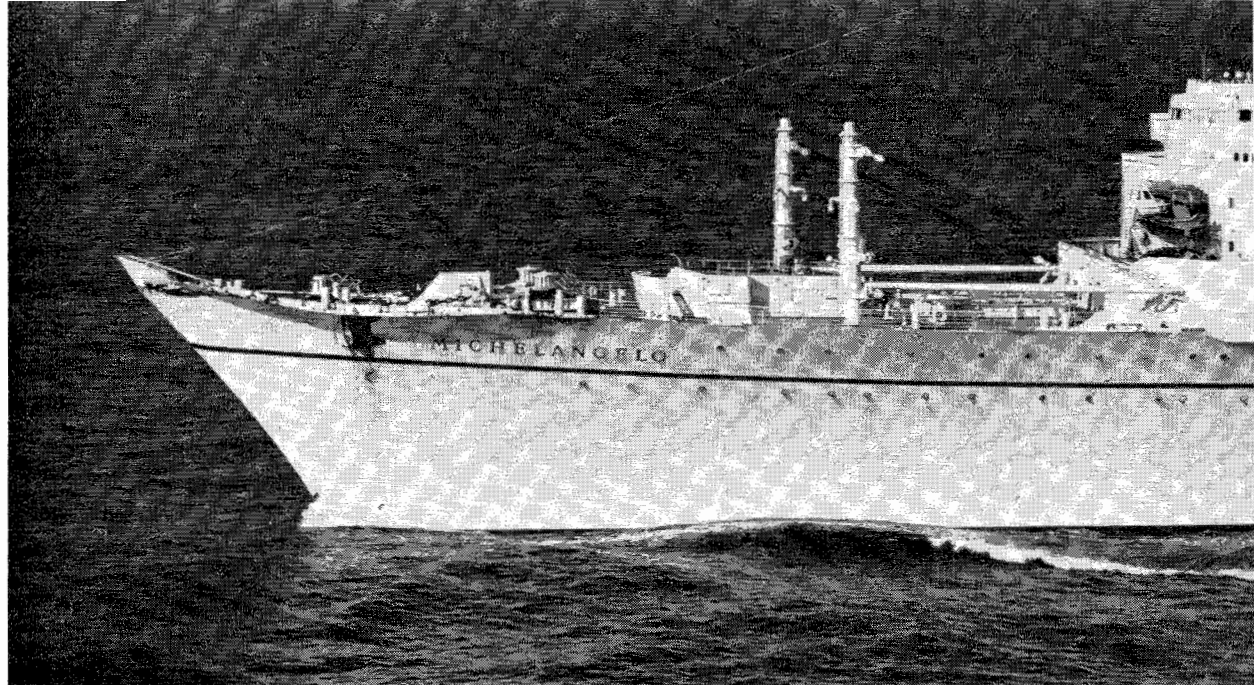
Heavy weather damage shows on the Italian Line Michelangelo.

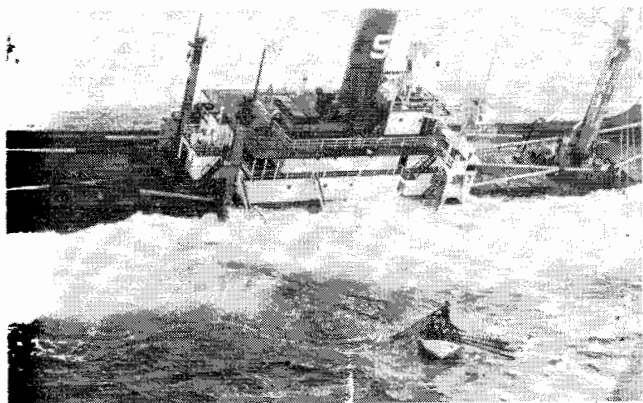
A lifeboat crew from the U.S. Coast Guard Cutter Rockaway inches toward the doomed *Smith Voyager* to make a rescue.
