PROCEEDINGS

OF THE MERCHANT MARINE COUNCIL

SS 'GULFSTAG' EXPLOSION, FIRE, AND CAPSIZING

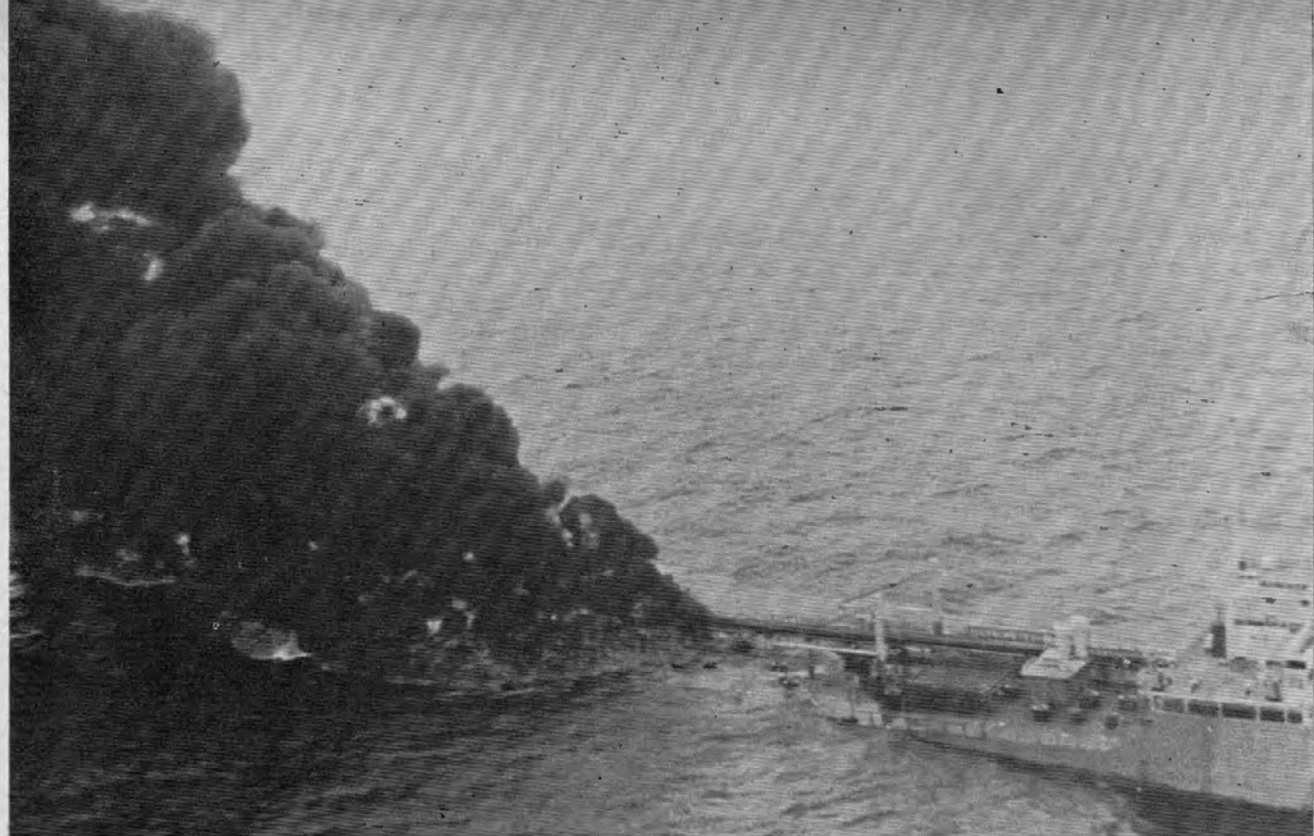
Aerial photo taken by Coast Guard HU-16E aircraft showing Gulfstag down by the stern, after main deck awash with after house engulfed in flames.

1. It is concluded that the SS *Gulfstag* burned and partially sank in the Gulf of Mexico on 24 and 25 October 1966 as a result of several explosions which originated in the after pumproom, and of subsequent fire and leakage of sea water, with the loss of the lives of eight crewmembers. Seven lives were lost during the fire on 24 October 1966 and one crewmember died on 12 November 1966 as a result of injuries received during the fire. The *Gulfstag* was eventually salvaged to the point where it floated and could be towed and was finally sunk at sea in 165 fathoms depth on 18 December 1966.

2. An explosion occurred in the after pumproom at 0305S, 24 October, which ruptured the surrounding bulkheads allowing gasoline to flow into the after pumproom and the engineroom bilges from No. 11 cargo tank, thereby causing further explosions and fire, with the subsequent eventual sinking and loss of the vessel.
