# PROCEEDINGS

Vol. 25, No. 1

## FOR THE WANT OF A TRAP TWO BOILERS WERE LOST

An unusual, cascading chain of events recently crippled a large oceangoing tanker. This article reveals what happened in the engineroom of a tanker and why it occurred.

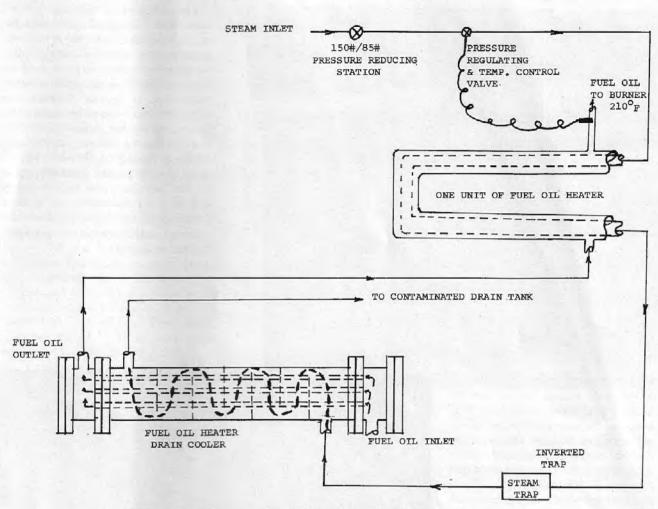
The trigger to the chain of events was a malfunctioning ball float steam trap installed in an inverted position between the fuel oil heater and its drain cooler. The term "inverted" is used in the sense that the trap was upside down and the inlet and outlet ends were reversed. The trap allowed steam to pass from the fuel oil heater

to the fuel oil heater drain cooler. Steam impingement occurred on the drain cooler tube bundle. Note there that with the trap operating properly, the steam would have been prevented from passing the trap and subsequently impinging on the tube bundle. Tubes in the path of the oncoming steam took the brunt of the wet steam attack. The drain cooler was not designed with an impingement plate to protect the tubes because the usual state of the fluid entering the shell side of the cooler was liquid. (See Figure 1.) The casualty proved that the usual was not the case.

FIGURE 1.-Schematic of fuel oil heater and fuel oil heater drain cooler.

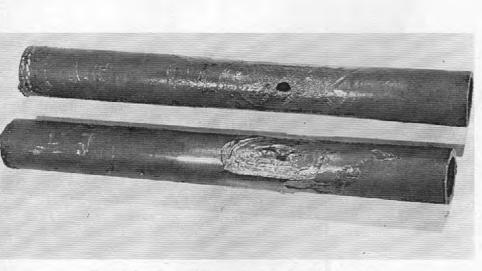
Drain cooler tubes hit by steam eventually necked to a critical wall thickness allowing fuel oil pressure inside the tube (300 p.s.i.g.) to penctrate the boundary of the tube wall and contaminate the drain system. The oil was not observed in the contaminated drain tank immediately, so it continued unnoticed to the clean

FIGURE 2.-Fuel oil heater drain cooler tube damage.

Figure 2 illustrates two of the drain cooler tubes and shows two types of steam attack on metal, wire drawing and splatter steam impingement corrosion. Wire drawing, the cleaner looking of the two attacks is commonly found across the seats and discs of steam valves. Splatter is caused by the high-velocity droplets of water in wet steam striking a surface and shattering tangentially. Many deep, clean grooves are shown in the cavity of the holed tube, the neck is less severe on this tube. Orientation of the holed tube with respect to the flow of steam must have been such that the

hole was 90° from a point on the surface of the tube in line with the steam flow. The nonholed tube must have been subjected directly to the flow of steam.

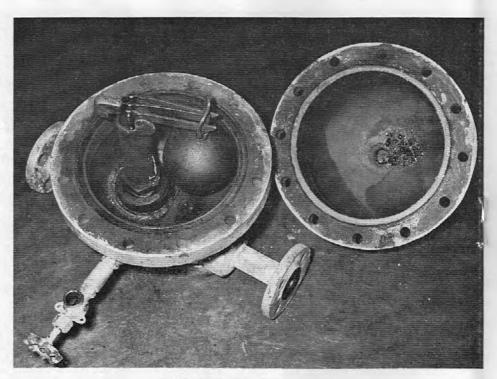
Further analyzing the situation, the trap as installed had the drain enter under the needle valve seat, flow up an internal nozzle, over the inner opening of the nozzle, onto the top of a ball float, then under a baffle

Two features of the trap should have been glaring indications of an inverted position. First, the cover containing the threaded drain plug would logically have to be on the bottom to allow the drain action to function when it became necessary to clean the trap-this cover was on the top rendering the drain action useless. Next, the steam baffle plate, which is usually on the inlet end of traps to deflect steam from impinging on the ball float, was on the outlet end of the problem trap. The only function of the baffle plate in the inverted trap was to act as a platform for the ball float.

plate to the outlet nozzle. (See Figure 3.) With the trap in this position, the needle valves are open when the trap is empty because the weight of the ball acting on its lever ann is greater than the needle valve assembly acting on its lever arm. The trap would only function in this position (See Figure 1) if it were always maintained with a level of water. In this way, action of the ball float would not be necessary to trap the steam. The trap would be a loop type instead of a ball float type. For the trap in the inverted position to maintain this level of water it would have to be low down in the system with a potential head pressure equal to zero. The trap was installed in the system higher than the fuel oil heater drain cooler so the water was not, in fact, held in the trap as a buffer to steam. The water simply gravitated to a lower level. In normal operation then, the trap was dry and the valves were open resulting in a "no trap" trap.

FIGURE 3. Trap assembly.

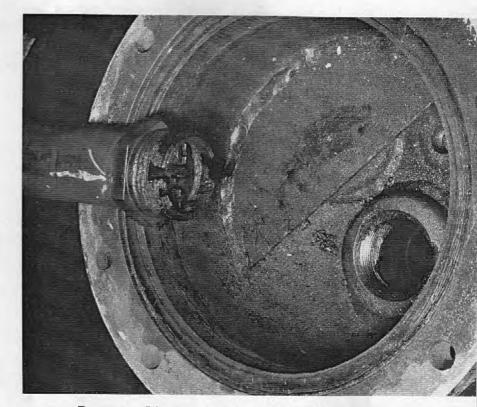
The trap, if installed properly, would have presented a resistance to the steam entering it. Since the trap was unable to function, this hackpressure in the steam line was reduced and the steam could flow with more ease.

The steam cuts observed in the threads of the inlet nozzle were made by the steam seeking an easier access to the outlet than through the three small openings offered by the three needle valve seats. (See Figure 4.)

FIGURE 4.—Dismantled steam trap showing deterioration.
