COAST GUARD

PROCEEDINGS OF THE MERCHANT MARINE COUNCIL

A PORT SAFETY DILEMMA

Captain William A. Jenkins, USCG

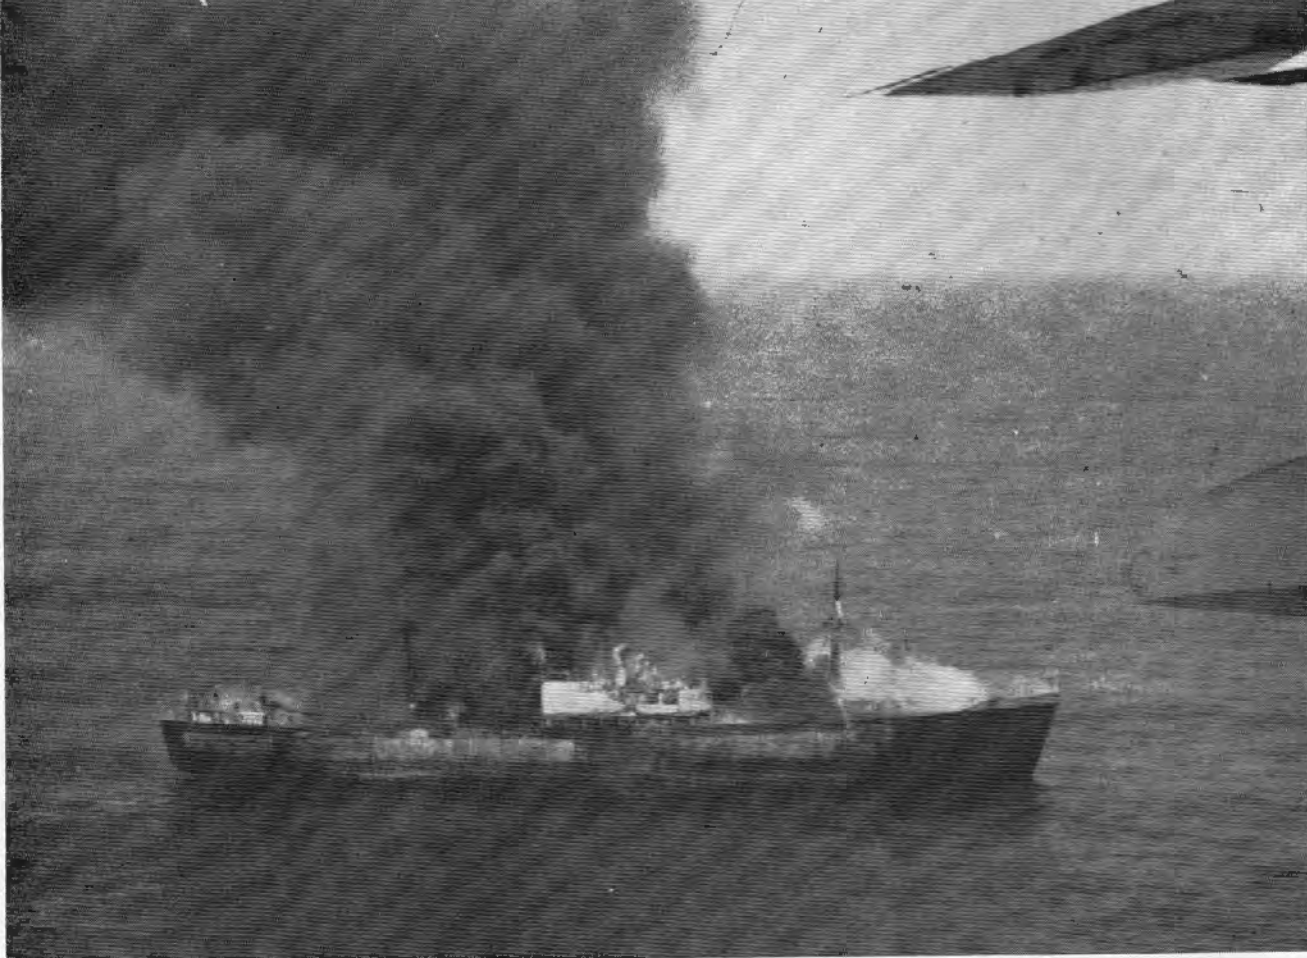
THROUGH THE YEARS, man has come to respect and fear the awesome sight of a vessel afire at sea. Figure 1 shows the Panamanian freighter *Beth* on fire 90 miles SSW of Santo Domingo, as spotted by a Coast Guard aircraft.

FIGURE 1. *The Panamanian freighter Beth on fire 90 miles SSW of Santo Domingo, as spotted by a Coast Guard aircraft.*

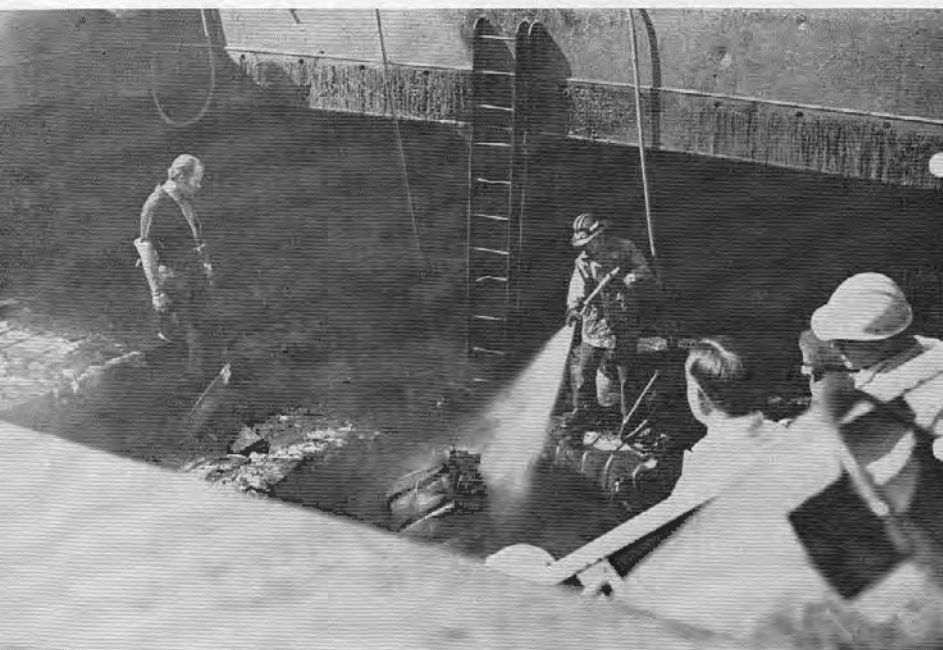
FIGURE 2. Some of the cargo on the *Holthill* that was still smoldering, is being wet down with a firehose.

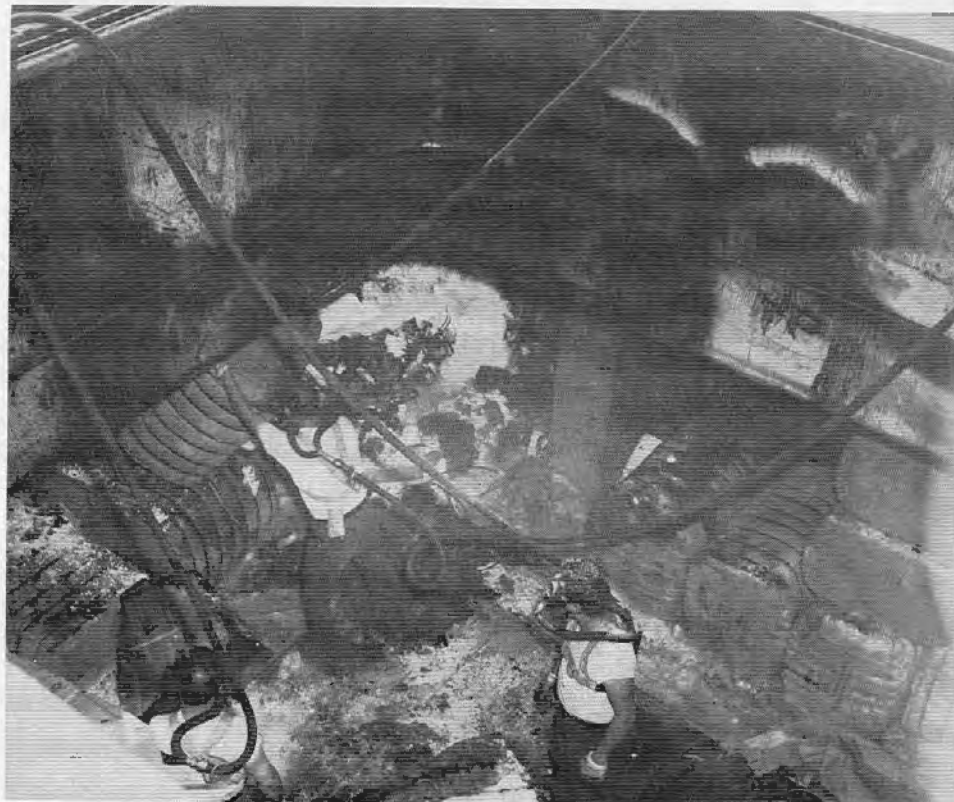
The *Holthill* arrived at Long Beach entrance April 22, 1966. The preliminary survey conducted at the sea buoy indicated that allowing the ship to enter would not constitute a danger to the port. The vessel was directed to proceed to Berth 22 in Long Beach and moored as planned. CO₂ was discharged periodically into the hold during the 23d and 24th. On April 25 the burnt cargo was off-loaded. Some of the cargo that was still smoldering, was wet down with a firehose. (See figure 2.) Breathing apparatus was used in the hold following the use of CO₂. (See figure 3.)

FIGURE 3. The use of breathing apparatus in a hold when CO_2 was used, eliminates the requirements for ventilating the hold prior to off-loading operations, thus retarding the possibility of reflash due to lack of combustible atmosphere.

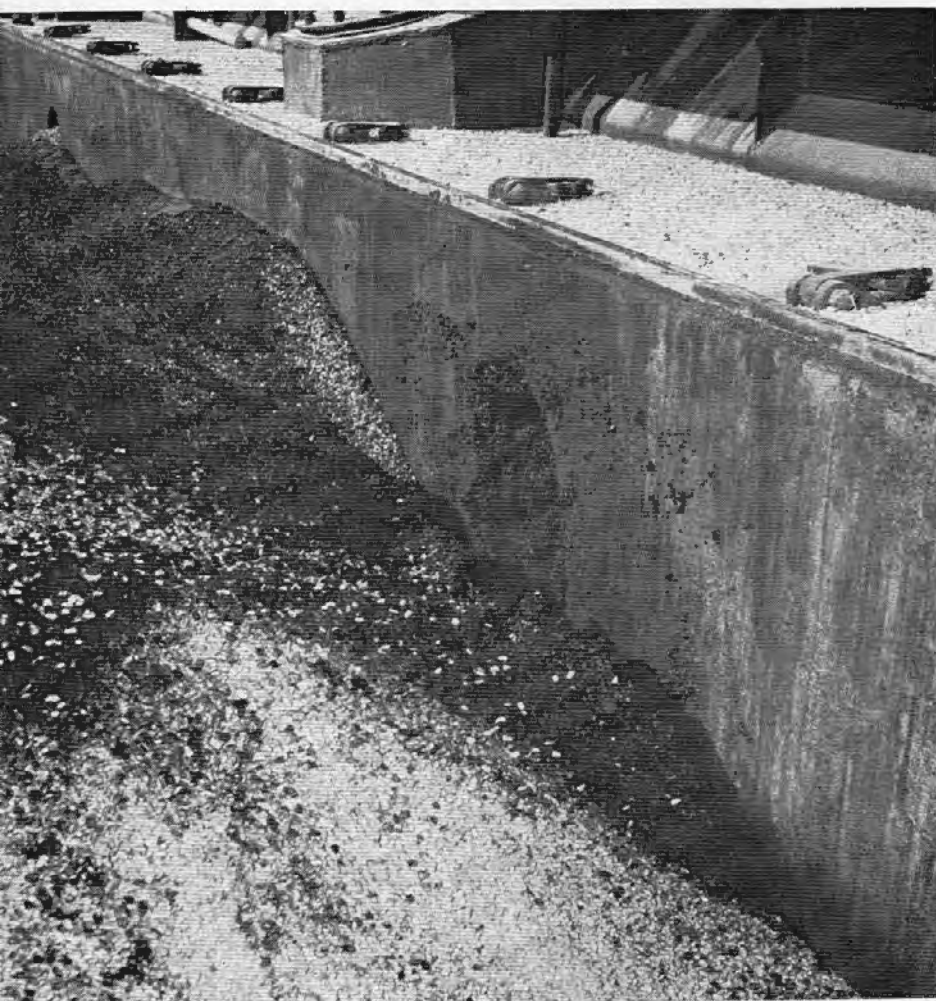
when the smoldering, fused grain was exposed to the air, but was immediately extinguished by application of water fog. (See figure 4.) The fire in upper No. 4 was caused by heat transfer through the bulkhead from lower No. 5. In all, 36,000 pounds of carbon dioxide were required to extinguish the fire. Subsequent examination revealed that corn had been burned in three holds; one apparently by the transmission of heat through a bulkhead.

FIGURE 4. Source of fire may have been a result of hold flood lights being left on after the cargo of corn was loaded. Note charred grain in recess of flood light.
