PROCEEDINGS OF THE MERCHANT MARINE COUNCIL

Arizona—Meiko Maru Collision . . . U.S. Coast Guard 1967 . . .

MORE SINNED AGAINST THAN SINNING

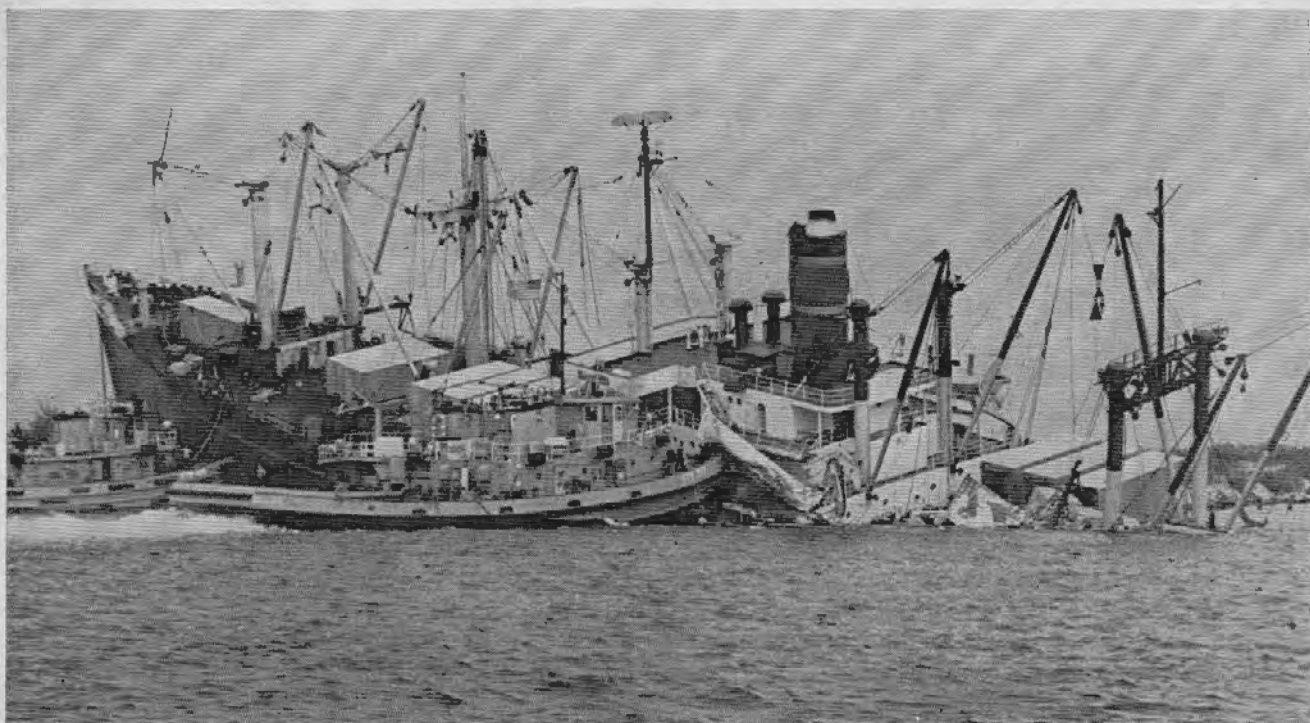
The most disastrous result that can follow from inadequate use of radar is collision at sea. The above vessel was declared a total constructive loss following a collision with another vessel. Fortunately there were no injuries or deaths.

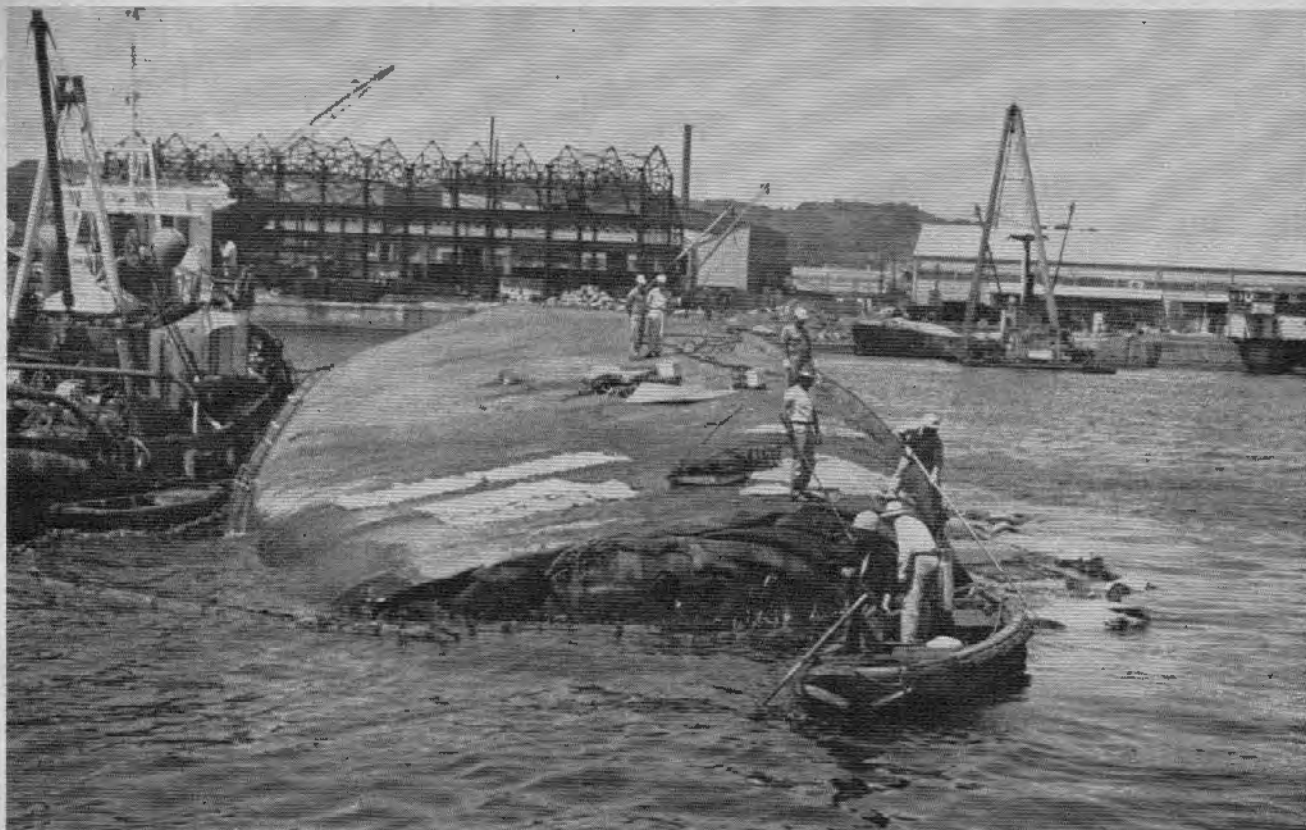
The capsized hull of the Meiko Maru is towed back to port and tended to by workers.

Photographs also show the forebody of the *Meiko Maru* floating capsized when discovered. Salvage photos show the hull is indented commencing at the main deck fashion plate port side and the stern section is sheared off immediately aft of the engineroom forward bulkhead. The concave rounded indentation extends into and to the top of the superstructure in the vicinity of the port bridge wing. This indentation at the level of superstructure top penetrates nearly to the vessel's centerline. From that point the line of shear tends generally aft and to starboard. The missing stern section comprises the main engineroom, machinery spaces, crew accommodations, and stores. The stern section is not known to have been recovered. The Board has received no information on the

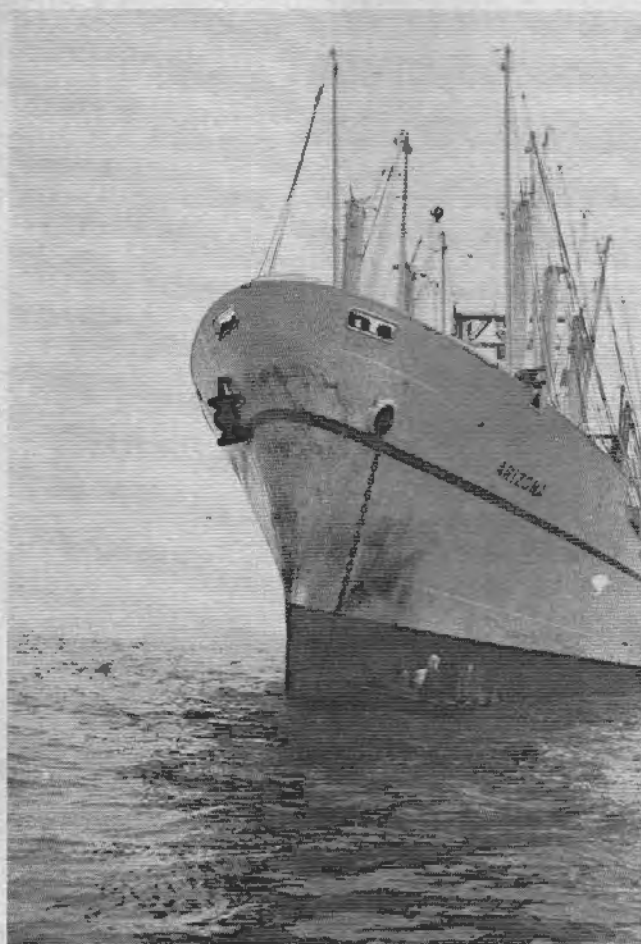
Close-up of the Arizona's bow indicates damage sustained from her contact with the Meiko Maru.

a. The SS *Arizona* and the M/V *Meiko Maru* were in collision at 0209 (-9 ZD) on 2 August 1965, on the high seas in the vicinity of Oshima Island, Japan. The approximate position was lat. 34°43.5'N., long. 139°13.8' E. The indent in the *Meiko Maru* conforms generally to the configuration and damage markings on the bow of the SS *Arizona*. Paint sample comparison, Exhibit 58, indicates intermingling of hull paint from the *Arizona* and *Meiko Maru*. Foreign debris found on the bow of the *Arizona* immediately following collision resembles material from the *Meiko Maru*. Evidence of time and position from both the *Arizona* and *Meiko Maru* place them in collision.

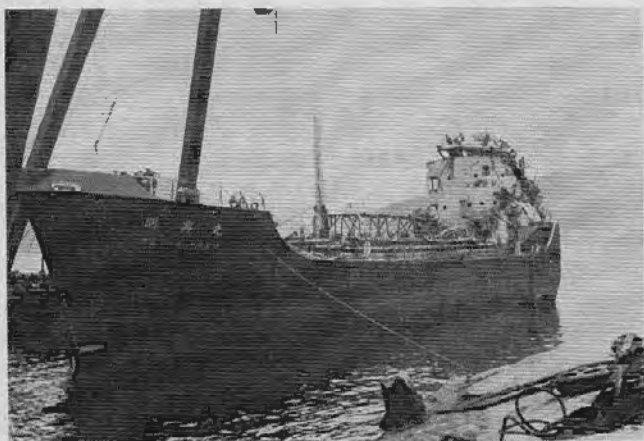
Missing her after section, which was not recovered, the Meiko Maru is refloated.

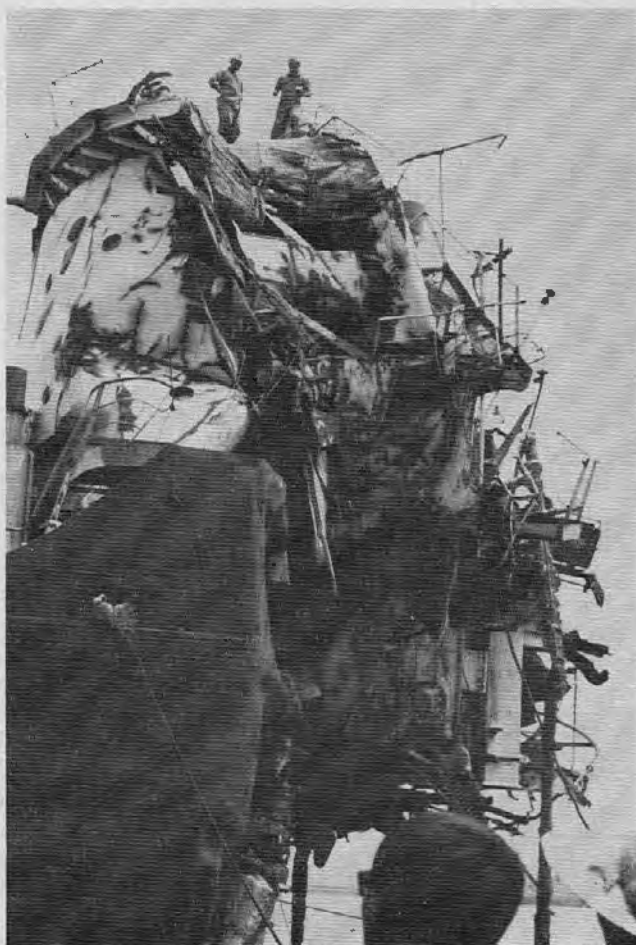
Workmen survey damage to the Meiko Maru at the point where she was sheared in two by the Arizona's bow.
