PROCEEDINGS

OF THE MARINE SAFETY COUNCIL

Collision Under the Golden Gate . . .

COLLISION UNDER THE GOLDEN GATE

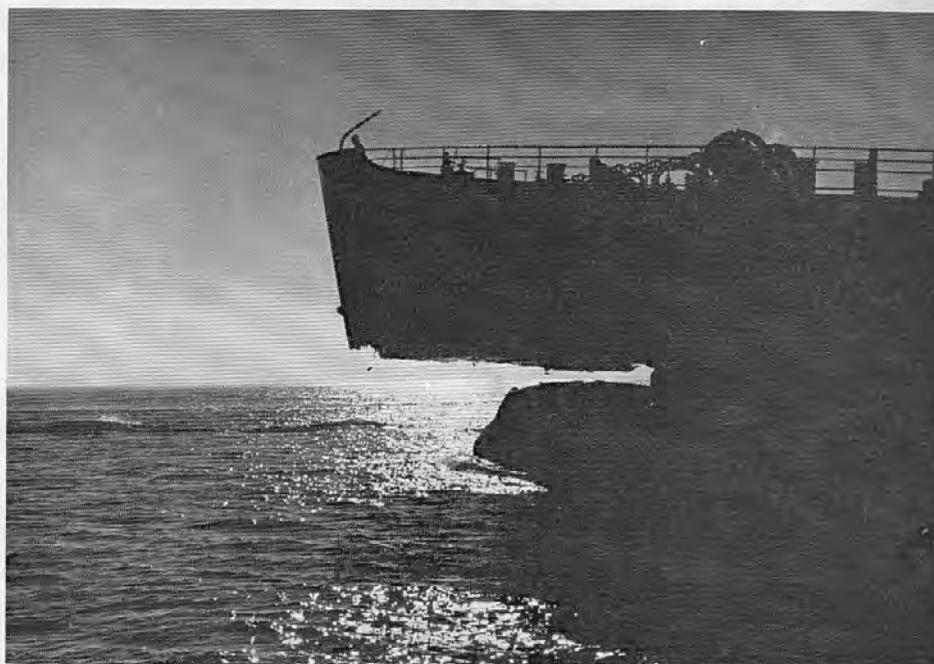
The SS Arizona Standard pictured here sustained severe damage to its lower bow areas forward of the collision bulkhead.

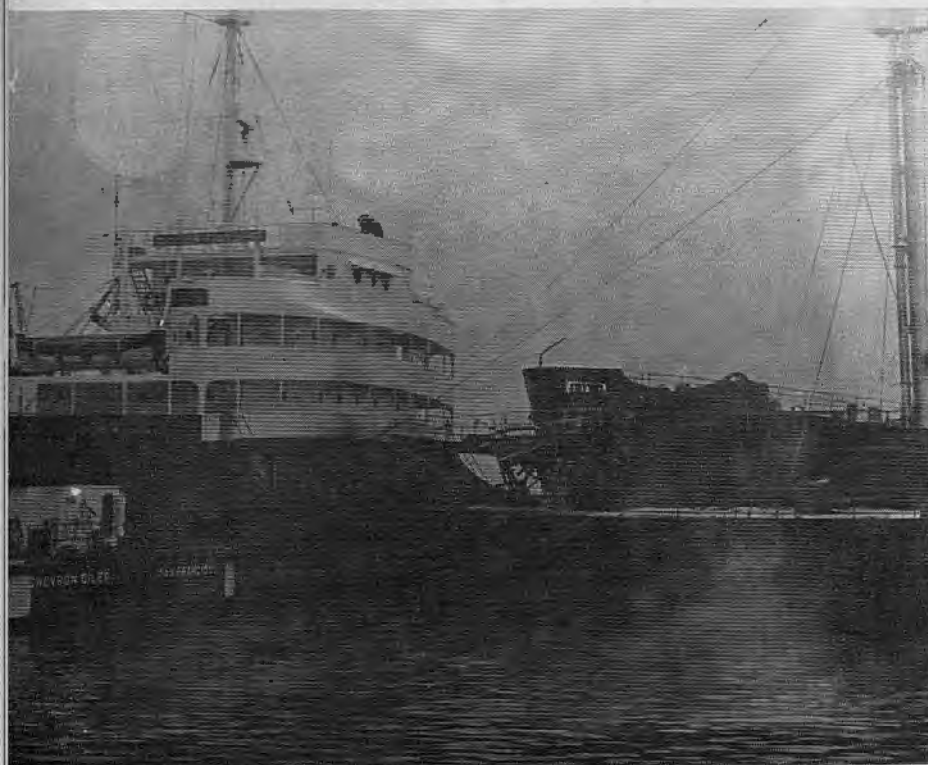
The bow of the SS Arizona Standard penetrated the port bow of the SS Oregon Standard. The vessels remained locked together as pictured above until 7 hours after the collision.

At approximately 0140 the two tank ships collided with a soft grinding crunch. Crewmembers of neither vessel lost their footing, and no one was hurt. The *Arizona Standard's* bow struck and penetrated the *Oregon Standard's* port side, rupturing three of the *Oregon Standard's* cargo tanks. The bunker oil from the tanks poured into the Bay. The *Arizona Standard* sustained severe damage to her lower bow areas forward of the collision bulkhead. The overhang of her bow slid aft on the *Oregon Standard's* deck, shearing ullage trunks and external fittings as it moved aft.

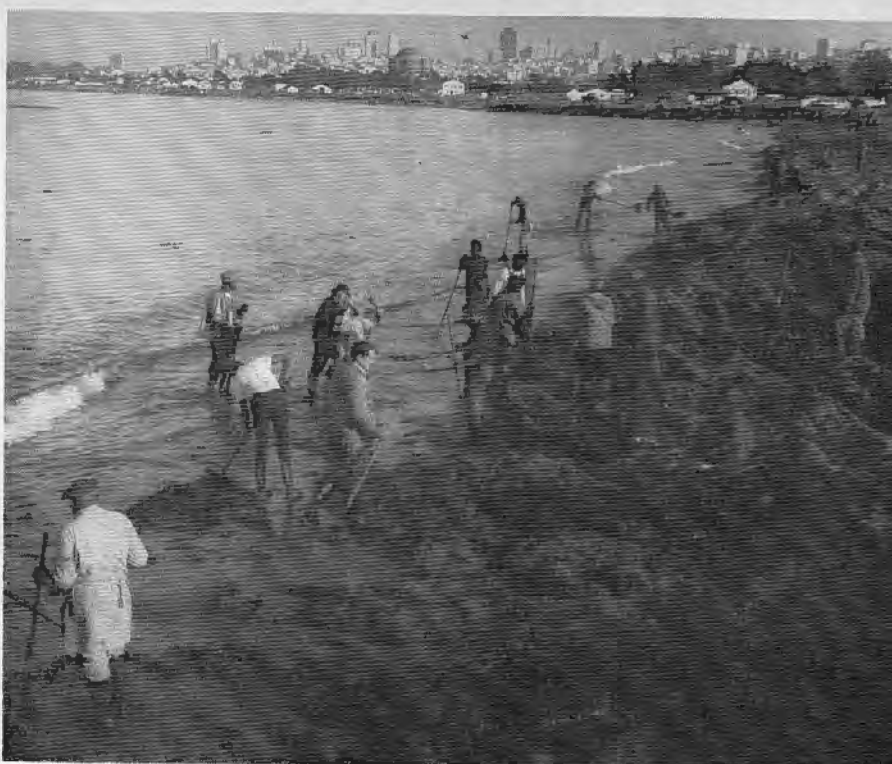
An estimated 20,000 barrels of oil spilled from the *Oregon Standard*. None was lost from the other vessel. The tide carried the oil into portions of the Bay. Later tidal action dispersed the oil and caused contamina-

Extensive cleanup efforts both ashore and in the water were required to minimize the harm from pollution. Scenes such as the above were familiar in many portions of the Bay and along adjacent coastal areas. The total damage to the environment as a result of the collision may never be determined.

tion of adjacent coastal areas. Extensive cleanup operations took place, but pollution damage was severe. Hundreds of waterfowl died, as efforts to save them were able to succeed for only about 3.5 percent of the birds coated with oil. Damage to marine life has not been determined.

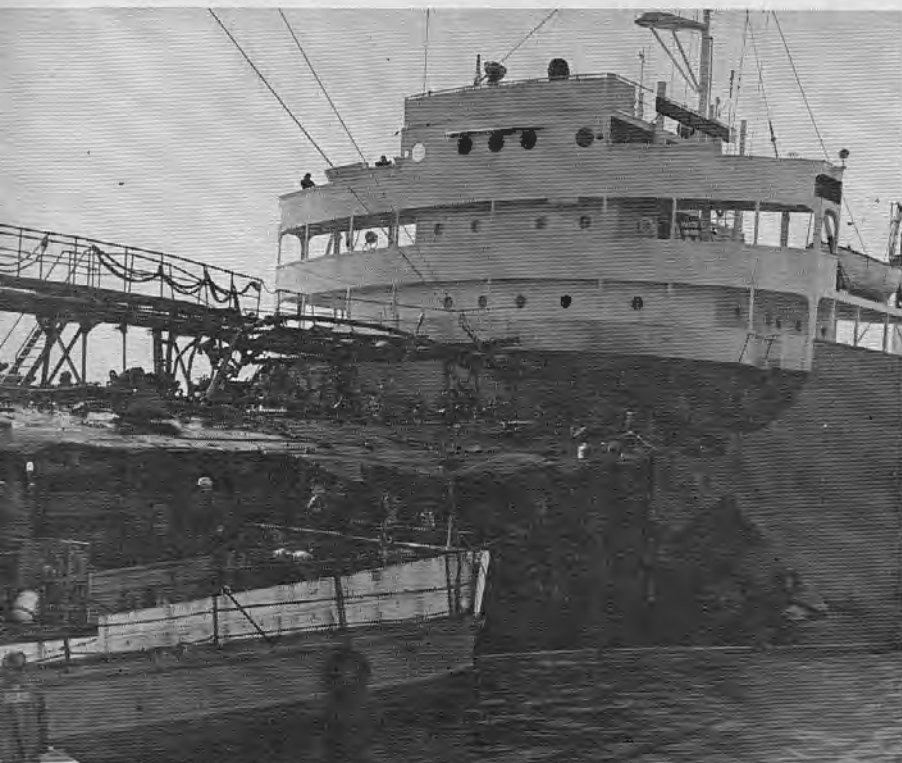
When the vessels were separated, the damage to the Oregon Standard looked like this. Ullage trunks and external fittings on the deck area were sheared when the overhang of the Arizona Standard's bow slid aft on the Oregon Standard. Heavy bunker oil from the three ruptured cargo tanks spilled into the San Francisco Bay, causing extensive pollution damage.

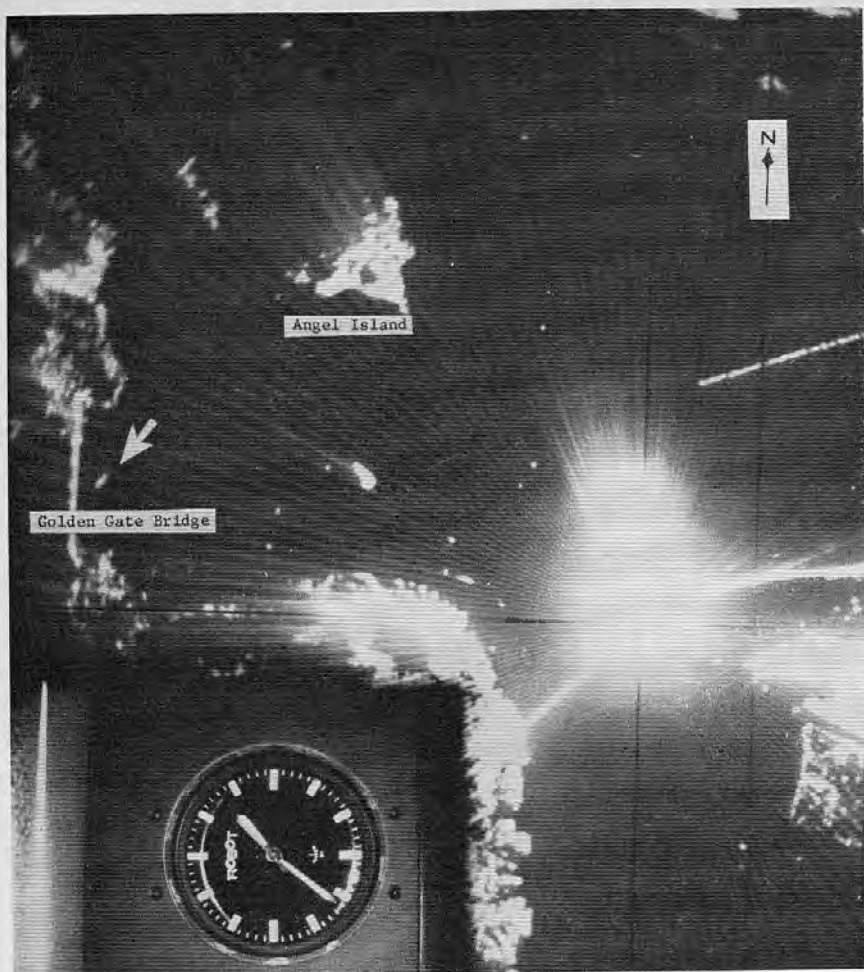
ILLUSTRATION 2

The 0136:08 photograph of the HART radarscope shows the blip of the SS Oregon Standard (indicated by arrow). This illustration indicates that Lime Point, at the north end of the bridge, was abaft the beam of the vessel before the vessel changed course to starboard to pass under the span.

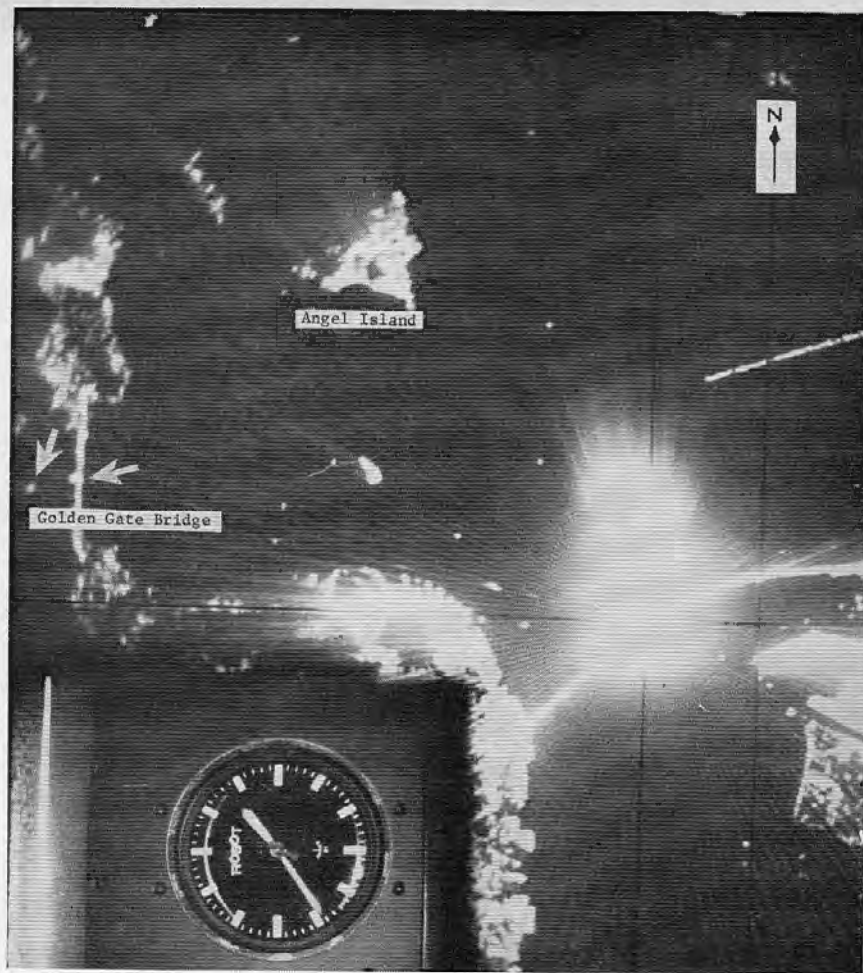
ILLUSTRATION 3

The 0139:02 photograph of the HAR radarscope shows both the Oregon Standard and the Arizona Standard (arrows). It indicates the Oregon Standard just passing under the bridge, a little south of the center of the channel. The Arizona Standard is approximately 900 yards west southwest of the center of the bridge.

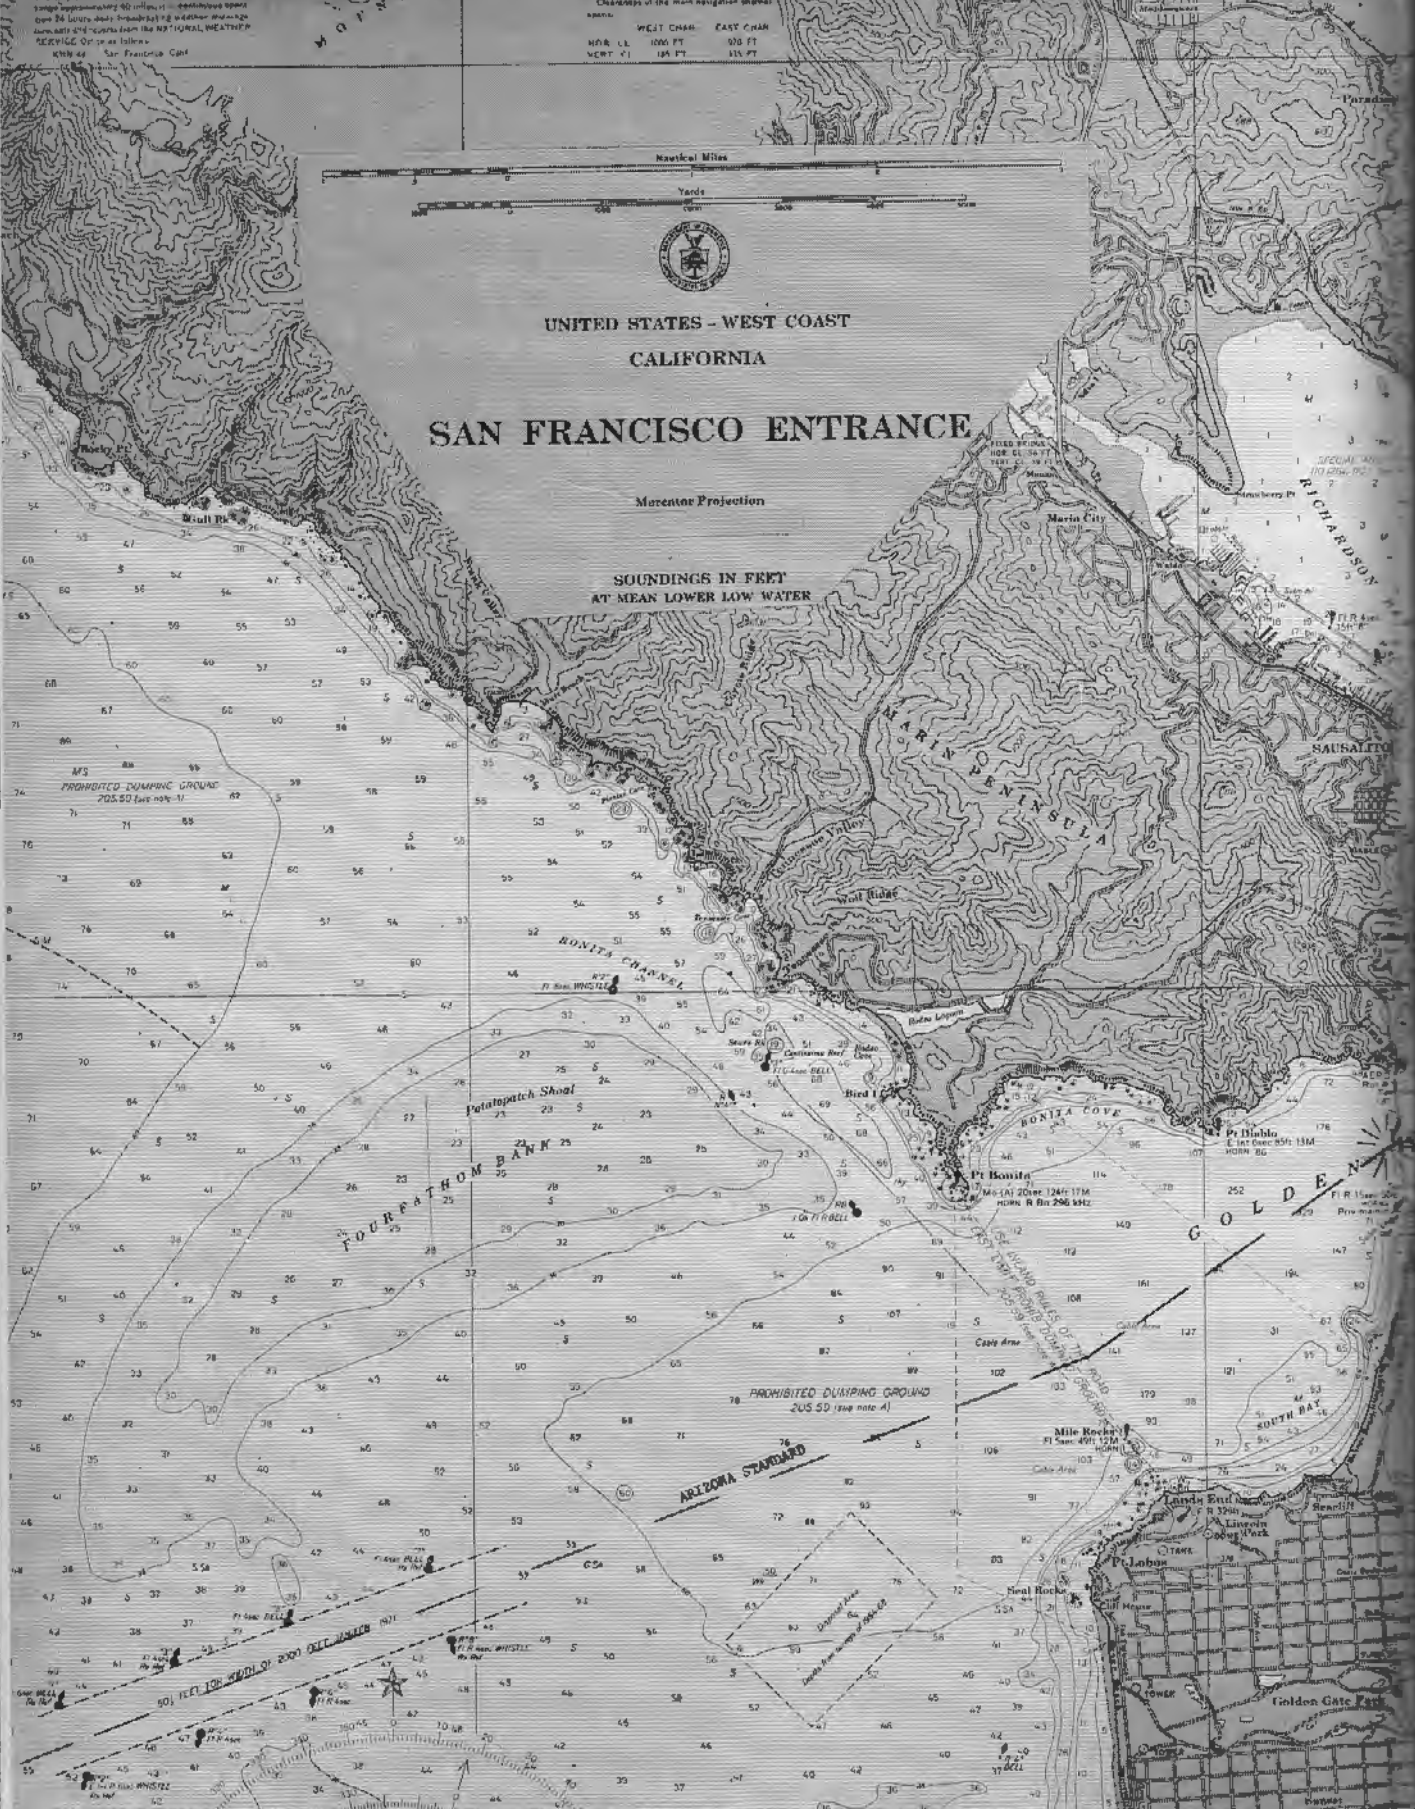
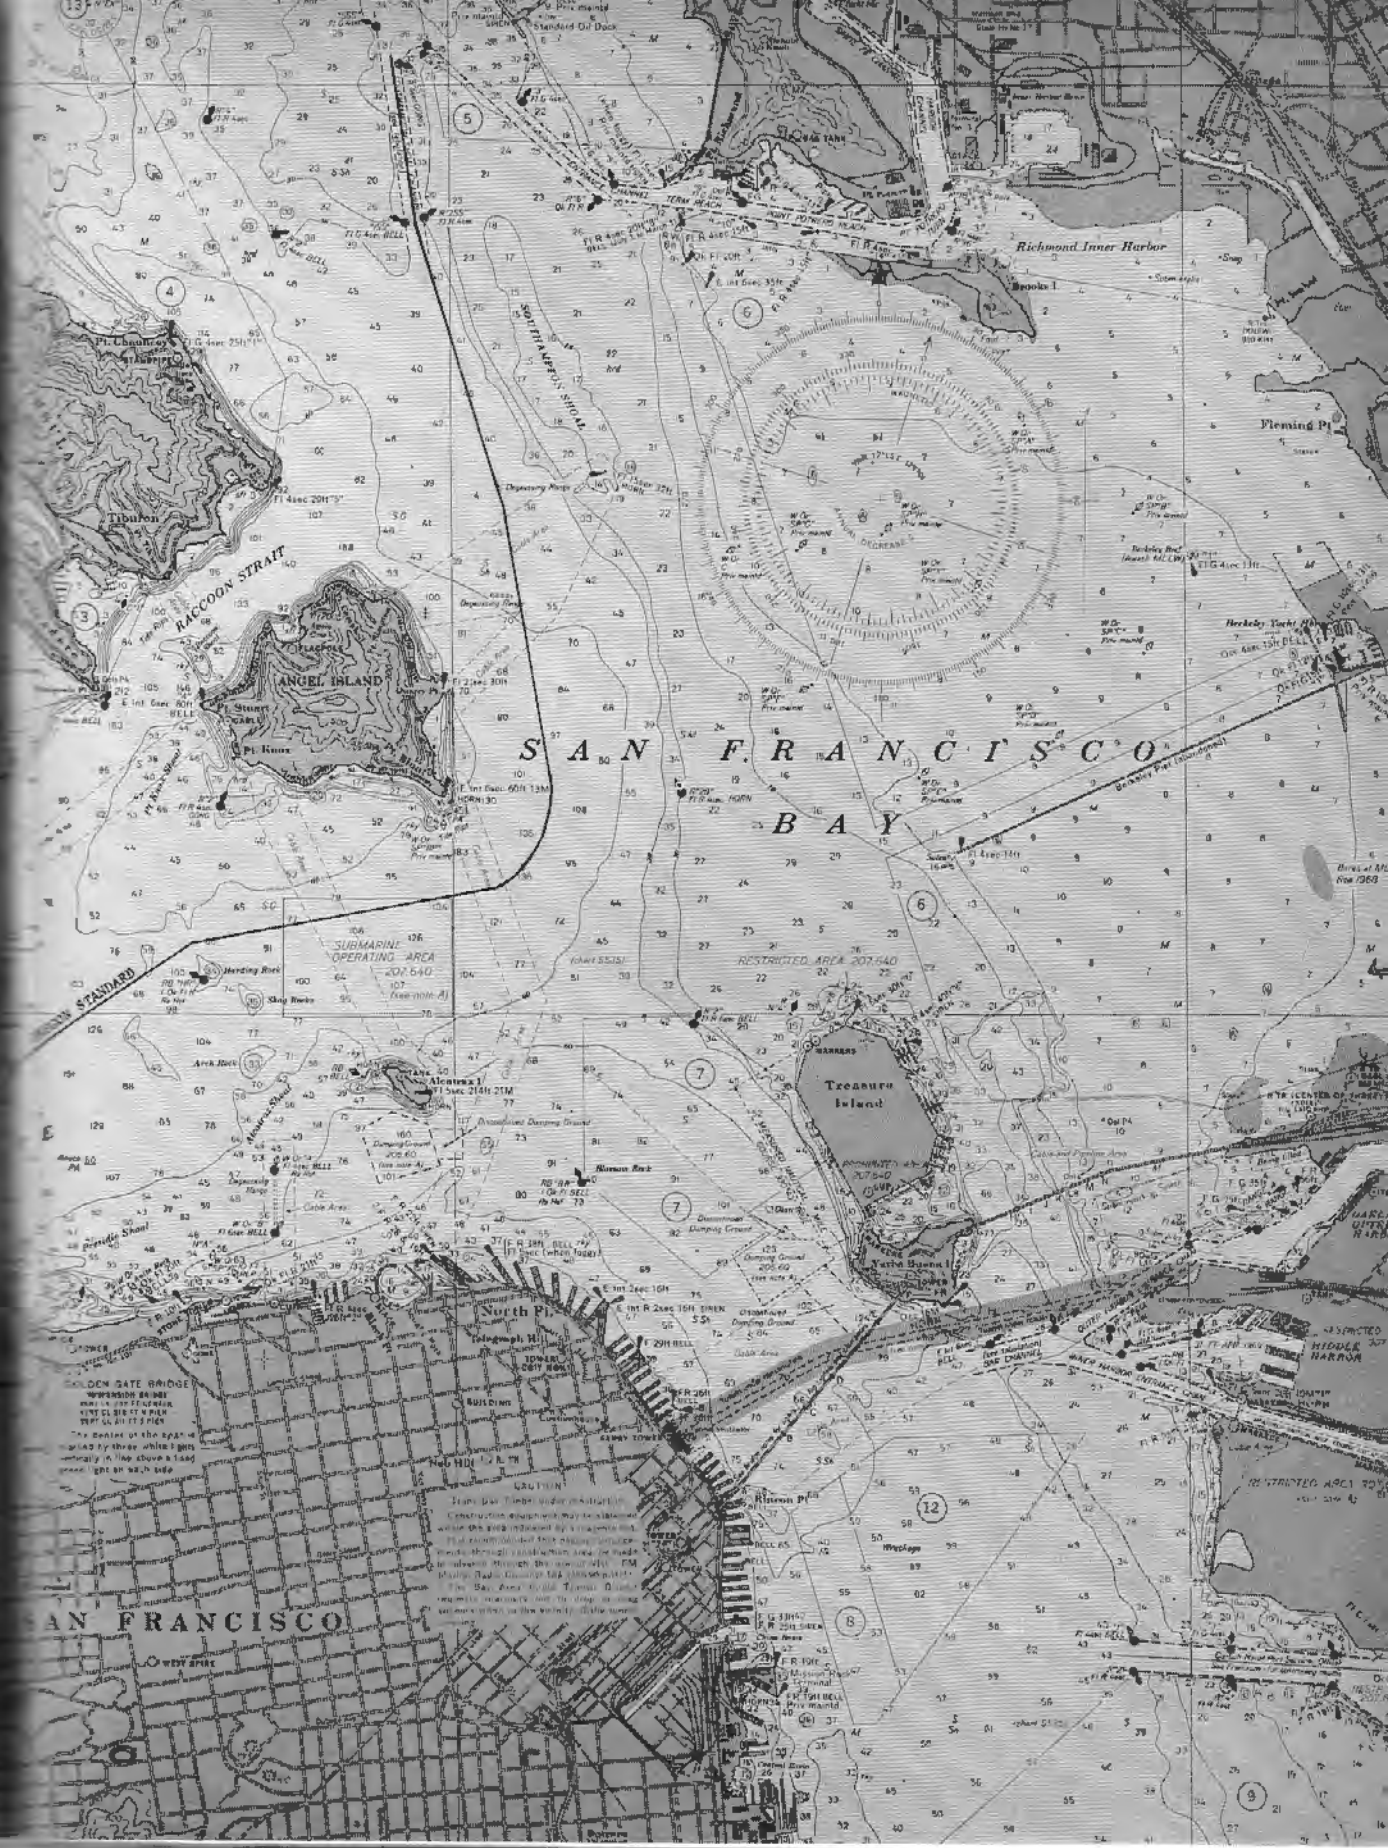
ILLUSTRATION 1

On the following pages is a chart of the San Francisco Bay entrance, the scene of the collision of the SS Oregon Standard and the SS Arizona Standard. The approximate tracklines of the vessels are drawn in, and the approximate point of impact is shown. It must be emphasized that the tracklines and the point of collision are estimated and are not intended to show exact positions.

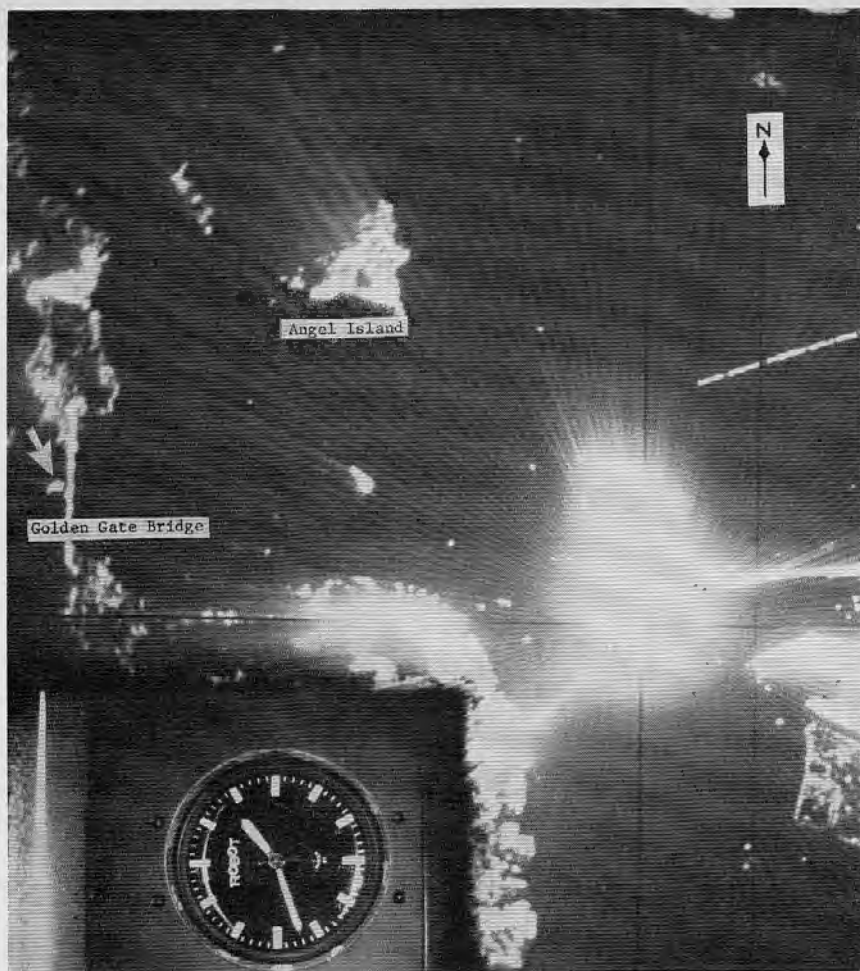
ILLUSTRATION 4

Two major violations of the rules of the road by each vessel contributed to the collision. Obviously, neither master was anxious, under the prevailing conditions, to pilot his ship close to the bridge abutments. Perhaps they tended to overcompensate toward the center of the channel under the bridge. Illustrations 2, 3, and 4 are photographs of the HAR radarscope taken at 3-minute intervals near the time of the casualty. Their evidence shows that the collision occurred in approximately mid-channel, 300 to 450 yards to the seaward side of the Golden Gate Bridge (illustration 4). Each vessel failed to

The 0141:58 photograph of the HAR radarscope shows the two radar pips representing the Arizona Standard and Oregon Standard merged in a position approximately 150 yards west southwest of the center of the bridge (arrow).
