Explosion and Fire on Offshore Platform . . .

EXPLOSION AND FIRE ON OFFSHORE PLATFORM

At 1605 on that day, explosions and fire ripped the Chambers and Kennedy Offshore Oil Platform about 12 miles south of Galveston, Tex. The fire resulted in the deaths of five workmen on the platform and four men on board the M/V *Carryback* which was moored below the platform. In addition, six platform workmen were injured, the platform and the vessel were severely damaged and Galveston beaches were moderately polluted by oil.

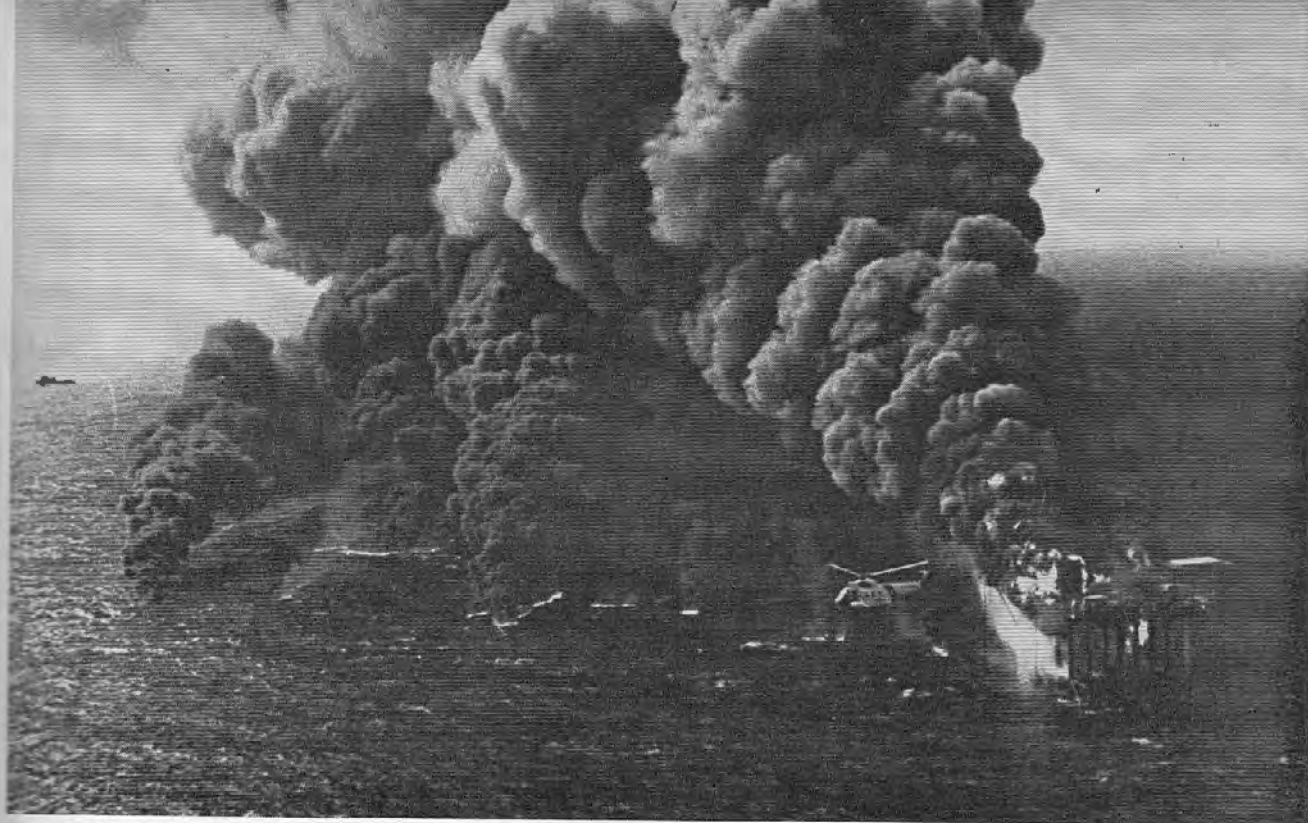
The fire rages on the platform and patches of oil burn on the Gulf of Mexico water as a Coast Guard helicopter searches for survivors. At the far left, the burning M/V Carryback drifts downwind toward Galveston, Tex.

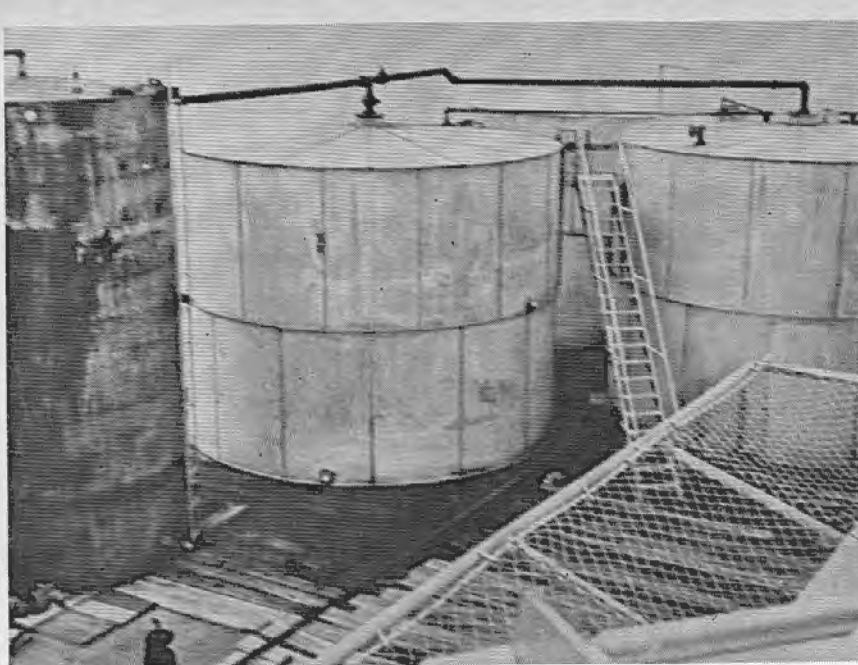
Pictured above is the Chambers and Kennedy Offshore Oil Platform before the casualty. At the far left is the "gunbarrel"; center is Number 1 storage tank; right is number 5 storage tank. A welder struck an arc on the equalizing line above the ladder to the tank tops, setting off the explosions and fire.

1. The casualty was caused by the ignition of explosive vapors due to welding on an equalizing line between crude oil storage tanks on the platform. Contributory causes were failure to gas free or inert the tanks before the work began, and improper supervision in allowing welding operations on a line leading to gaseous tanks.

2. That operations such as welding and flame cutting on platforms be prohibited in hazardous locations adjacent to tanks or lines containing explosive vapors and in other locations where there is danger of ignition of explosive gases.

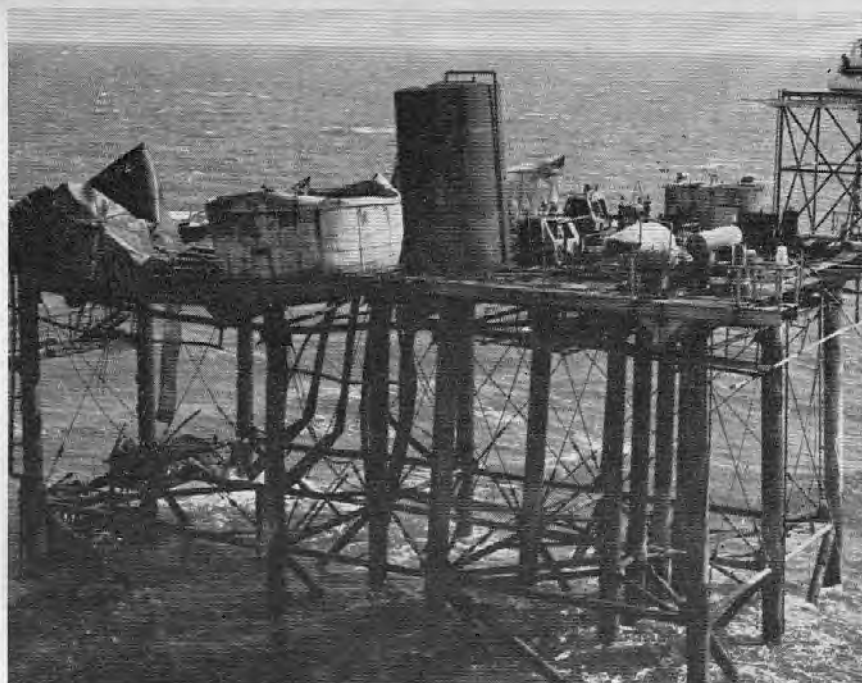
The Chambers and Kennedy platform was extensively damaged by the explosion and fire on 28 May 1970. Damage to the structure was estimated at \$200,000.

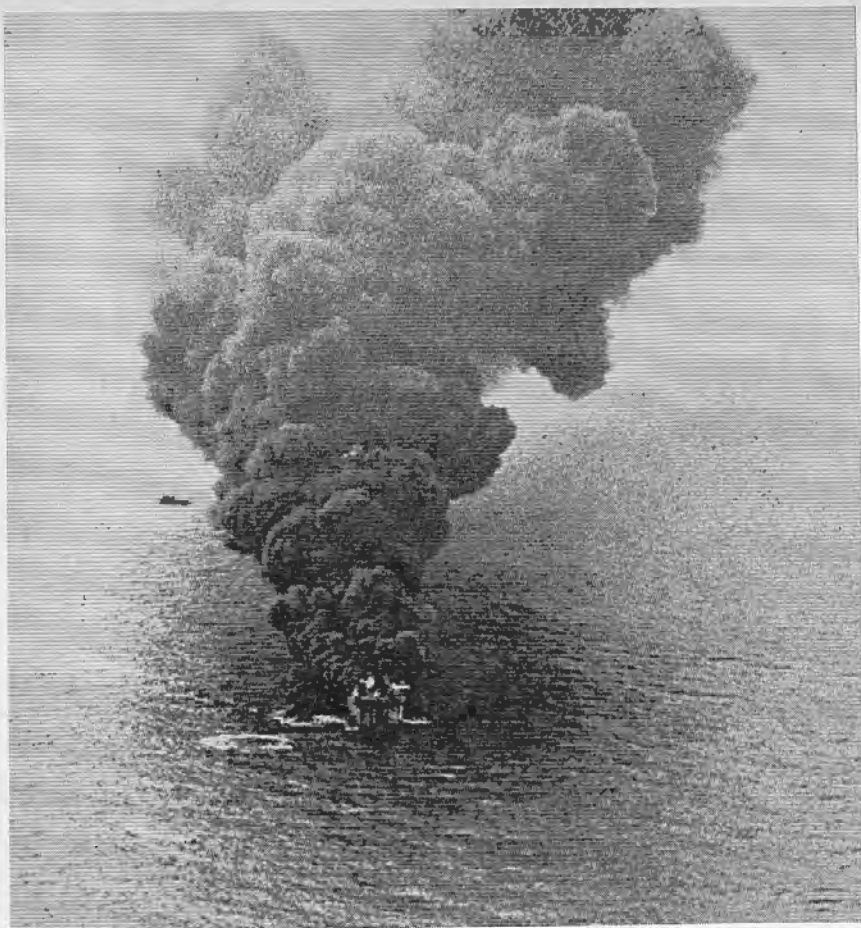
A view from a Coast Guard aircraft looking north shows the billowing smoke from the burning crude oil stowed on the platform vessel thought to be the M/V Carryback drifts away.

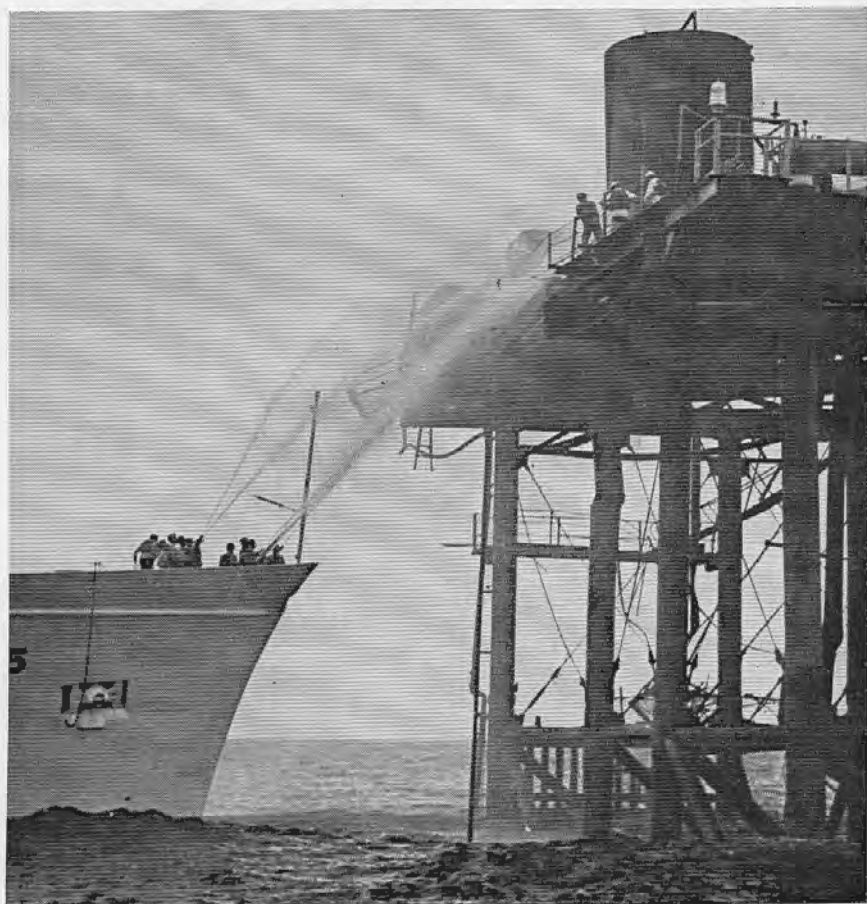
Crewmembers of a Coast Guard Cutter pour water on the still hot platform on the day after the explosions as firefighting personnel look on.

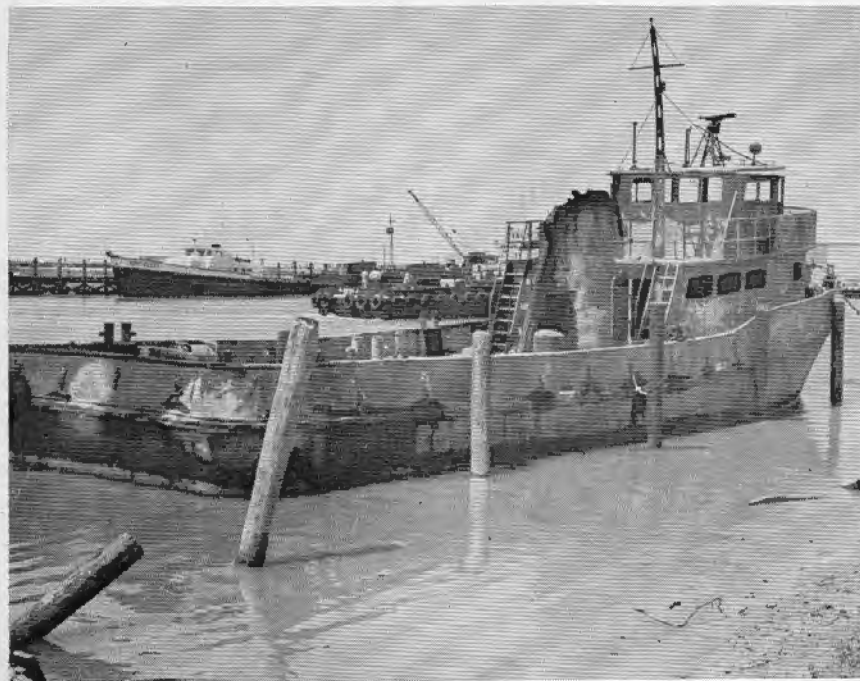
The M/V Carryback is shown gutted and scorched moored at Galveston, Tex. where she was towed after the casualty.
