# Fire and Explosion on Tank Barge *MOS 106* . . .

- Fire and Explosion on Tank Barge *MOS 106* at La Grange, Mo.,  
on Mississippi River, on May 12, 1969 . . . . . 84

# FIRE AND EXPLOSIONS ON LA GRANGE, MISSOURI ON MAY

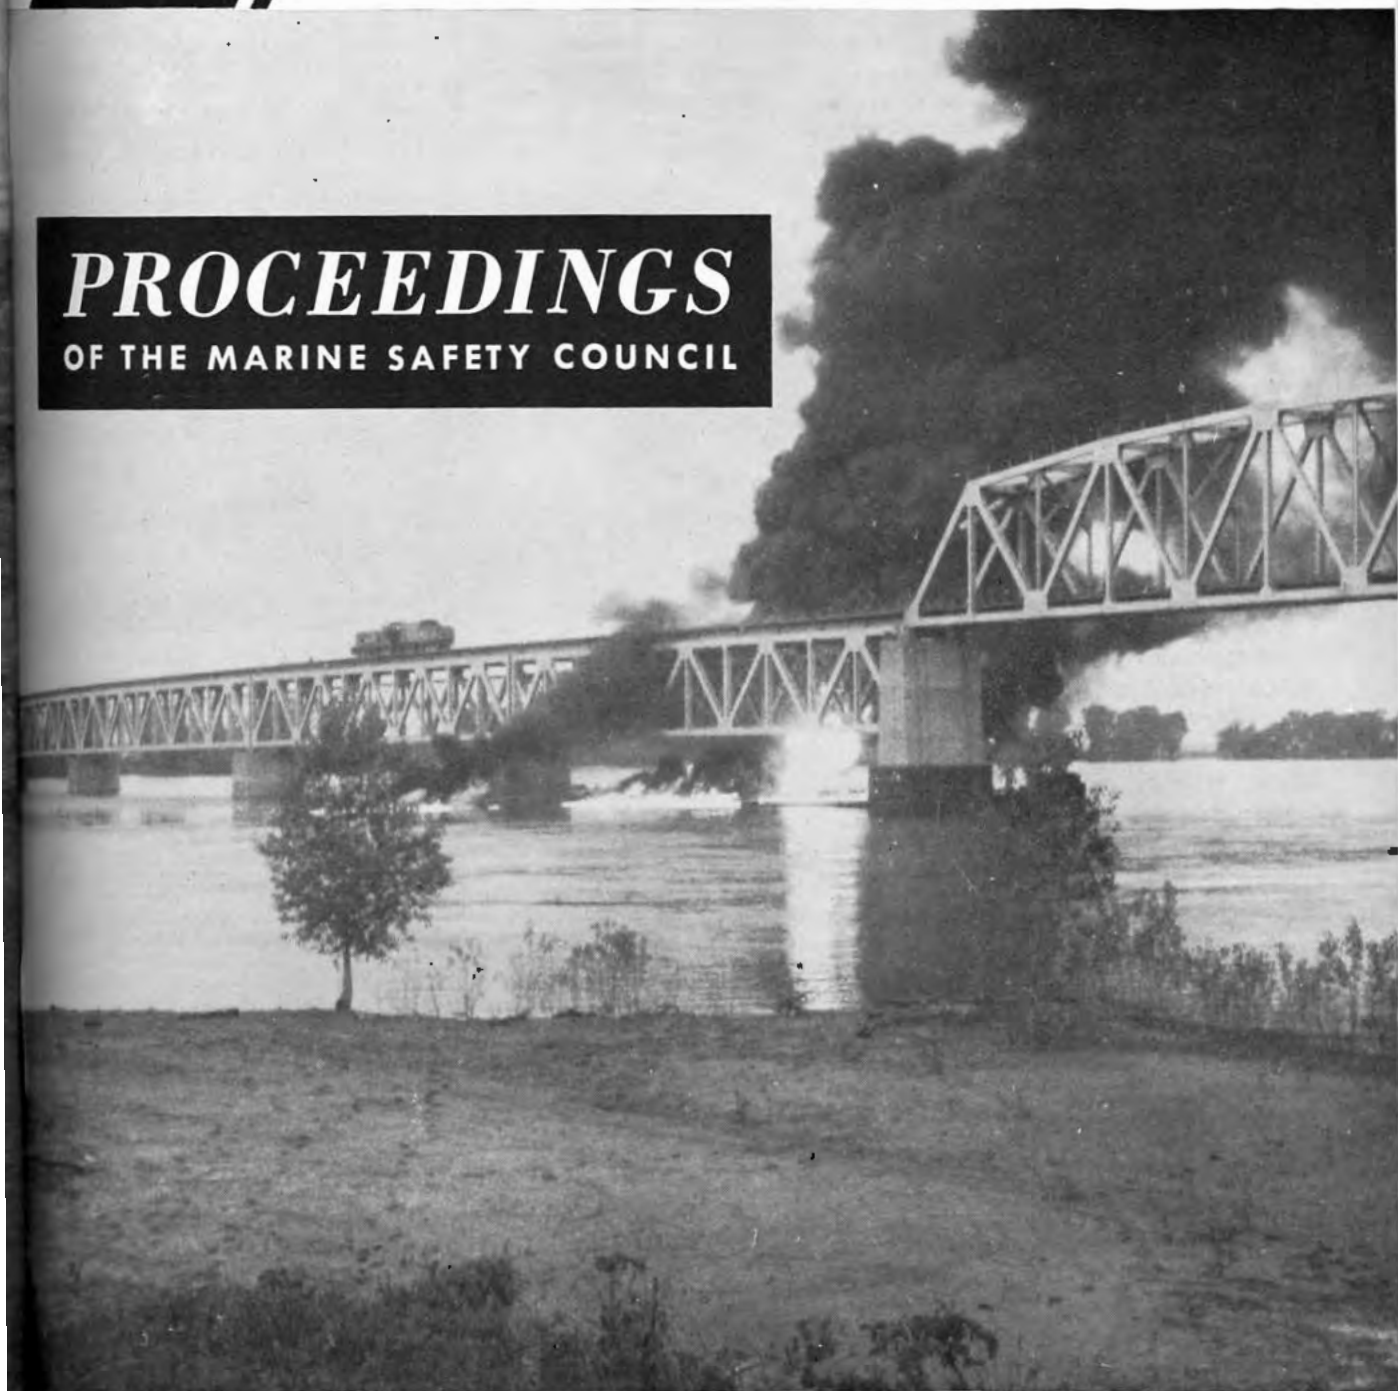
**FRONT COVER:** The Tank Barge *MOS 106*, burning intensely, lodged against the upstream side of the Chicago, Burlington & Quincy Railroad bridge span at Mile 328. Fortunately for the Quincy, Ill., waterfront just downstream, the barge did not become dislodged from the railroad bridge piers.

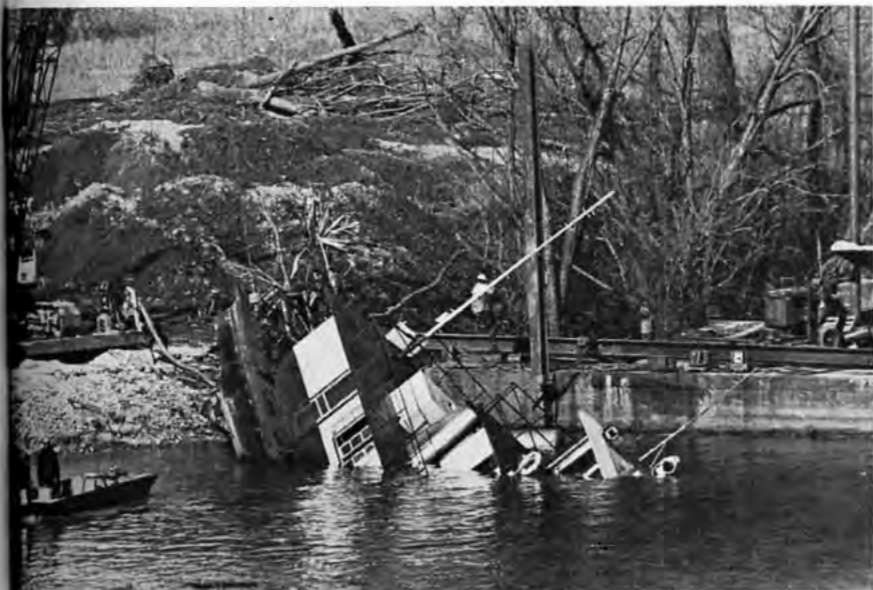
### CHANGING PROPELLERS THE HARD WAY

*The pilot of this towboat was forced to leap into the chilly waters of the Wolf River near Memphis, Tenn., when a cable, supporting the vessel while propellers were changed, suddenly parted. No one was injured and the craft was refloated the same day.*

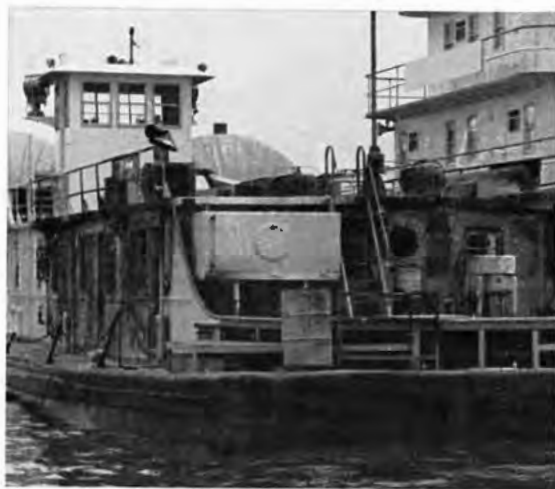
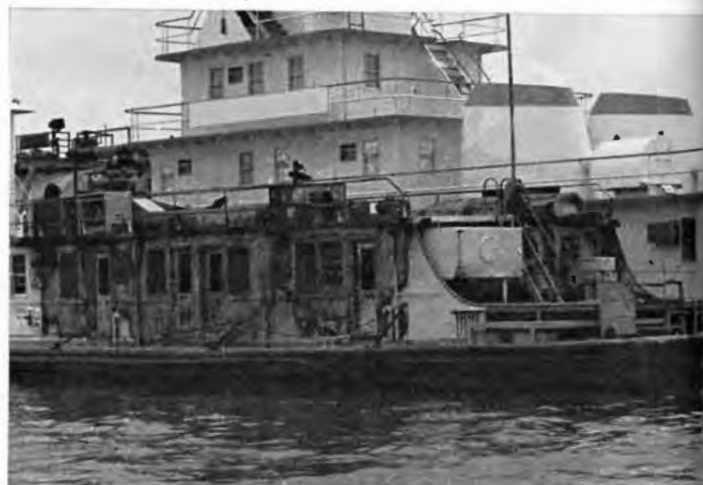
These two views of the M/V Martin show the burned-out galley (at the stern) and adjoining spaces.

16. During the afternoon of 13 May 1969, the *M/V Martin* was removed from the wing dike and brought to Quincy, Ill. The complete interior of the crews' quarters and galley were burned out by the fire. The *M/V Martin* was later towed downstream to Greenville, Miss. The *MOS 104* was removed from the wing dike at Mile 330 on the morning of 14 May 1969, and taken to Alexandria, Mo., to be offloaded. None of the cargo on this barge was burned or lost.

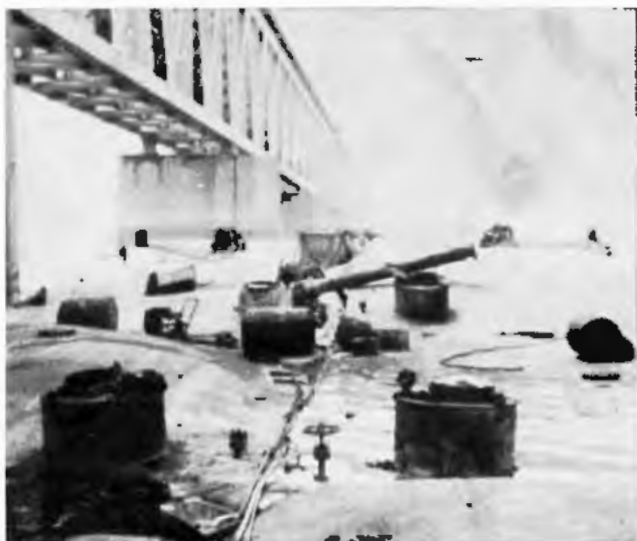
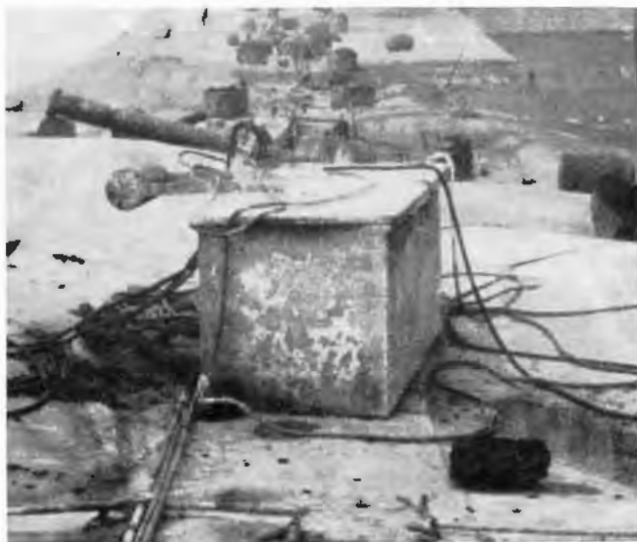
The extreme buckling which resulted on the tank barge *MOS 106* can be seen in these two photographs which were taken from essentially the same position looking in opposite directions. The Chicago, Burlington & Quincy Railroad bridge is visible in the upper picture.

Damage to the *MOS 106* was concentrated in the forward tanks, No. 1 starboard, No. 2 port, and No. 2 starboard. These tanks were bulged and ruptured on deck, and on the sides. No substantive damage resulted in the after portion of this barge. The drums over No. 3 tanks exploded. The *MOS 104* was not damaged appreciably, the galley and living spaces on the *Martin* were gutted by fire, and the north end of the dock barge sank. After the fire threatened the shore facilities, an unidentified person severed the wire securing the rake end of the *MOS 104* to a deadman on shore. The nylon lines connecting the

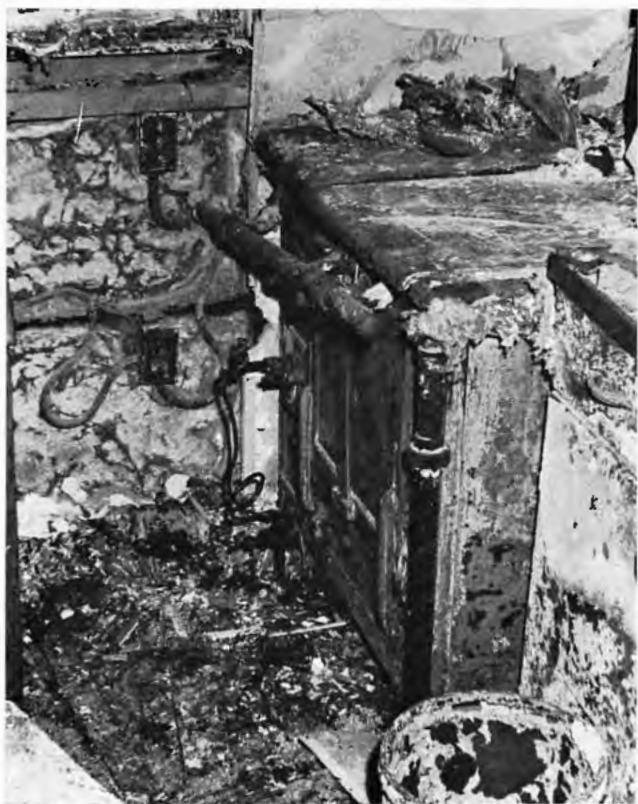
This interior view taken 2 days after the incident, shows the scorched remains of the oil-fired galley range on the *M/V Martin*.

most probable source of vapor ignition was the open-flame galley range which was in operation on board the *M/V Martin* at the time of the casualty. While there are a number of potential sources of vapor ignition under the circumstances prevailing in this case (for which precautions must always be taken) the only direct evidence of such a source at the time of the explosion was the fire in the galley range. The most probable cause of the explosive vapors was a gasoline spill on one of the barges. While there was no direct evidence as to the source of such a spill (due to the unfortunate death of all experienced witnesses who would have been in a position to know) it was possibly caused by an overflow of gasoline from the open hatch of No. 3 port tank, the area where the first explosion occurred. There was evidence of the presence of gasoline in that area, along with the water that was being used to wash down the decks and undamaged threads on the dogs for the missing hatch cover of No. 3 tank, indicate that the cover was not securely closed at the time of the explosion. It is likely that No. 3 port was almost completely full following the transfer of cargo from the damaged tanks into the forward tanks at Cape Girardeau, Mo. on 9 May 1969. It follows that gasoline may have overflowed from that tank due to a change in trim as No. 1 and No. 2 cargo tanks were discharged.

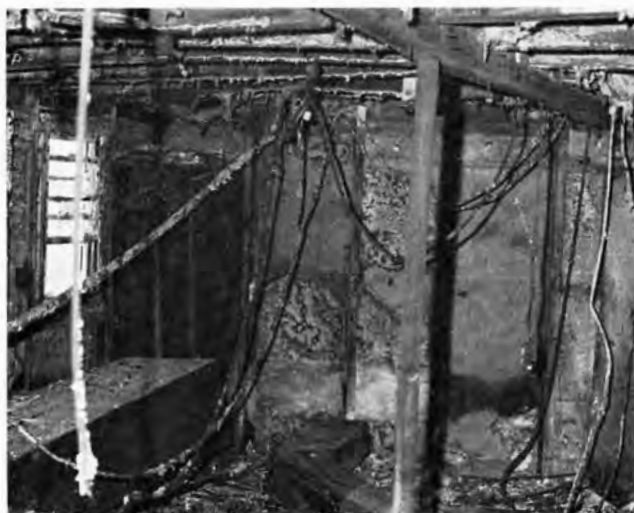
Another photograph of the M/V *Martin* taken a few days after the fire shows extensive damage to the interior of the towboat.

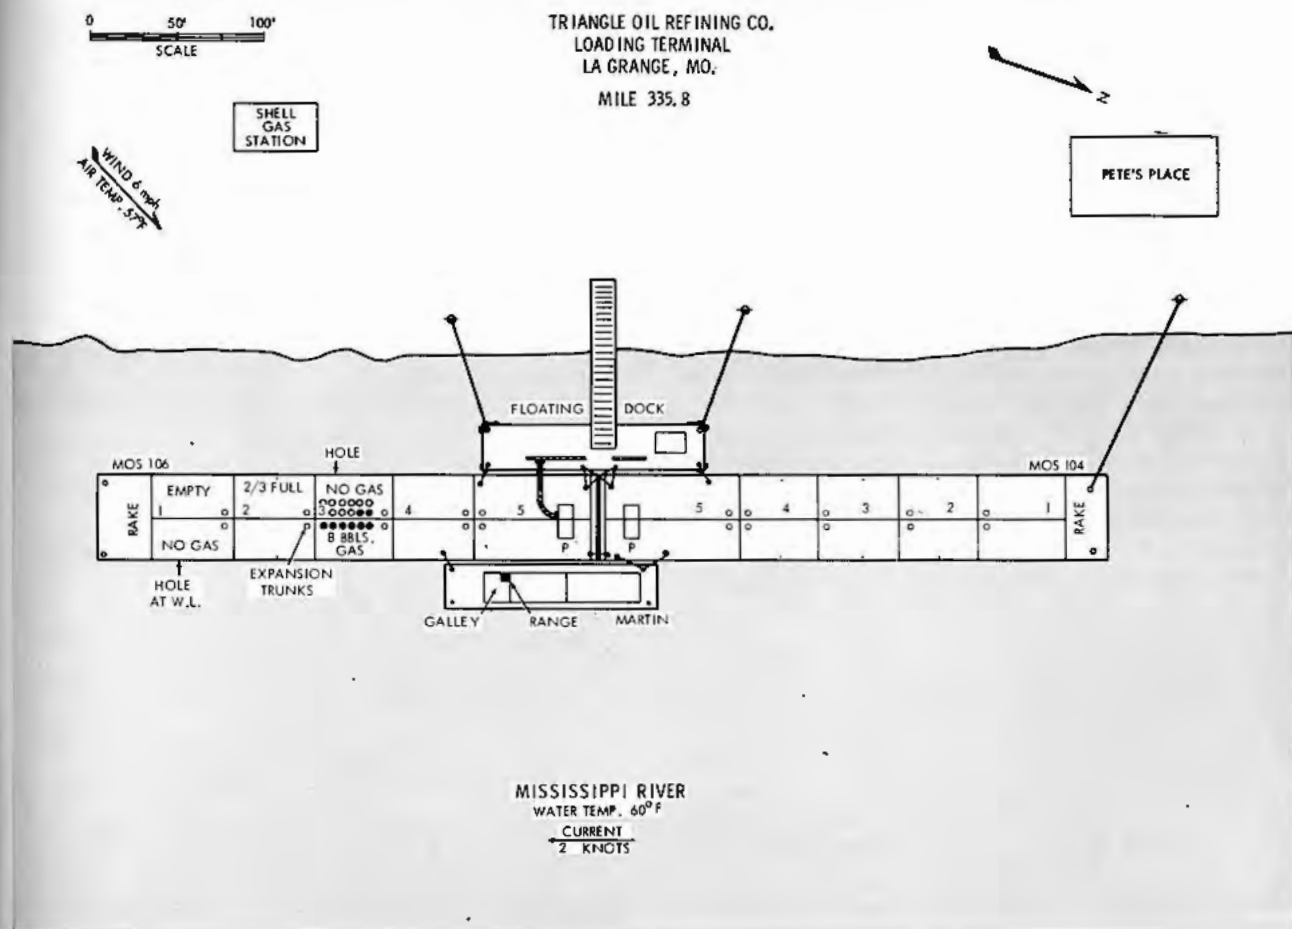
**Figure 1**

A Coast Guard inspector issued the *MOS 106* a permit to proceed to La Grange, Mo., to discharge her cargo prior to effecting permanent repairs. No leakage of gasoline was noted en route to her destination, which included transit of several locks. The tow arrived at the Triangle Oil Refining Co. terminal at La Grange, on May 12th. The *MOS 106* and *MOS 104* were moored, stern to stern, alongside the terminal floating dock, with the *Martin* moored outboard of the barges, heading upriver. The oil-fired galley range on the tug was operating, and the galley door and windows were opened. Figure 1. shows the arrangement of the tow at the oil terminal.
