PROCEEDINGS

OF THE MARINE SAFETY COUNCIL

CG-129

CHRONICLE OF DISASTER

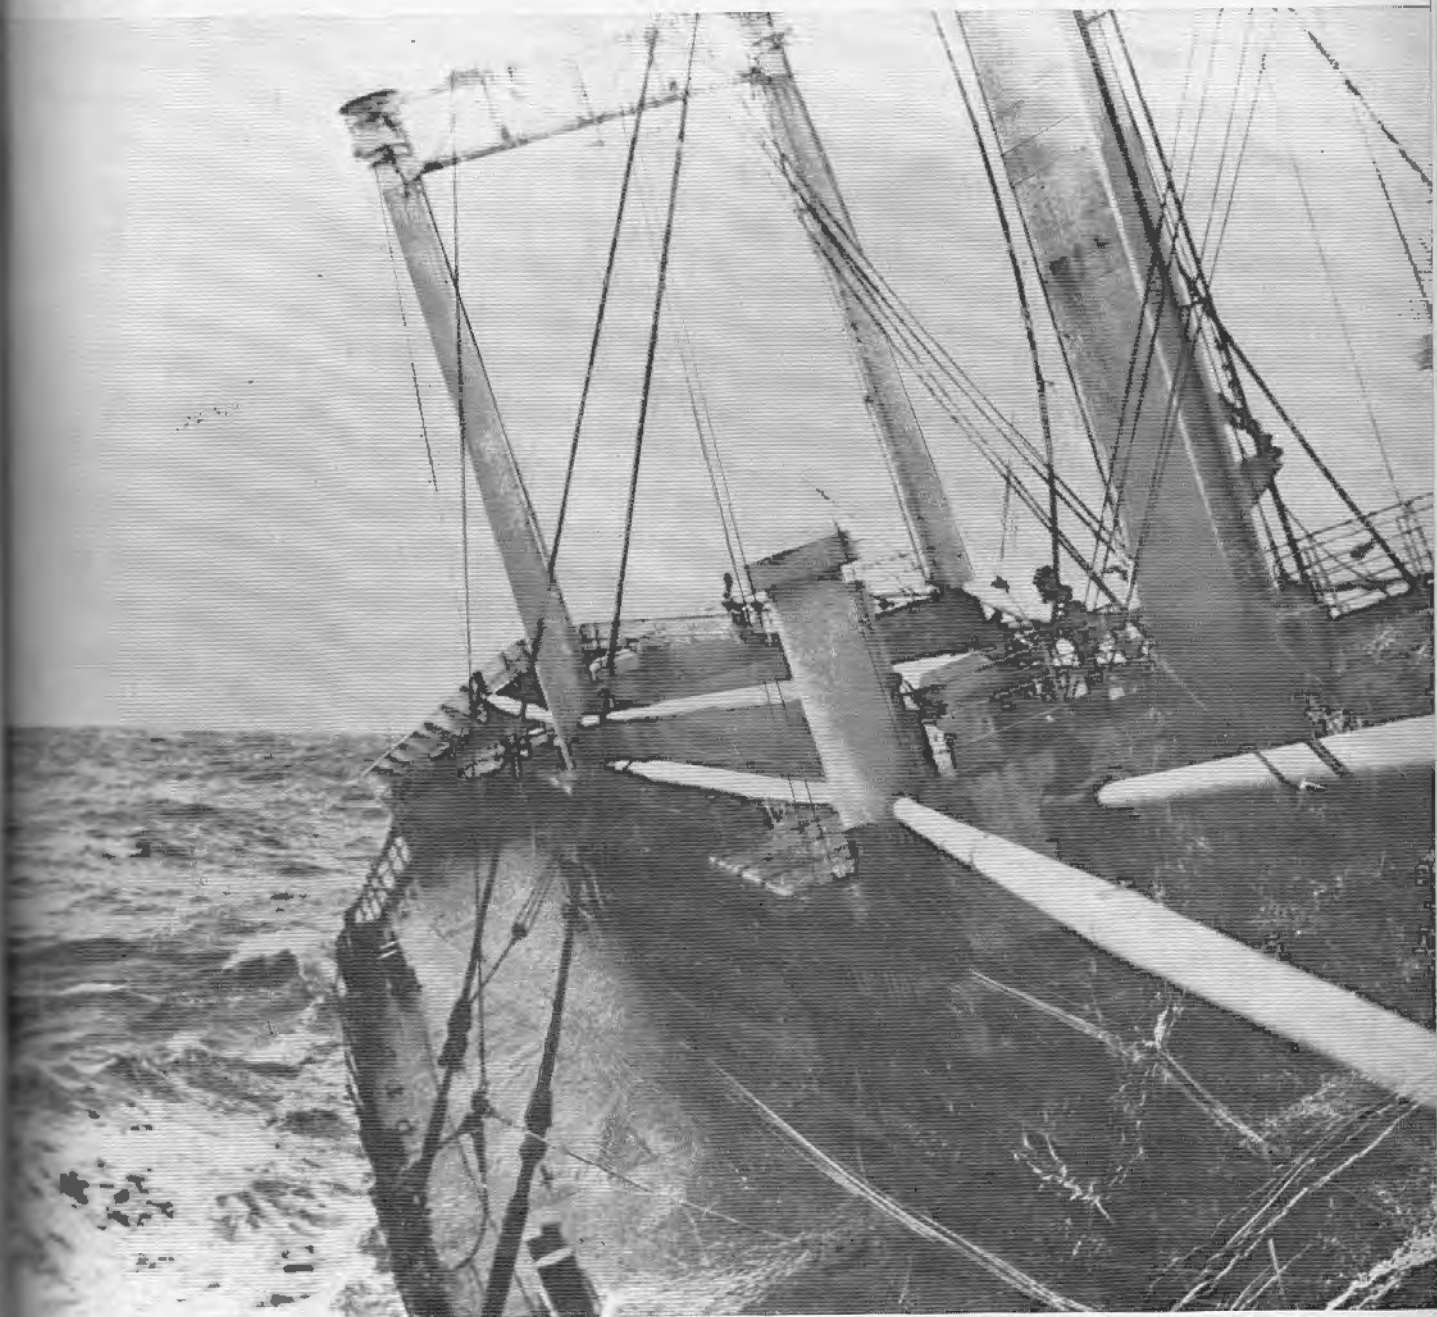
FRONT COVER: A crewmember of the SS *Badger State* stood on the port side of that vessel and took this photograph of the ship's bow area as she took a roll to nearly 35° on Christmas Day in 1969. The very next day, the photographer and the rest of the personnel aboard the *Badger State* were forced to abandon ship. See the dramatic story of the *Badger State* in this month's feature.

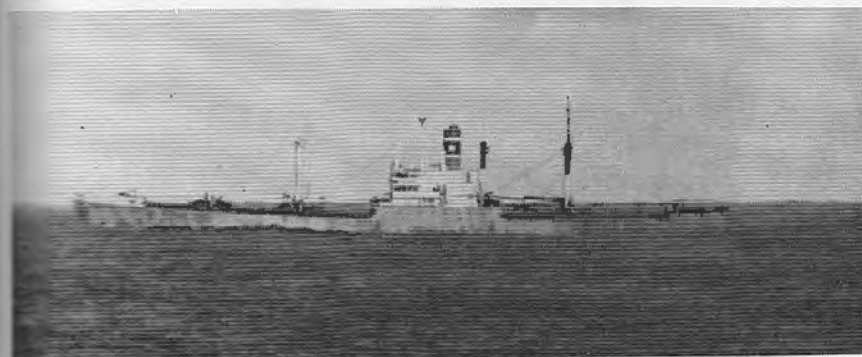
The SS Badger State, abandoned and derelict, drifts aimlessly in the North Pacific on 31 December 1969. The blackened portion of her hull on the starboard quarter is a hole caused by a low order detonation of a 2,000-pound bomb in the No. 5 upper 'tween deck.

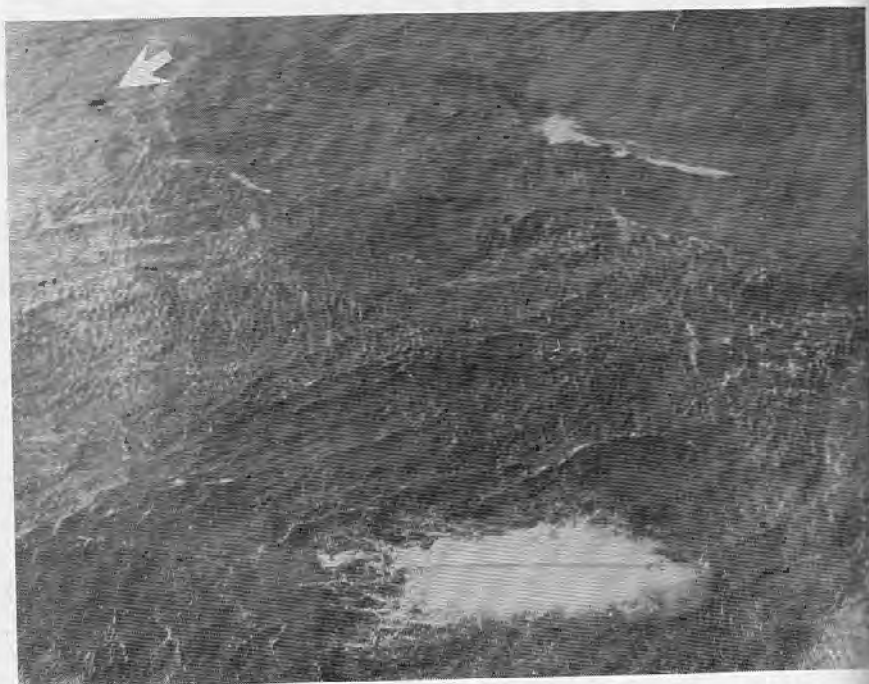
The starboard lifeboat of the *Badger State* capsized when a 2,000-pound bomb fell onto it from a gaping hole in the ship's side. The arrow points to one of the 40 personnel from the *Badger State* who abandoned ship. Even capsized, the boat aided rescuers in finding survivors in the icy water.

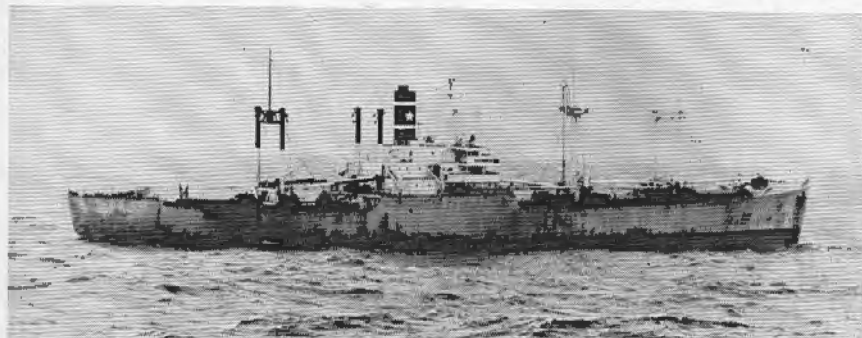
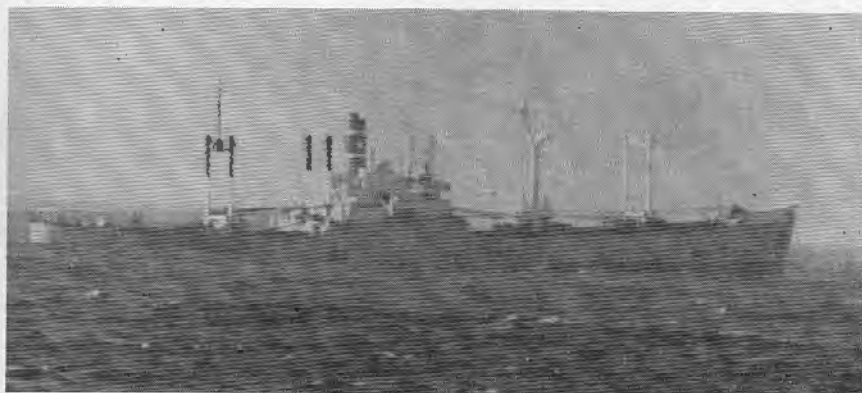
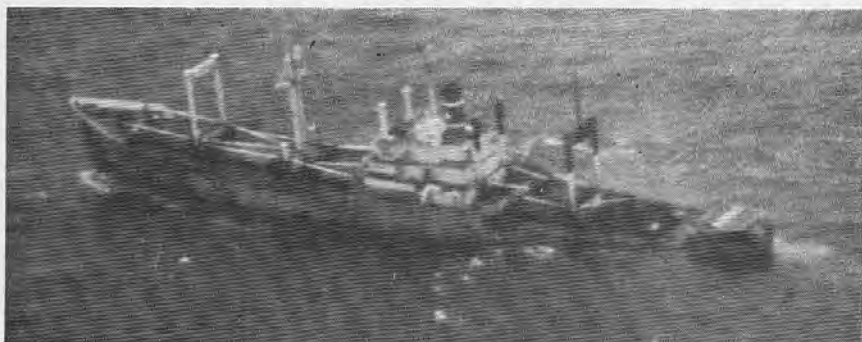
The above series of photographs shows the *Badger State* on (from top to bottom) December 27 and 31, 1969 and on January 5, 1970. Once the vessel was abandoned, she drifted with water washing into her through the hole in her starboard side (upper photograph). Boarding the derelict for salvage purposes would have presented an unwarranted hazard to personnel. On January 5, 1970, she sank by the stern.

possibly additional damage to the forward bulkhead of number five hold. This would allow progressive flooding as water entered number five hold through the holed starboard side and possibly through the underwater shell plating damaged by the explosion or fire, causing the abandoned derelict to eventually sink.

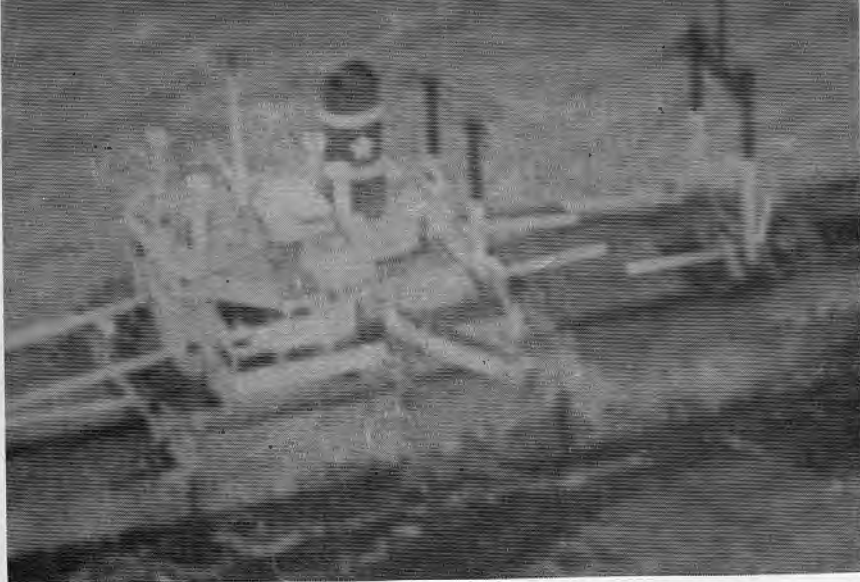
During a 52° roll to port a mountainous wave swept the deck on the port side of the Badger State, washing away a turnbuckle securing the port lifeboat. The after arm of the gravity davit rolled down the track to the extended position and the after falls payed out, leaving the lifeboat in the position pictured above. Heavy weather prevented resecuring the lifeboat.

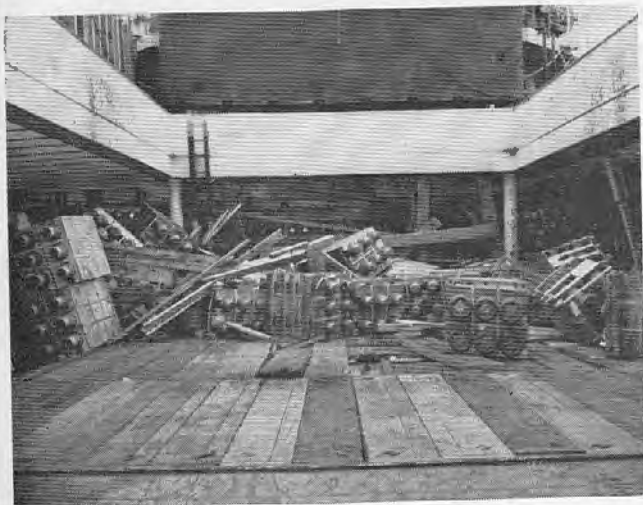
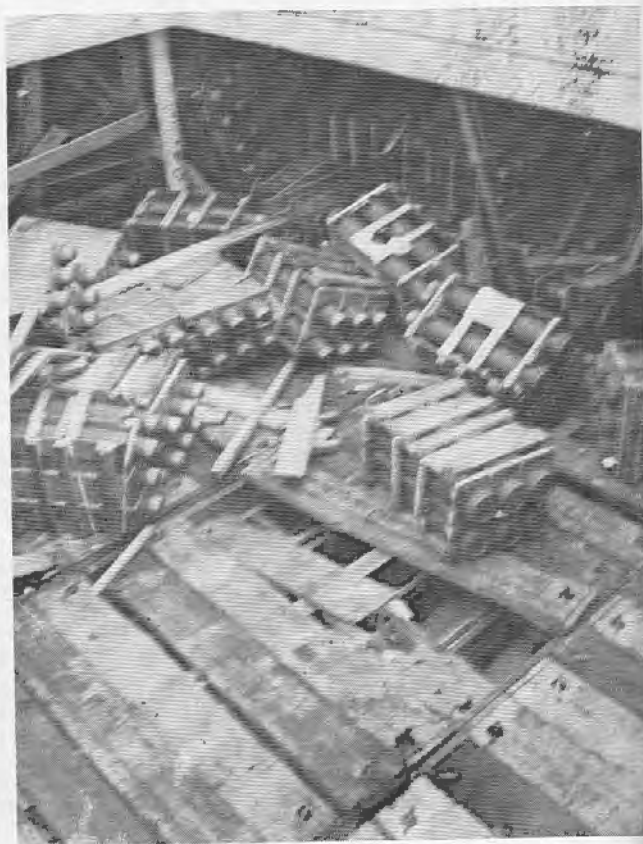
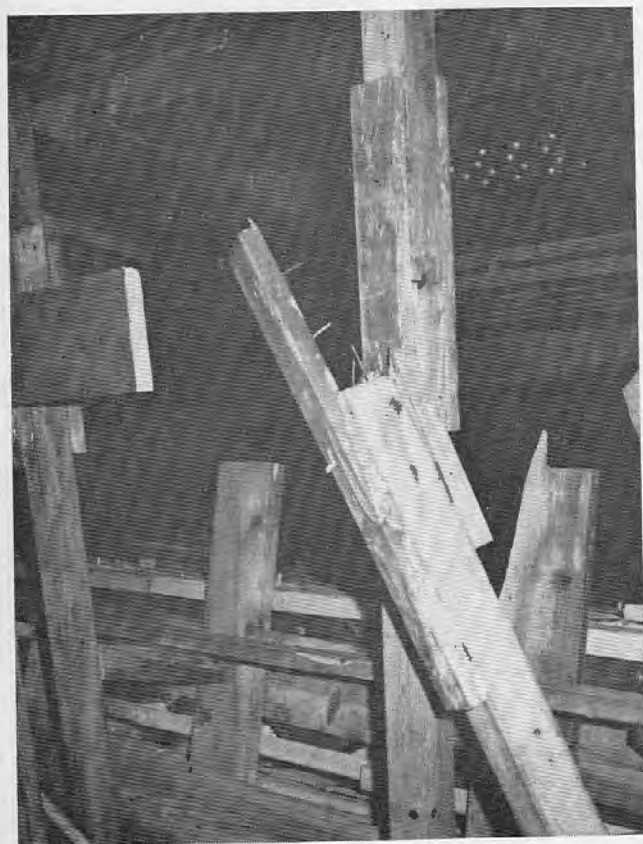
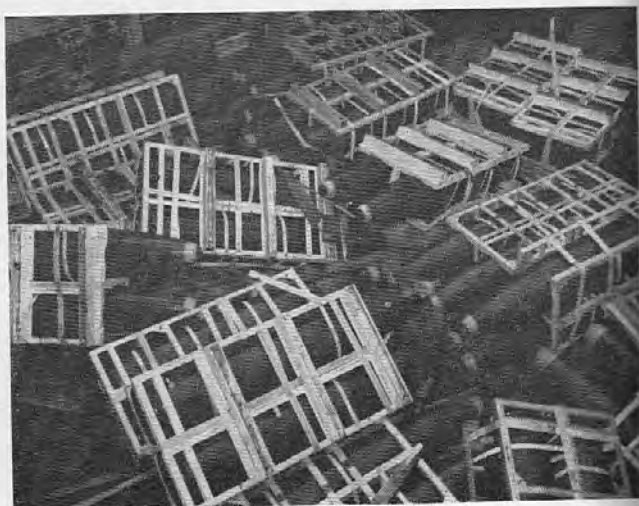
Pictured below are the results of a sea voyage with improperly stowed ammunition. These photos were taken in the holds of a ship—not the *Badger State*—which survived the improper stowage. Perhaps this is the sort of sight which greeted the crewmembers aboard the *Badger State* day after day. The hazards of improper cargo stowage need not be emphasized further. The message? Be safe; stow it properly!
