# ***PROCEEDINGS***

OF THE MARINE SAFETY COUNCIL

May 1972

# Gas Fire and Explosion Fatal to Four . . .

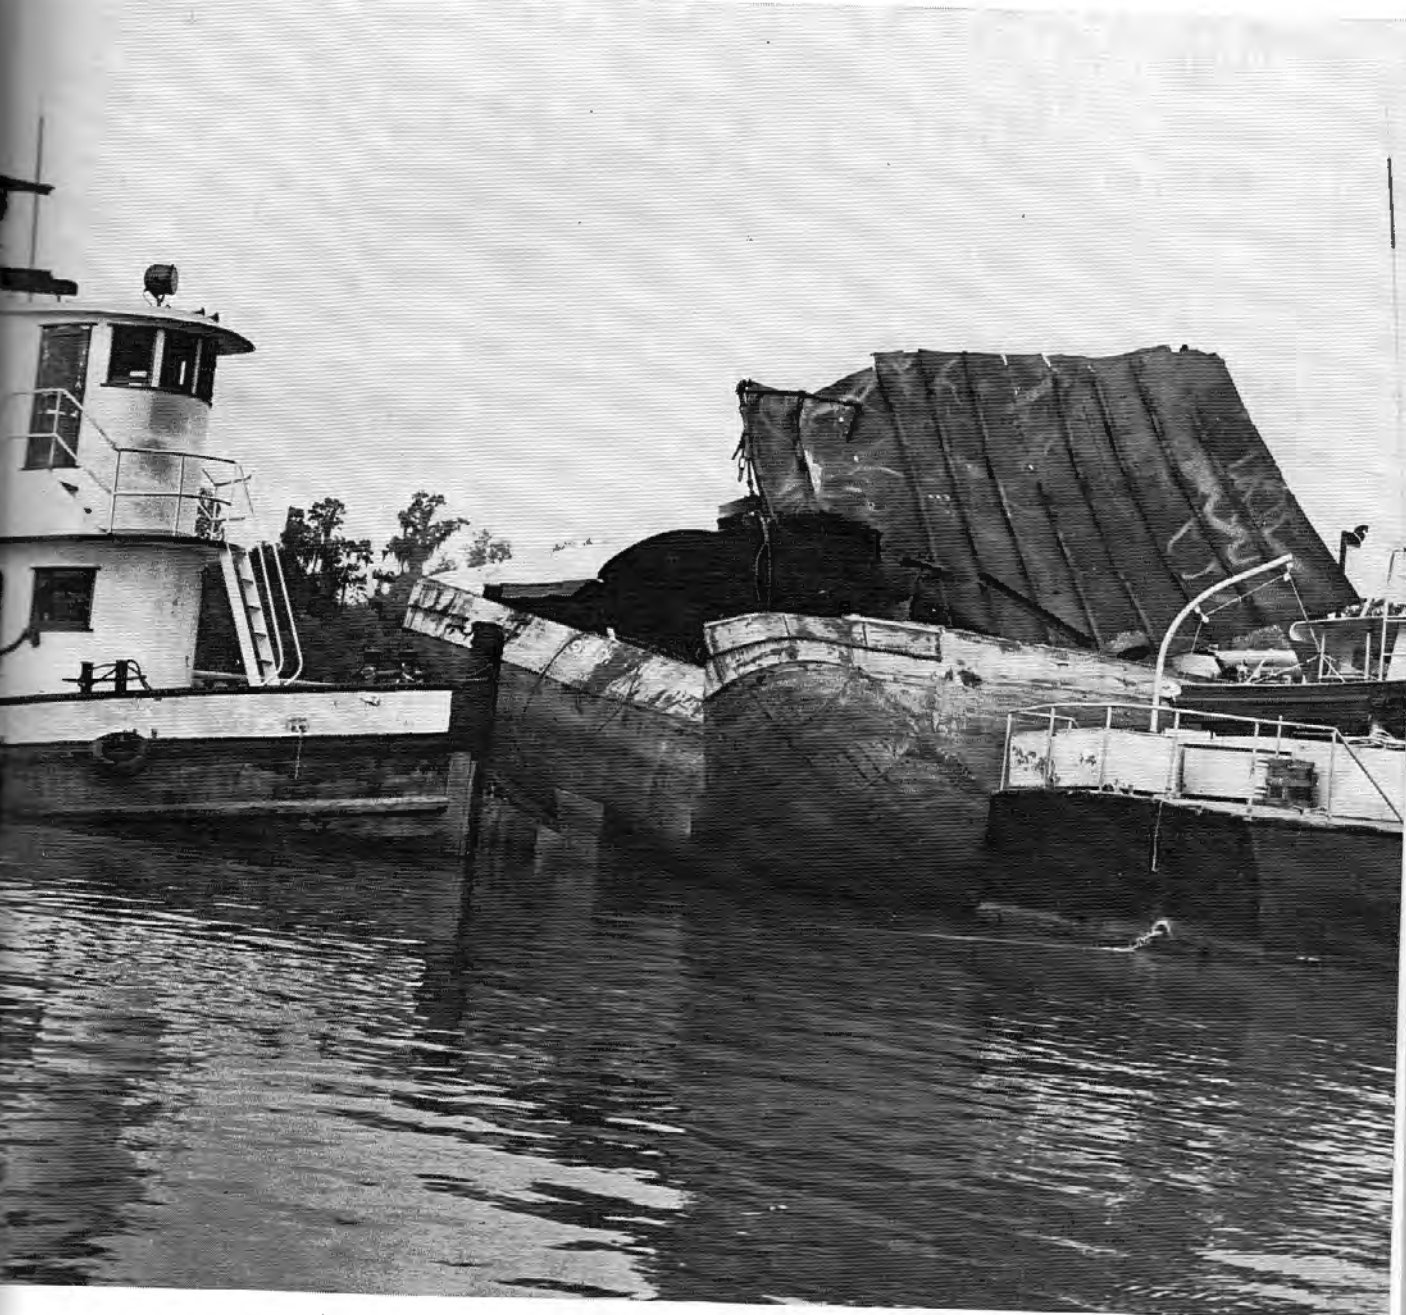
**FRONT COVER:** This month's feature casualty involved a tugboat, a tank barge, a motorboat and a waterfront petroleum product loading facility. Pictured on our cover are the involved tugboat, left, and the heavily damaged barge, which suffered a violent explosion in its after rake tank. The vessel at right assisted in firefighting efforts.

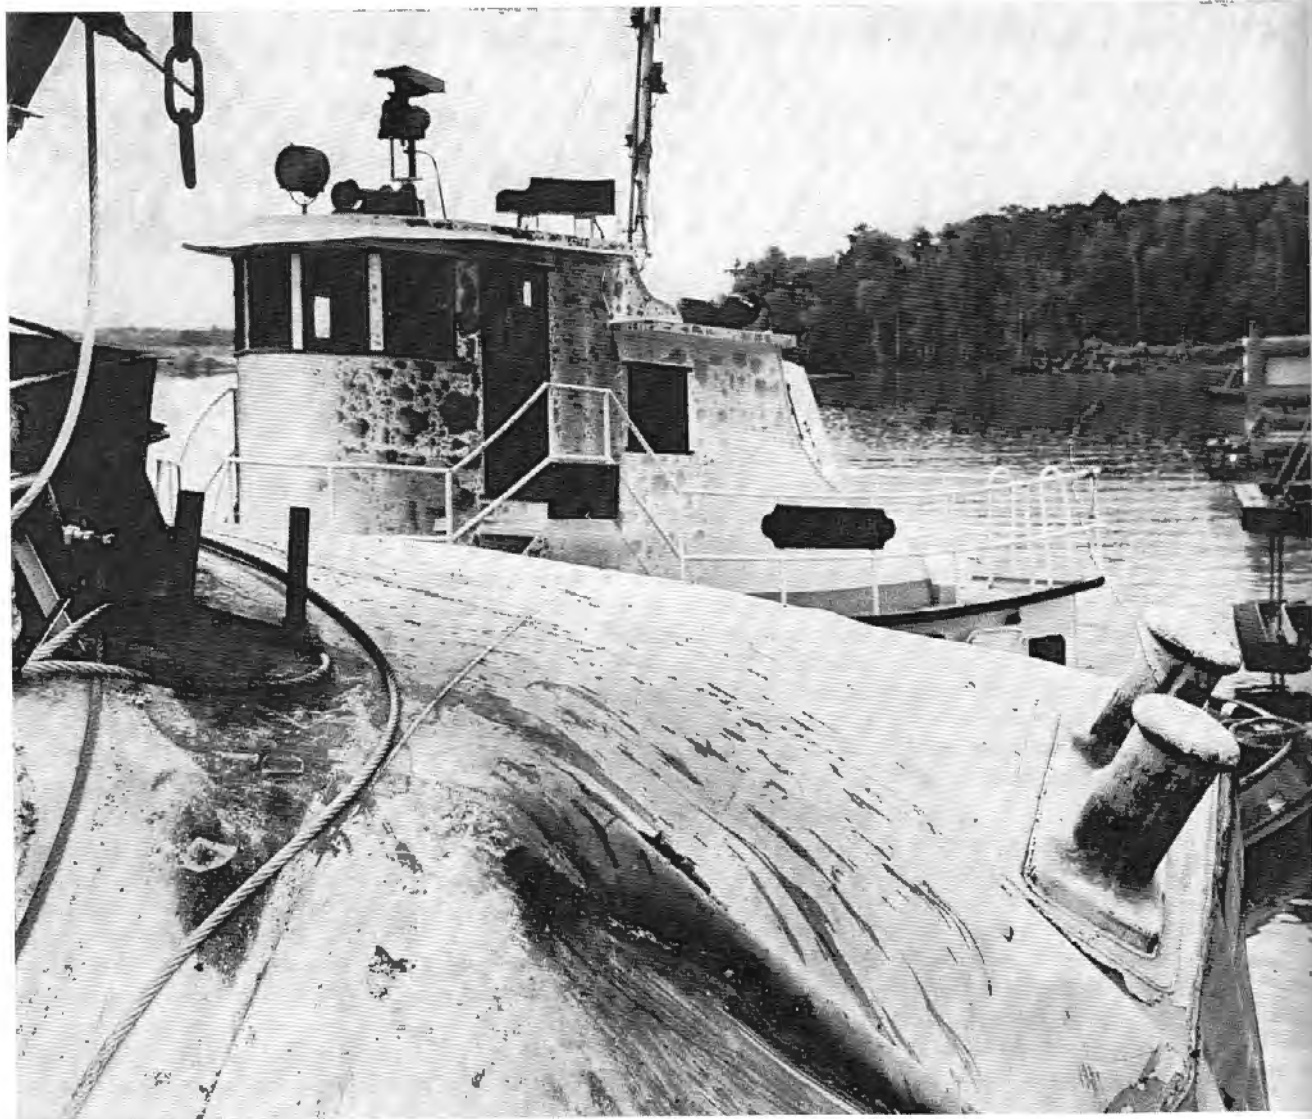
*The New Work was scorched by the fire in the alternate route of the Gulf Intracoastal Waterway, but otherwise she remained seaworthy and was able to push the still watertight Sun Chem 1100 to Port Arthur, Tex., for repairs.*

The tug *New Work* received moderate damage from the explosion and her paint was scorched, but she re-

mained seaworthy. The *Sun Chem 1100* suffered severe explosion and fire damage above the waterline, but remained watertight. Repairs were made to the barge at Port Arthur, Tex.

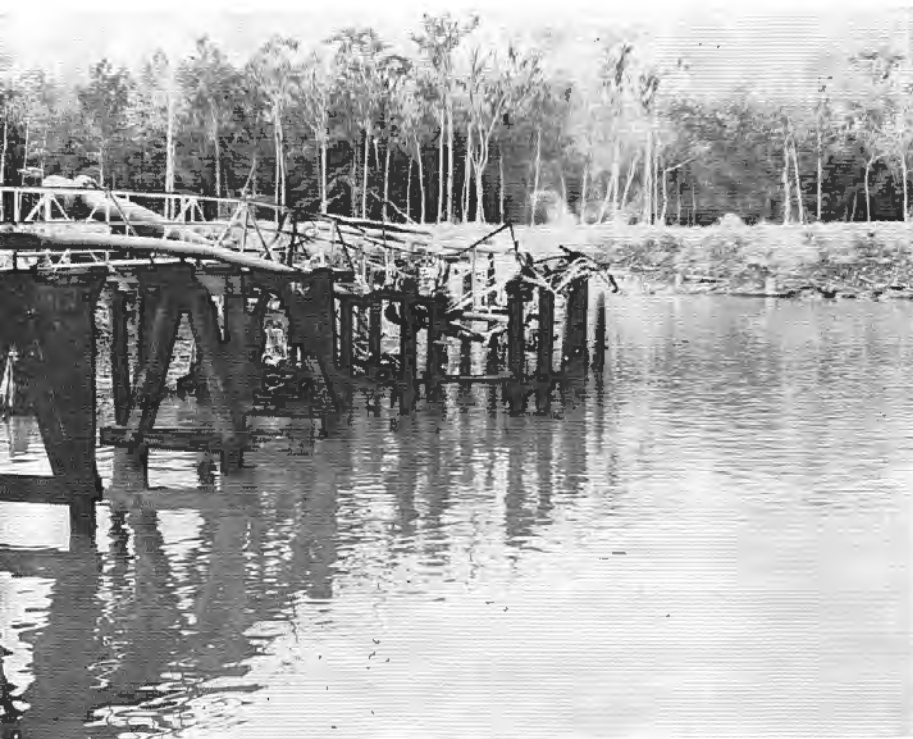
*In this picture, taken from the barge, is shown the damage to the railing structure and the pipeline that leads from the shore to the barge loading terminal. Parts of the structure are still smoldering, as manifested by the smoke rising at the center of the picture.*

In the early morning hours of July 24, a Corps of Engineers vessel arrived. The fire on the tug was out and fire on the barge had diminished. Fire continued to burn from the ruptured pipeline. The vessel moved alongside the barge and extinguished the fire with foam. The fire at the ruptured pipeline was not considered a further hazard and was allowed to burn itself out.

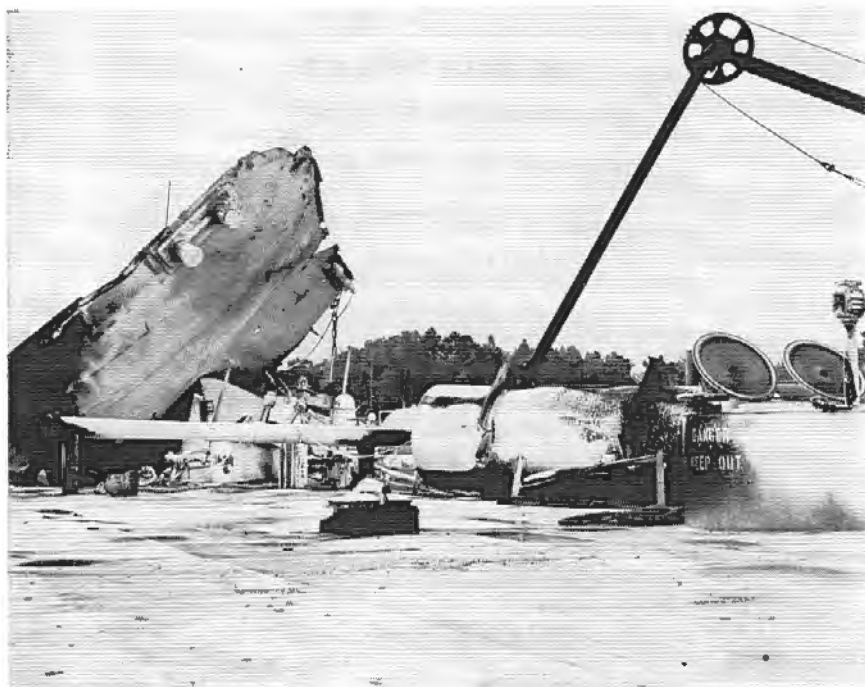
—That it is likely that the manhole for the *Sun Chem 1100*'s after rake tank was open or not fully secured, allowing the ingress of hazardous vapors and ignition into that tank. This resulted in the explosive atmosphere and subsequent explosion within the tank. In addition, it is probable that flame screens were in place over the open manholes to the cargo tanks, accounting for the fact that these tanks burned only at their openings.

*The above photograph was taken from the starboard side of the Sun Chem 1100's deck, looking aft. It shows the expansion trunk to the No. 3 port and starboard tanks, the manifold, and much of the damaged area. The rigging at the top right is the shore side connection to the manifold on the barge.*
