# ***PROCEEDINGS***

**OF THE MARINE SAFETY COUNCIL**

**UNITED STATES COAST GUARD**

# BARGE BLASTS KILL TWO

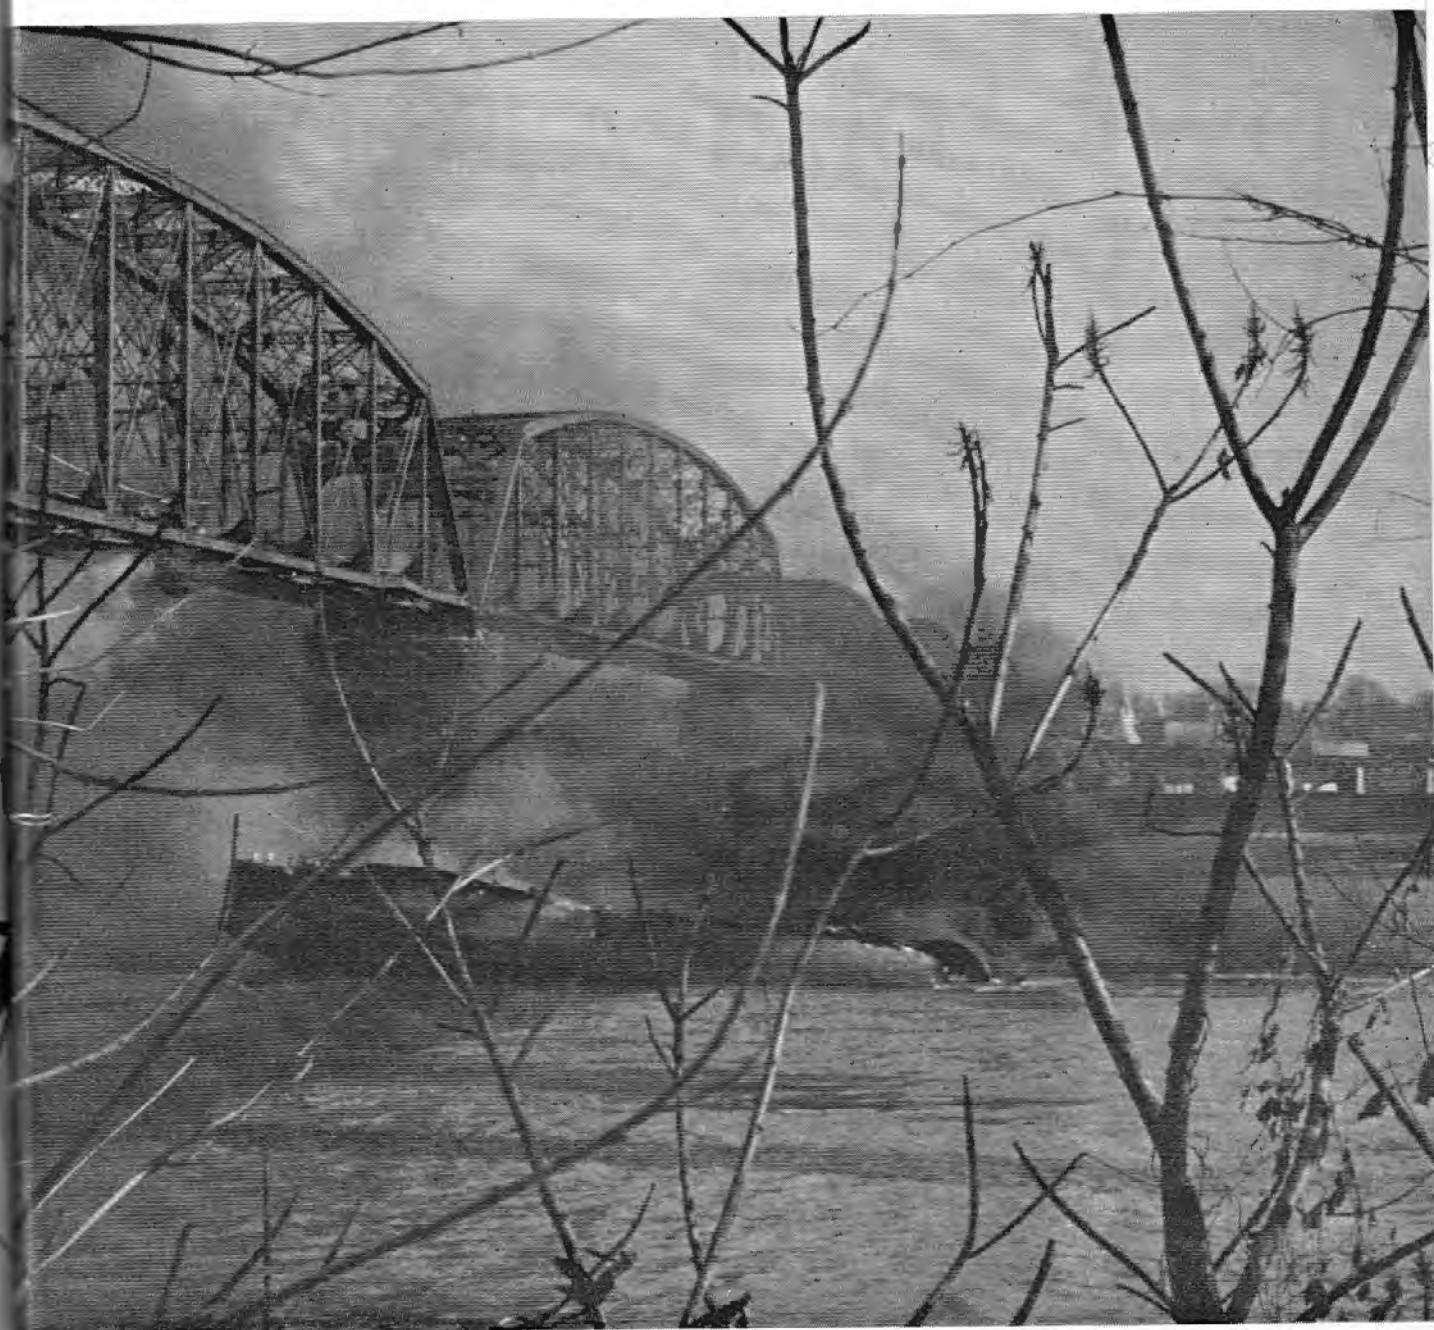
**FRONT COVER:** Smoke from the fiery remains of two tank barges that exploded after striking a bridge support at Parkersburg, W. Va., smudges an early January sky. Story on page 3.

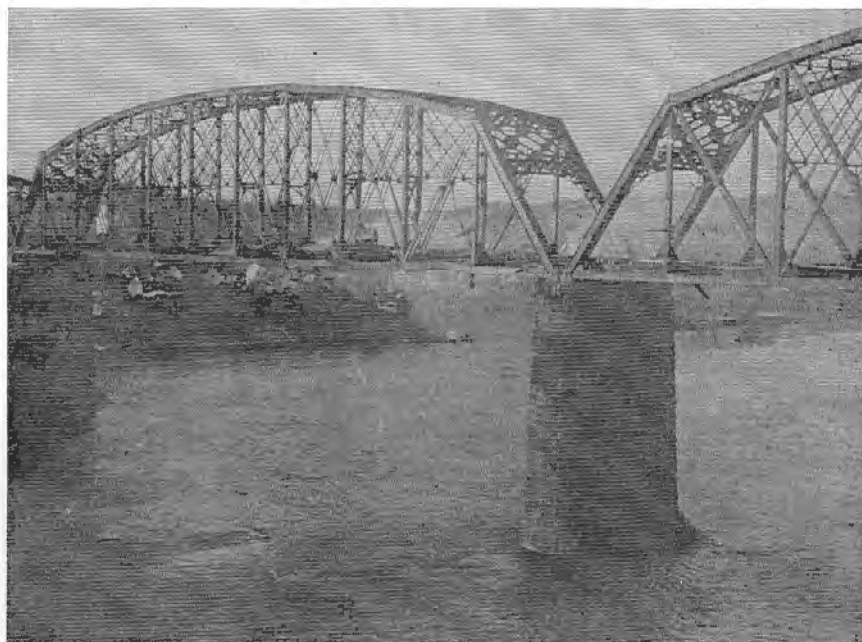
Damage to the bridge at Parkersburg was estimated at \$1 million. Replacement rather than repair of the span that suffered the effects of the explosion was deemed the most efficient method of returning the bridge to service.

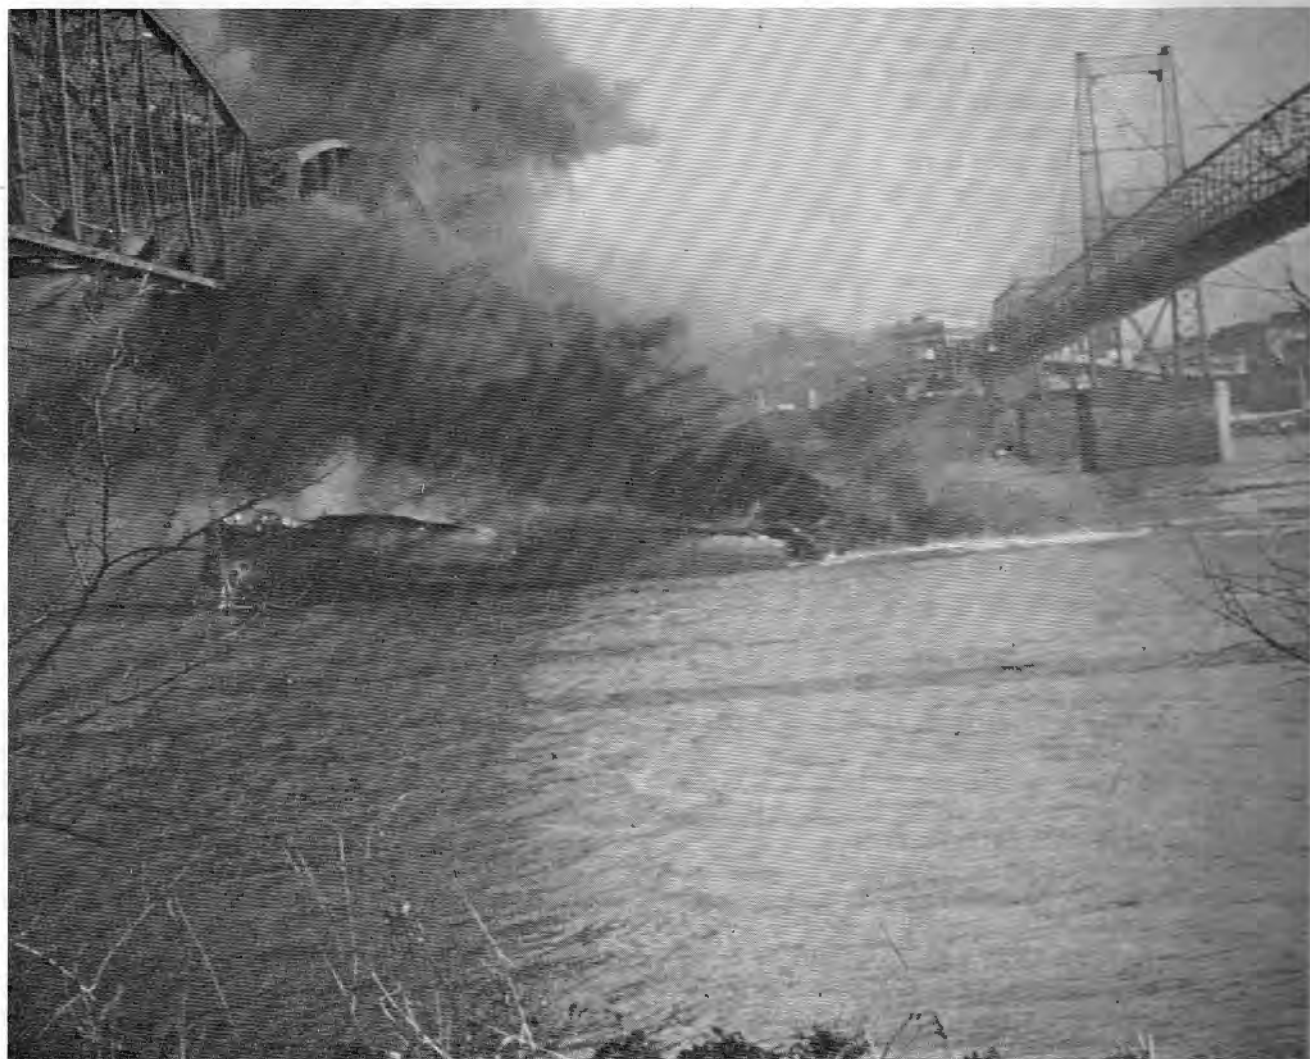
This close-up photo shows the burning MOS 103 as it came to rest in the main channel of the Ohio River at mile 184.5.

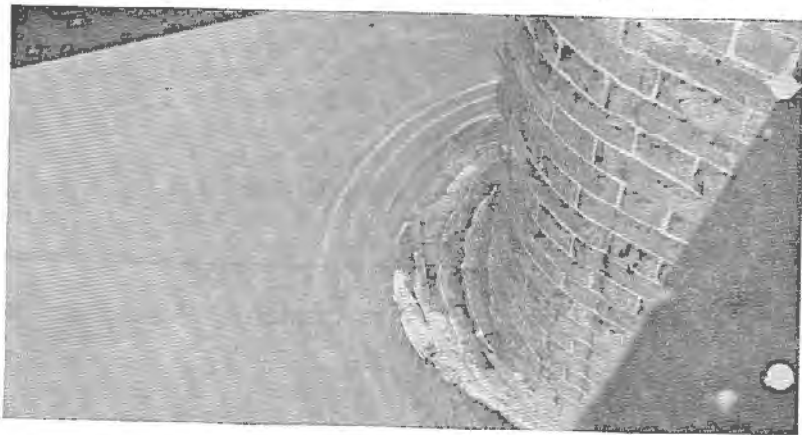
In addition to the narrowness of the channel between the bridge piers, the Coast Guard investigating officer also cited the construction of the supports as a possible hazard to navigation. Each of the piers has approximately 12 steps located on the upstream side of the supports, with the vertical distance between the steps measuring 24 inches.

Because many of these steps are under water most of the time, a vessel passing under the bridge has to contend with what amounts to an unseen projection from the pier. A projection of this nature poses the danger of holing a vessel below the waterline—a possibility which was mentioned by the investigating officer as one possible explanation of the explosion aboard the MOS 101.

A study of the Parkersburg Railroad Bridge is now underway in the Second Coast Guard District as a result of the casualty. If the facts of the case warrant further investigation, the Commandant may conduct a public hearing. With the information garnered from the public hearing and from other sources, a more exhaustive study of the condition of the bridge would be made, after which the bridge could be declared an unreasonable obstruction to navigation. An order to alter the structure would then be issued under authority of the Truman-Hobbs Act of 1940.

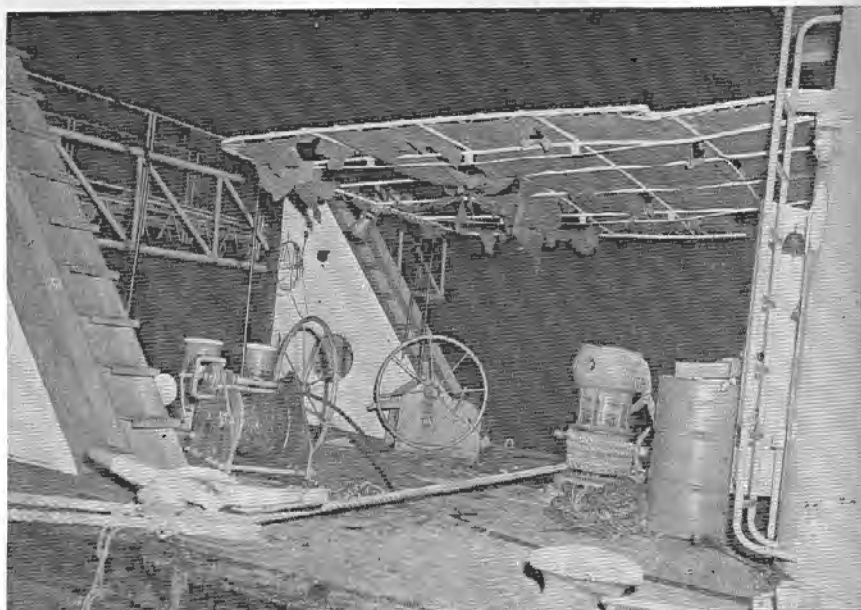
This photo shows some of the damage incurred by the *Martin* in the casualty. The vessel was back in service following repairs.
