PROCEEDINGS

OF THE MARINE SAFETY COUNCIL

Steel Vendor Stranding . . .

THE LOSS OF THE STEEL VENDOR

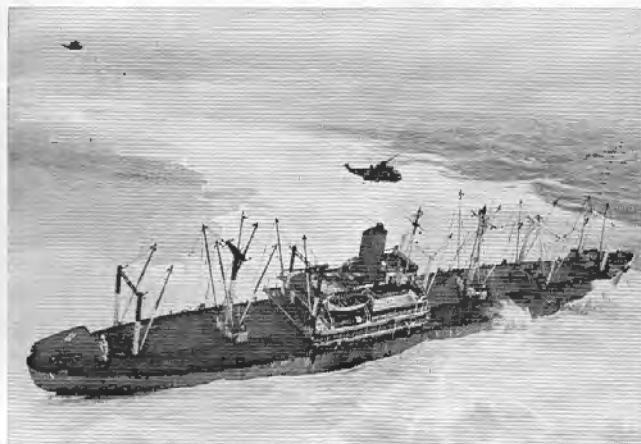
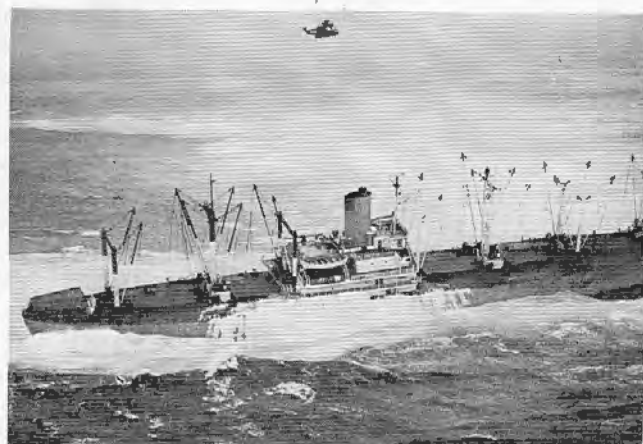
At about 2:36 p.m. on October 7, 1971, the *SS Steel Vendor*, at the mercy of the wind and the sea, slammed into the Loaita Bank Reef in the South China Sea. The photographs above show the ship grounded during evacuation of her crew by helicopter. Heavy waves pounded the vessel's starboard side, walking her farther onto the reef.

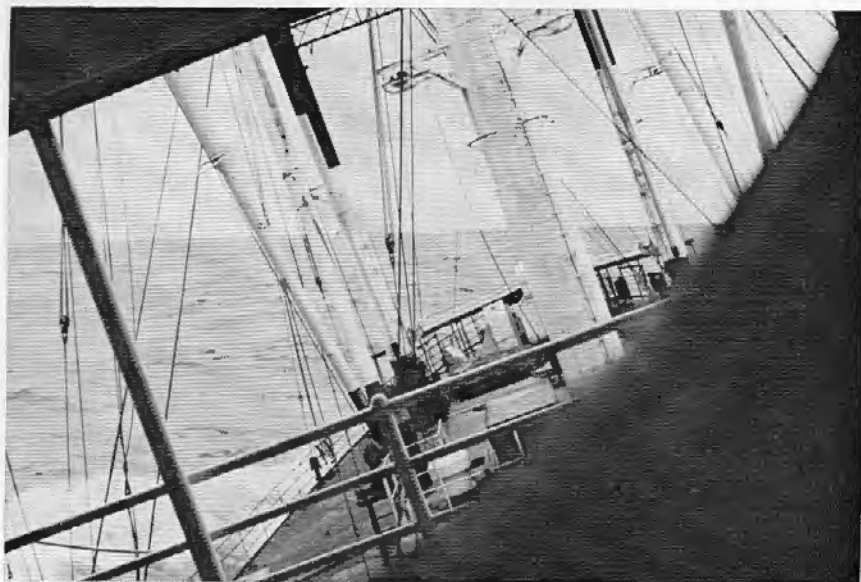
The above photograph, taken looking aft on the *Steel Vendor*, gives an impression of the vessel's list as she lay stranded on the reef.

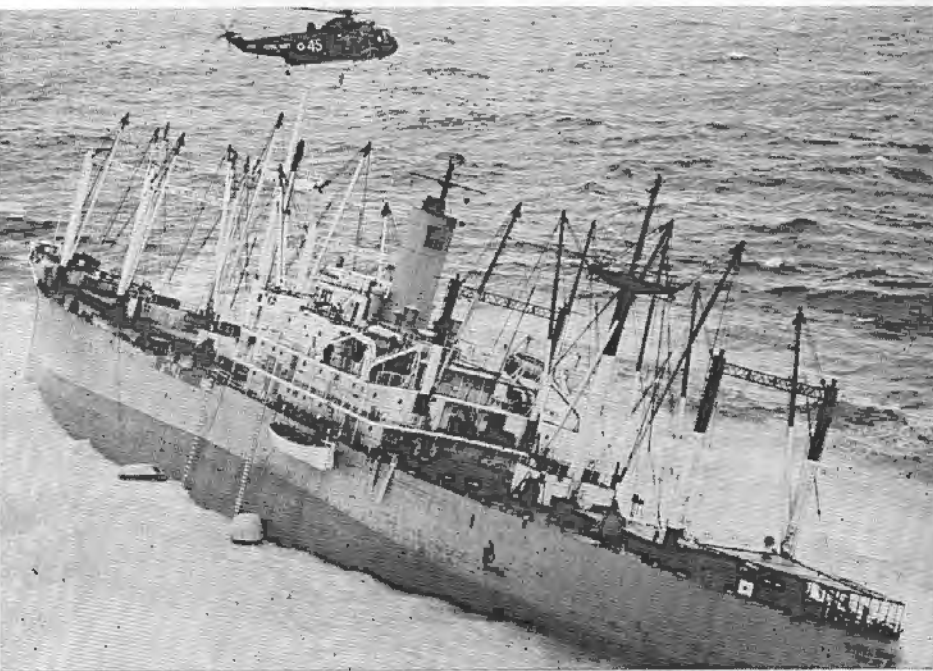
The crew of the *Steel Vendor* had prepared emergency gear for abandoning ship in the event that help did not arrive in time. The ship provided a lee to the crashing breakers enabling the crew to lower the inflatable liferafts without difficulty.
