PROCEEDINGS

OF THE MARINE SAFETY COUNCIL

UNITED STATES COAST GUARD

Lessons from Casualties

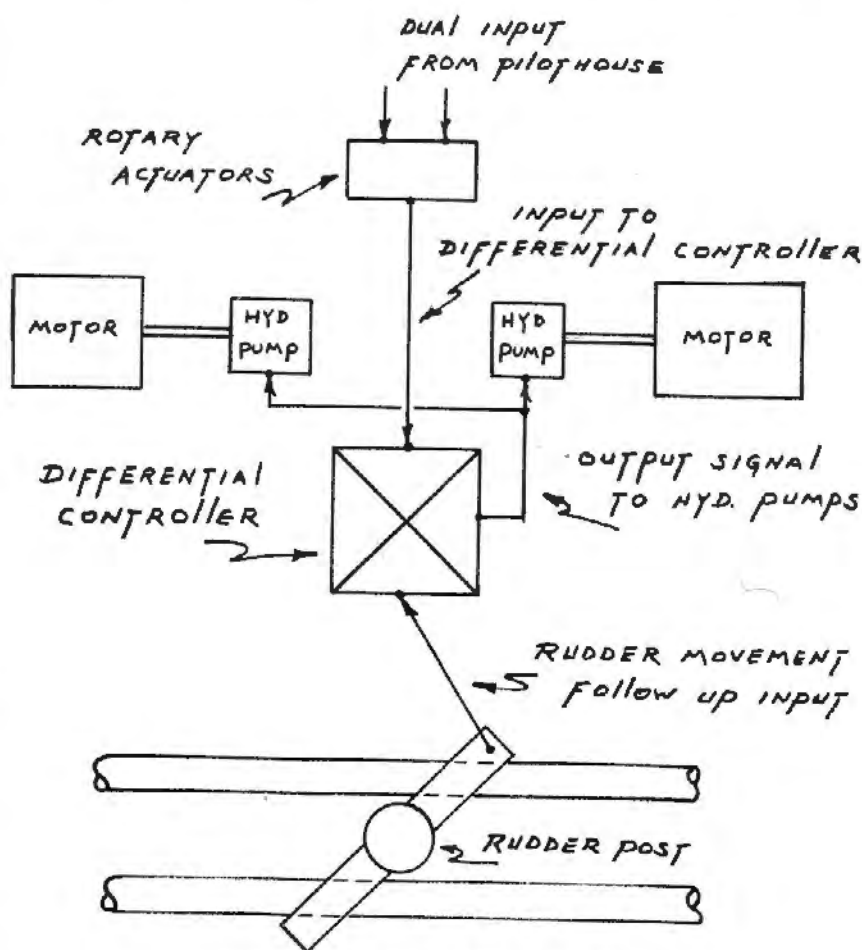
Typical Steering Gear Differential Control

The most significant of these is the differential controller, a gear box which receives a helm order signal, a follow-up signal, and provides an output signal to the main hydraulic pumps. These signals are transmitted by rotating shafts or plungers which may be connected by various type couplings and universal joints held in place with taper pins, keys, set screws, cotter pins, or compression pins.

directly connected to the differential controller. Service has shown this piece of equipment to be extremely reliable; thus no requirement has been established for its duplication. What has failed, however, is the connecting linkage between the differential controller and the other components.

the follow-up linkage to the differential controller failed. Undoubtedly, vibration of these units is a contributing cause of these casualties. Because of their proximity to the ship's screws, steering gear units are subjected to considerable vibration; thus there is

substantial likelihood for this type of failure to occur unless proper remedial action is taken.
