OF THE MARINE SAFETY COUNCIL

THIRTY HOUR RESCUE EFFORT SAVES TWO IN SEA LINK INCIDENT

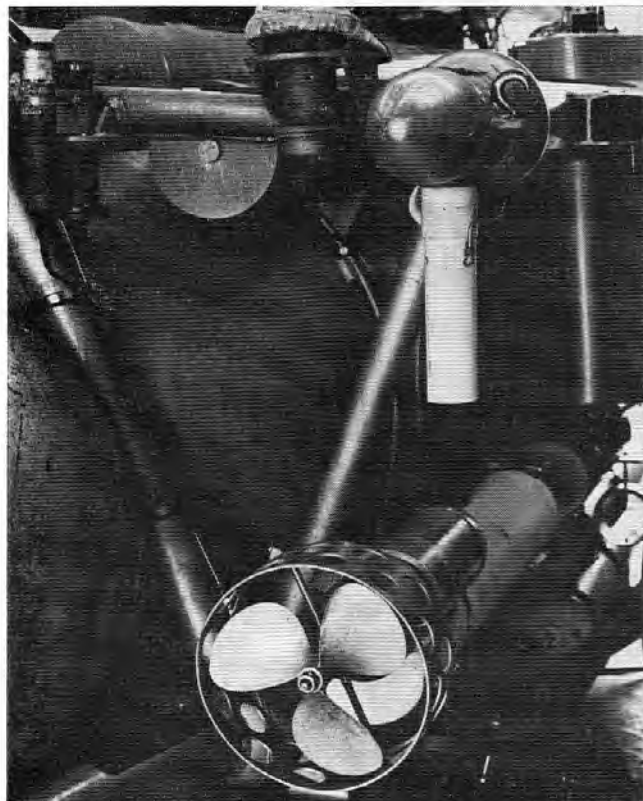
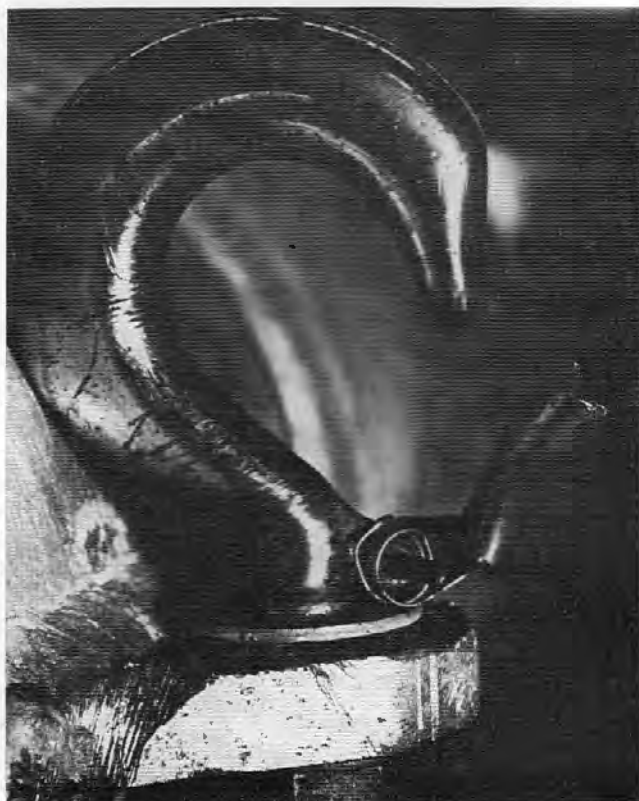
Immediately above the starboard propeller shroud is a steel hook, which is used to restrain guide lines. This hook displayed evidence of chafing and scoring. The spring-loaded mousing device was also wrenched from its normally closed position.

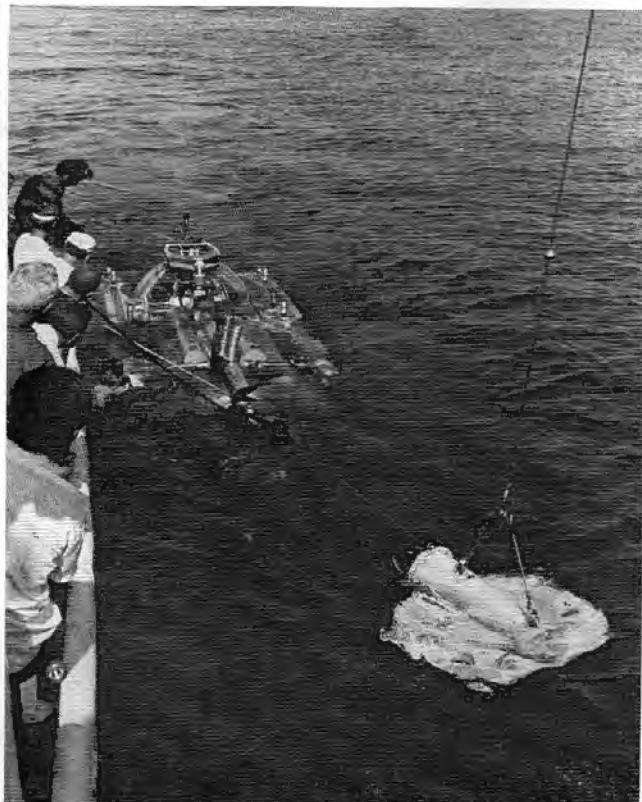
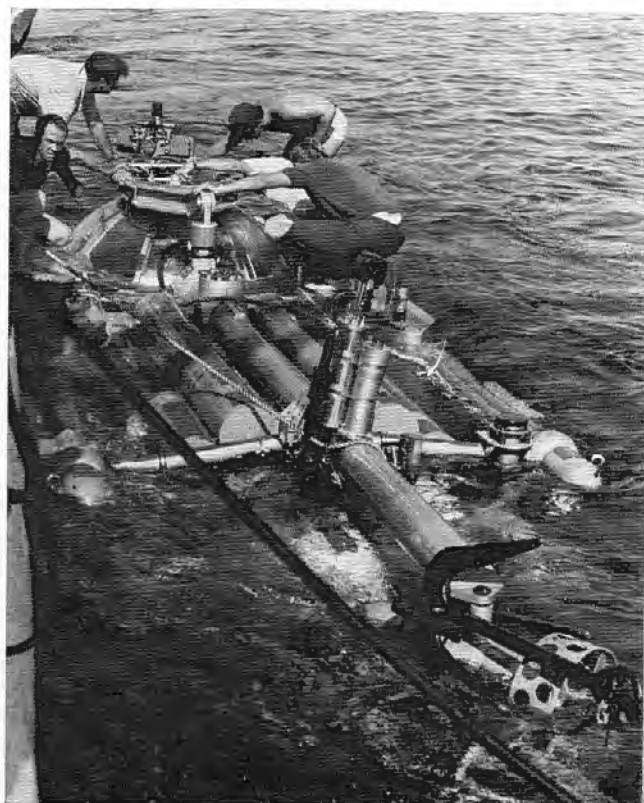
The *Sea Link* is brought to the surface still connected to the T.V. camera and maneuverable platform which guided the grapple to the stranded submersible and its four occupants.

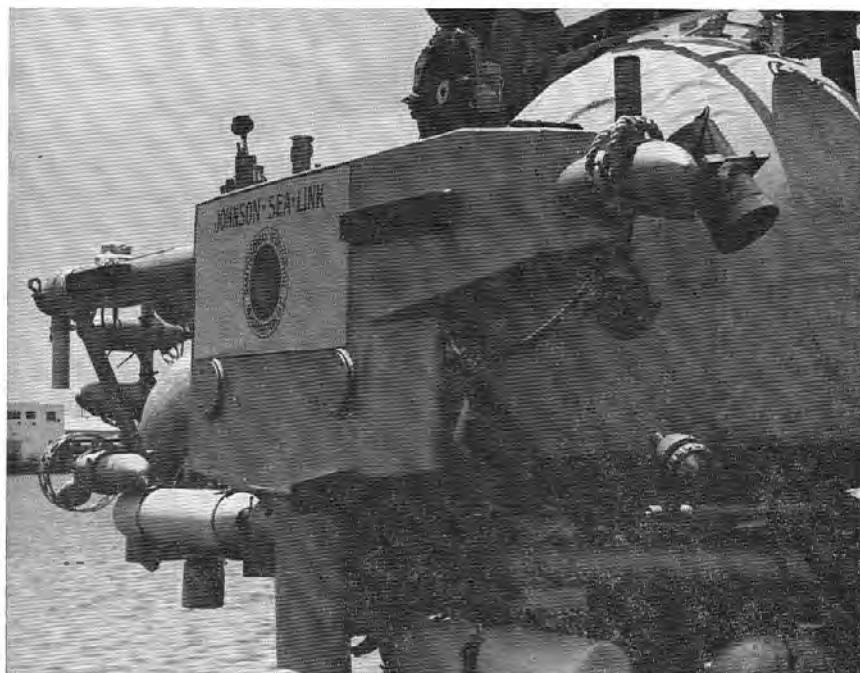
The *Sea Link's* unconventional configuration of assorted appendages was found to be a factor leading to the entanglement.
