# ***PROCEEDINGS***

**OF THE MARINE SAFETY COUNCIL**

**Vol. 32, No. 8**

# TANKER GROUNDING

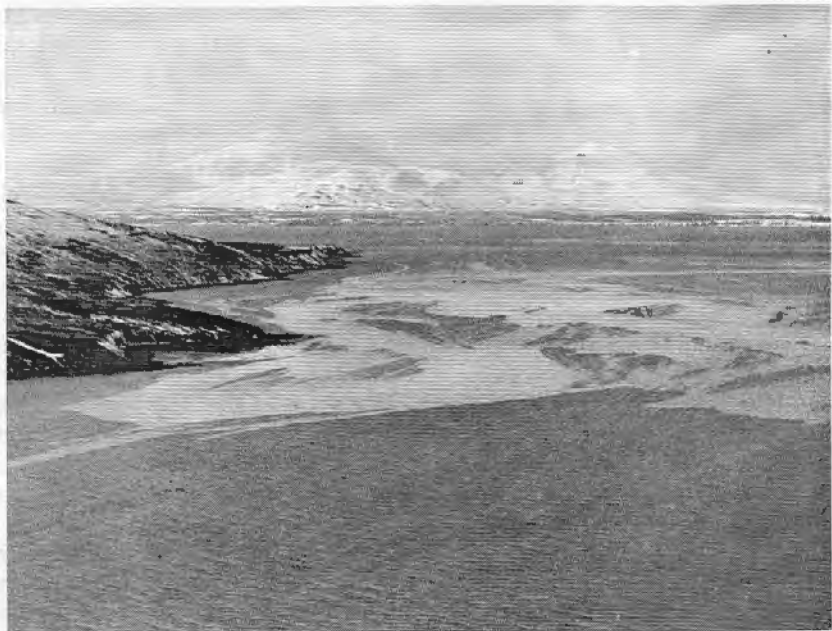
*oil slick spreads as strike team*

*moves to minimize damage.*
