OF THE MARINE SAFETY COUNCIL

The Silver Dove

The following narrative account was extracted from the Marine Casualty Report (No. USCG/NTSB-MAR-76-1) released 28 November 1976. Single copies of the complete and detailed report may be obtained without charge by writing to the Commandant (G-MMI-1/83), U.S. Coast Guard, Washington, D.C. 20590. Multiple copies may be purchased by mail from the National Technical Information Service, U.S. Department of Commerce, Springfield, Virginia 22151.

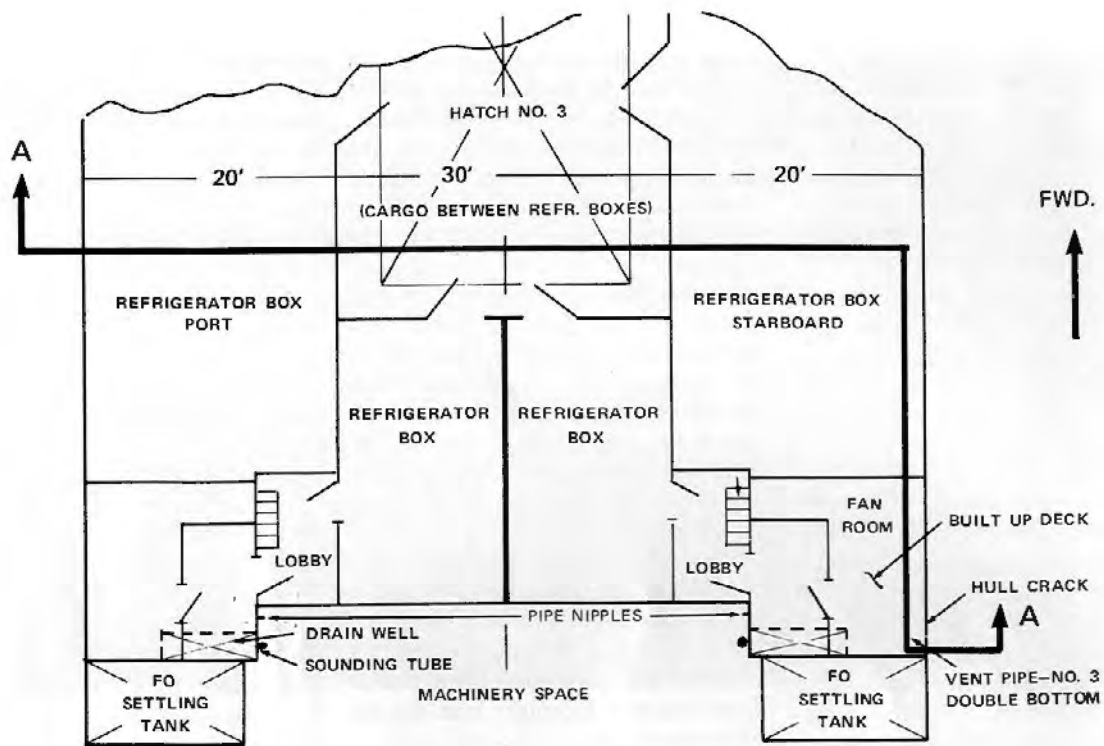
PARTIAL PLAN VIEW OF THIRD DECK

The largest hold on the vessel was the No. 3 cargo hold (where the hull failure occurred) which was capable of accepting 147,330 cubic feet of bulk cargo. The lower tween deck space of the No. 3 hold was fitted with four refrigerated cargo boxes, two of the boxes located longitudinally in the wings and two smaller boxes located aft of the hatch opening. The diffuser (fan) rooms were located at the after outboard corners of the hatch. Inboard of these diffuser rooms and adjacent to the smaller refrigerated boxes were small lobbies which had inclined ladders leading up to the upper tween deck. The lobbies provided access to either the adjacent diffuser room or the inboard small refrigerated box.

The master and chief engineer were immediately notified and came to the scene. Initial attempts to remove the water with a bucket were unsuccessful, so the general alarm was sounded and all hands turned to forming a bucket brigade. Upon further inspection an 8-inch hull failure, variously described as either a series of small holes or a crack, was located approximately 8 inches above the steel deck. This crack was generally horizontal, centered on frame 100, and passed through a half-round scallop in the frame.

After returning to the master's cabin the inspectors discussed the type of repair to be made. Since no commercial drydock facilities were available at Guam, it was agreed that a temporary repair would be acceptable, consisting of a concrete patch inside a fabricated steel box between frames 99 and 101.

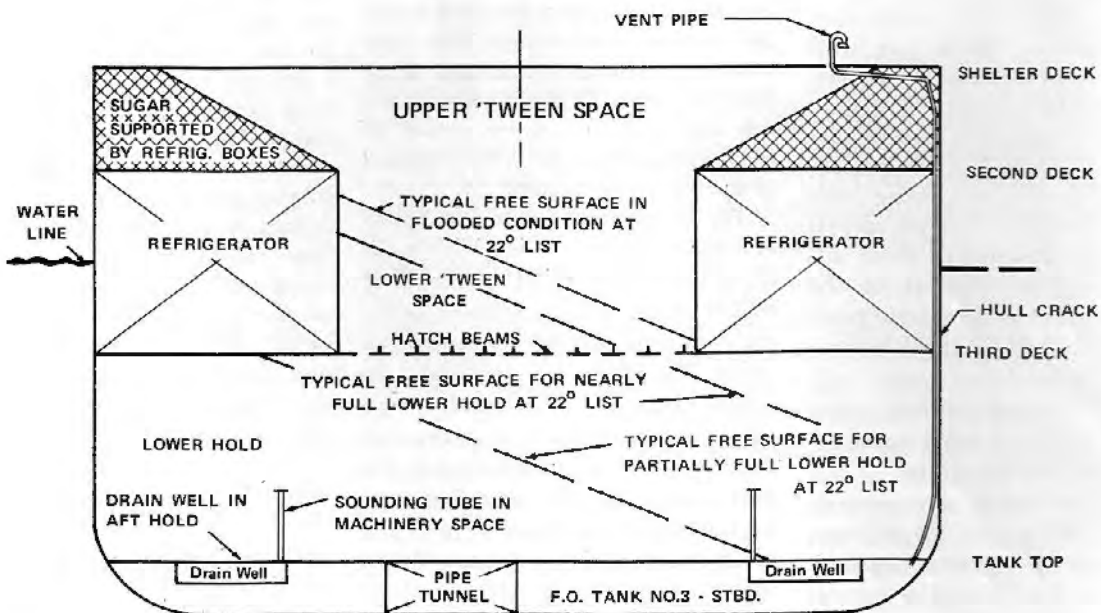
SECTION VIEW - A-A LOOKING FORWARD

The exact cause of the hull failures is unknown. The testimony provided conflicting descriptions of the faults; however, heavy deterioration was observed by many who were directly involved with the repairs. The probable cause of the deterioration was localized corrosion in the trough formed by the deck plate on the bottom, the built-up deck insulation on the inside and the shell plate on the outside where moisture from condensation, water, and brine spills could collect. This corrosion resulted in reduction in plate thickness and severe pitting near the deck.

The plate thickness near the deck was probably reduced to a point where the combination of plate stress plus stress concentration factors associated with pits resulted in a number of plate penetrations connected by a fracture line. Since the exposure to a corrosive environment would be essentially identical in the three after frames spaces, it is conceivable that the plate failure would occur in several places over a short timespan. Additionally, an indentation existed in way of the original failure in plate SG-12. Such an indented condition in way of deteriorated plate would have a decided influence on the location and extent of the original hull failure.
