PROCEEDINGS

OF THE MARINE SAFETY COUNCIL

Acid Spill

Where Did All the Acid Go?

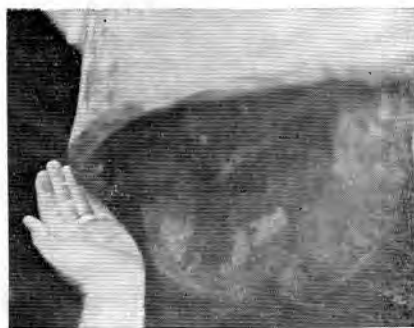
The Coast Guard investigating officer concluded that the proximate cause of the casualty was the hole in the forward rake. Water entered this hole as the AC 38 was first pushed and then towed, with the following wind and sea adding to the influx. As the forward rake filled with water, the barge trimmed by the bow and the range of stability decreased to a point where, when the AC 38 sheared to port and the hawser took a heavy

strain, the barge could not right itself and it rolled over. The damage to the cargo hatches and main deck was caused by the extreme reaction between the oleum and seawater as the acid escaped.

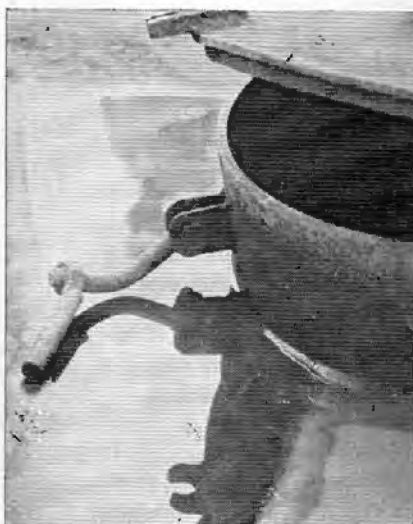
Another problem which soon became of more than just passing interest during the salvage was the fact that the barge was highly stable in the inverted position. The configuration of the barge was such that it was more stable upside down than right-side up when loaded with cargo.

The barge was built with externally framed centerline tanks. Surrounding each tank was a cofferdam about 4 feet wide at the sidewalls and about 3 feet above the barge bottom. Free transverse communication existed between the sidewall cofferdams under the bottom of the barge.

cargo. When the barge capsized, the location of the cargo tanks was effectively shifted downward 3 feet—or 1,000 tons in a 1,250 tons system was moved 3 feet closer to the keel of the barge, thus moving the center of gravity correspondingly downward. The barge would be quite happy to maintain an inverted attitude, assuming the cargo tanks were full and the void spaces empty.

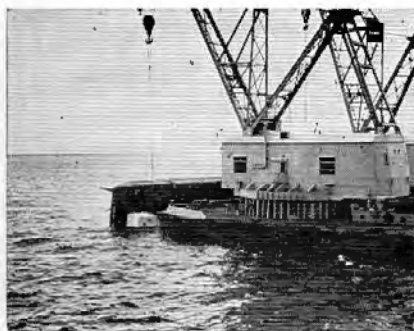
Upon righting, there was no indication of any acid-water interaction or vapor cloud production. In fact, the four cargo hatches were wide open. Onboard inspection of the barge showed no acid left in the cargo tanks although they were full of water. Many of the exterior deck longitudinals were deformed inward along with the tank tops, and many of the cargo tank gaskets and dogs were missing. There was evidence of

accelerated recent corrosion around the cargo tank hatches.

The most interesting aspect of the damage was that the cargo tank tops were deformed inward—indicating there had been a vacuum inside the tanks. This was somewhat unexpected, since the tanks must have been placed under tremendous pressure when the hatches were blown open and should have been deformed outward. After some thought a possible explanation for this damage emerges.

When the barge capsized, the weight of the oleum bore directly on the inverted tank tops. The structure was not designed for this weight and the tank tops, along with the external framing, were plastically deformed outward—as if under pressure. After the cargo had been released, the tanks were full of steam, acid mist, and hot air. The rapid reduction in pressure caused by cooling
